**ASBESTOS CONTAINING BUILDING MATERIALS
SURVEY REPORT**

**ASBESTOS CONTAINING BUILDING MATERIALS SURVEY
CHILD DEVELOPMENT CENTER
BUILDING 2213**

FORT McCLELLAN, ALABAMA

U.S. ARMY CONTRACT NO. DABT02-96-D-0005
DELIVERY ORDER 0005

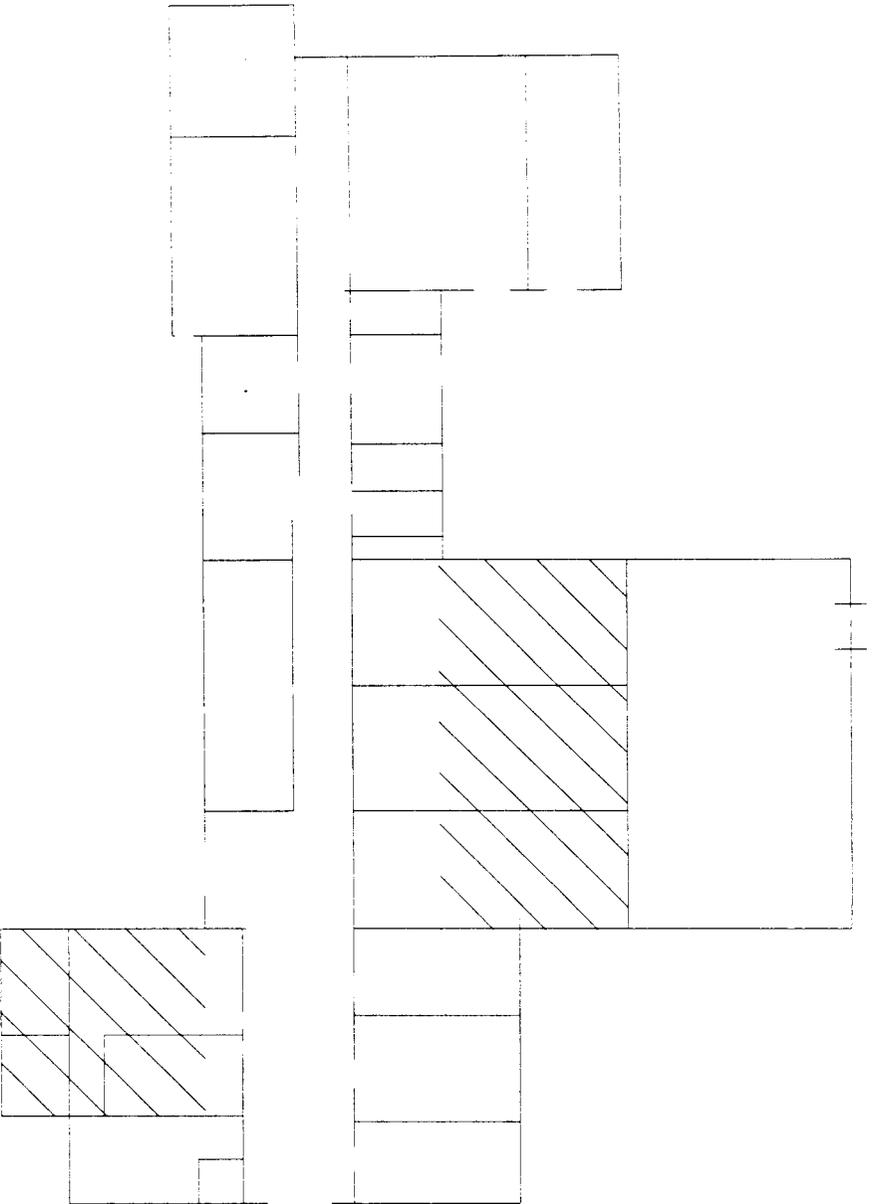
- 1) 9x9 inch asbestos containing vinyl floor tile was found in a small part of the building. The material was found to be in generally Good condition.

- 9 x 9 Floor Tile

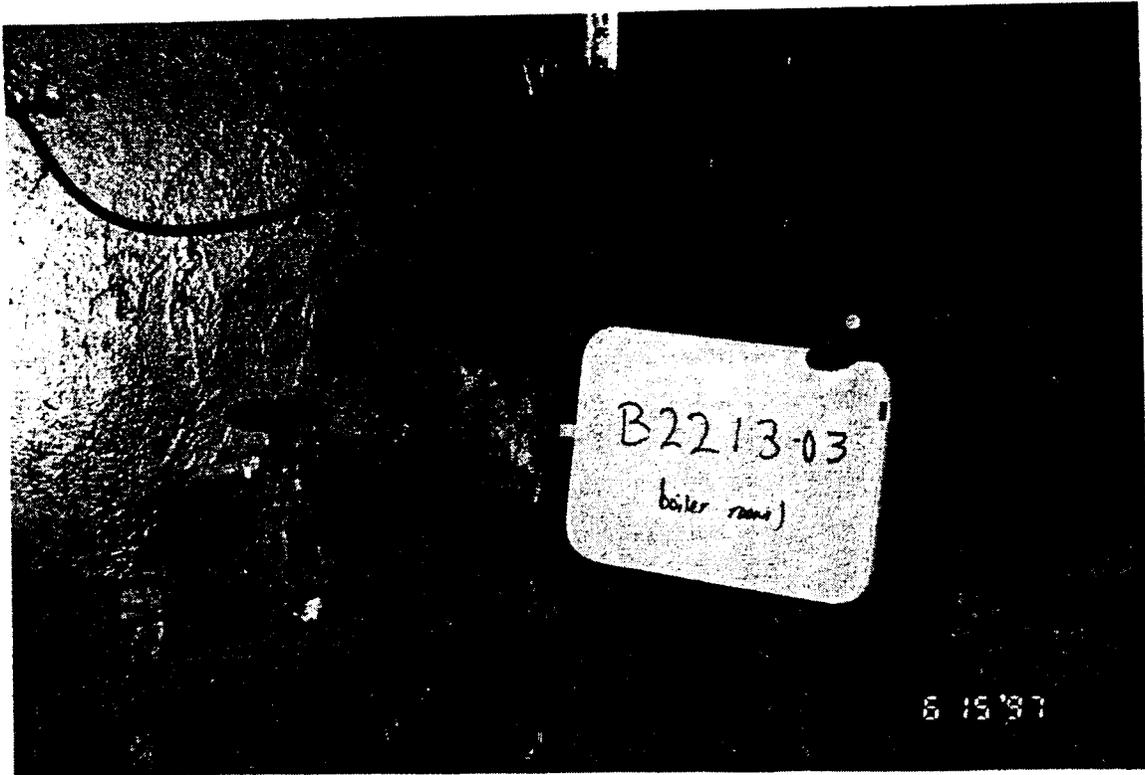
- 1) A friable, hand-formed, asbestos containing insulation compound is applied to some of the fittings of pipes located in the boiler room of the building. This material was found to be in generally Good condition.
- 2) A friable, white, asbestos containing insulation is found on some of the straight runs of piping in the boiler room. Piping accessible outside the boiler room was found to have fiberglass insulation. This material was found to be in generally Good condition.
- 3) A friable, white, asbestos containing insulation is found on the boiler in the boiler room. This material was found to be in generally Good condition.

B2213-03: Boiler Insulation

None of the materials identified within this report are damaged to the extent that significant asbestos fiber release may be likely under normal conditions. However, some of the asbestos containing materials are subject to routine maintenance activities that could involve significant disturbance. Those materials include the pipe fitting, straight run, and boiler insulation located in the boiler room. Proper management of the material in-place may be acceptable assuming the proper precautions are taken to eliminate exposure of personnel to any airborne asbestos. Reisz Engineering has written a Building Operations & Maintenance Plan for Building 328 and we suggest that recommendations included in this plan be followed.

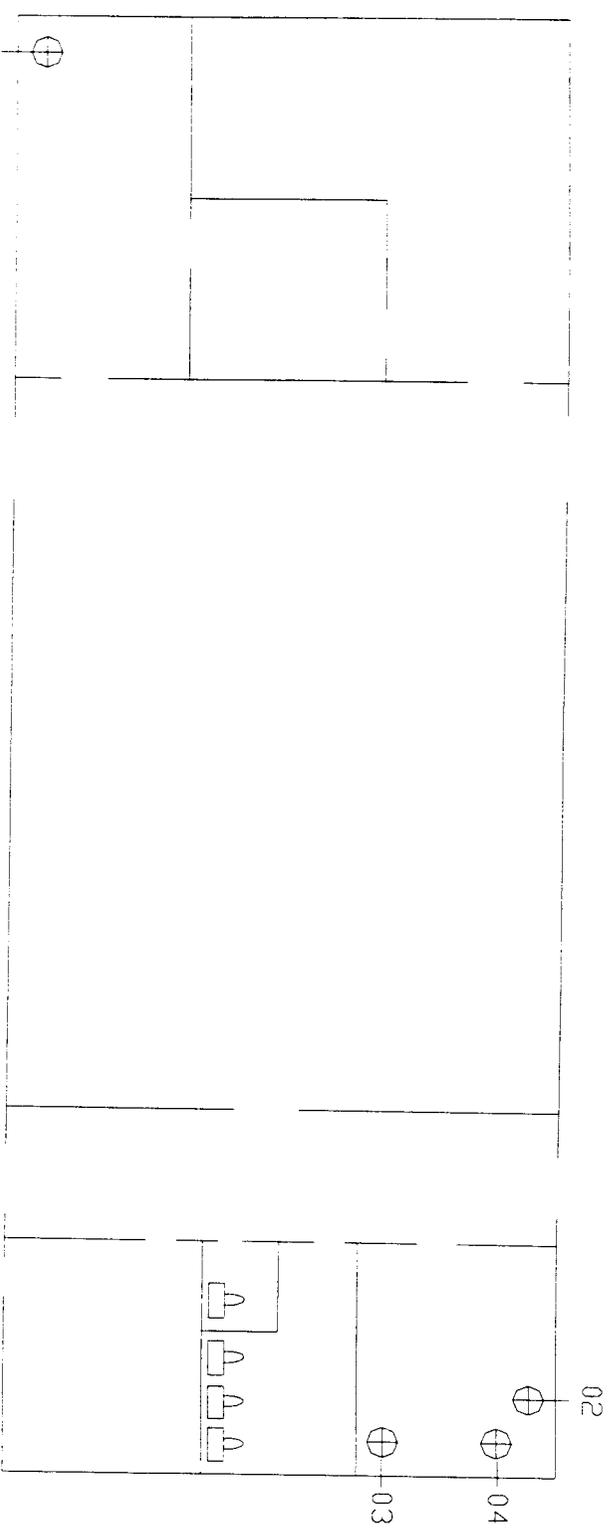
B3184 01
in basement mechanical room

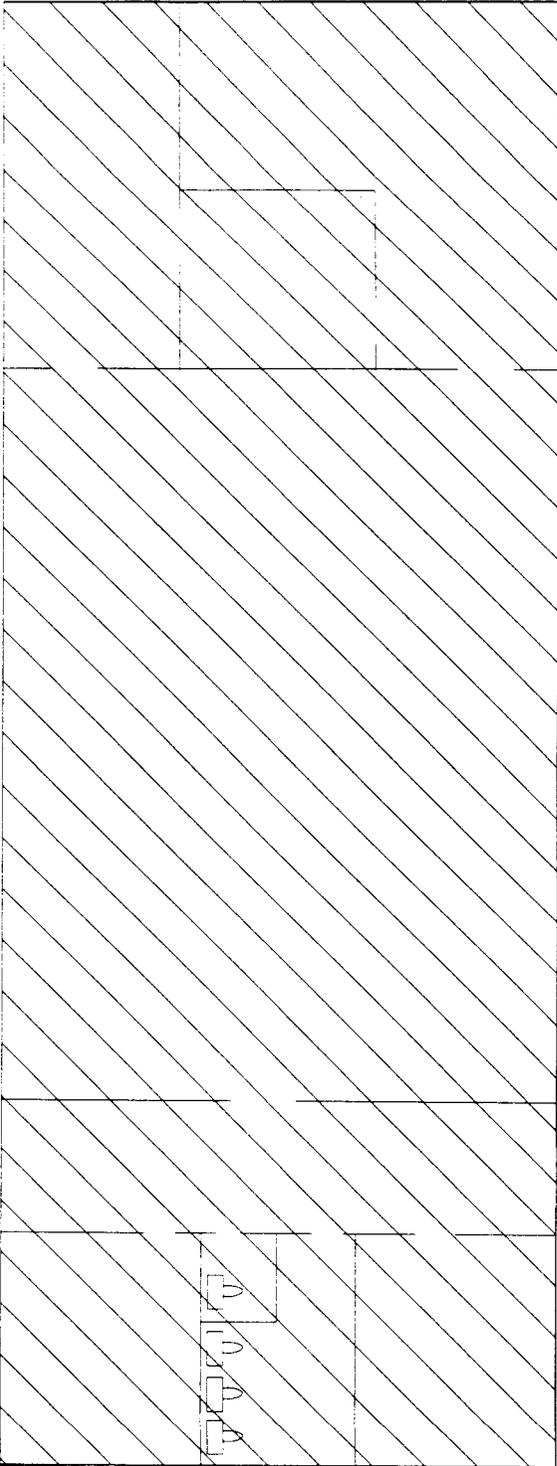
BUILDING 3184

- 1) 12x12 inch asbestos containing vinyl floor tile was found throughout the building. The material was found to be in generally Good condition.
- 2) Black, asbestos containing mastics are present below 12x12 vinyl floor tiles in the building.

12 x 12 Floor Tile
