**ASBESTOS CONTAINING BUILDING MATERIALS  
SURVEY REPORT**

**ASBESTOS CONTAINING BUILDING MATERIALS SURVEY  
BUILDINGS 3220-3244**

**FORT McCLELLAN, ALABAMA**

U.S. ARMY CONTRACT NO. DABT02-96-D-0005  
DELIVERY ORDER 0005

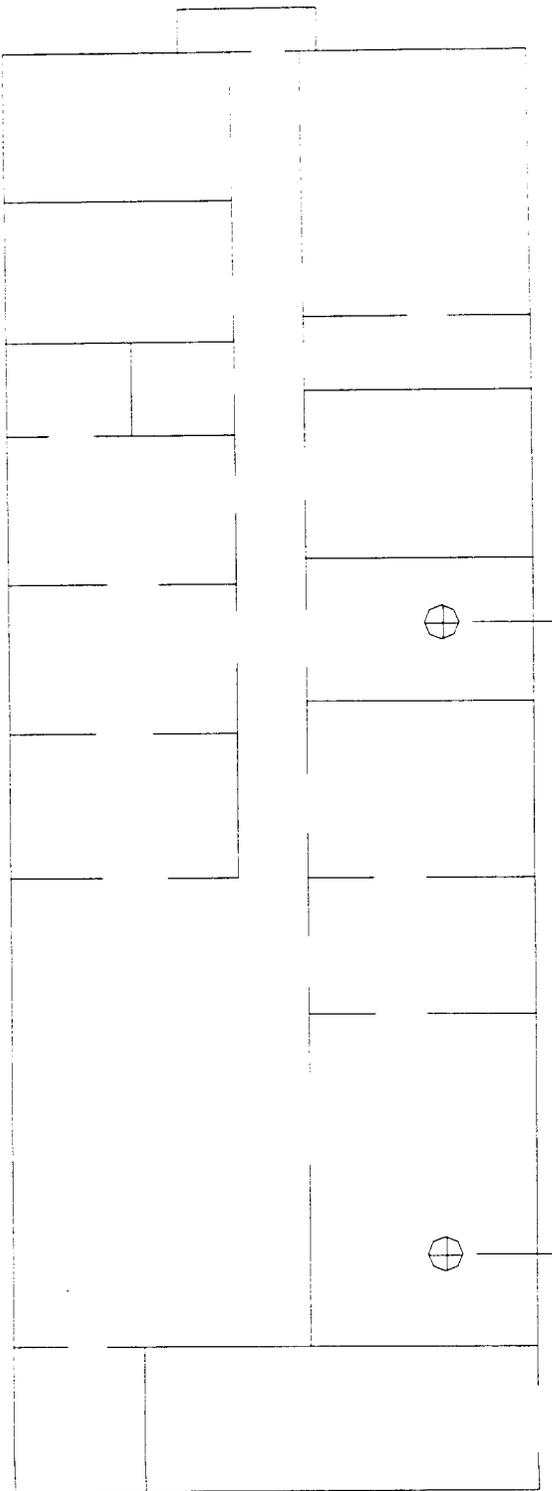
**SAMPLE LOCATIONS PLANS**

- 1) A friable, asbestos containing insulation is found on 3 inch pipes located in the mechanical room and other areas of Building 3290.

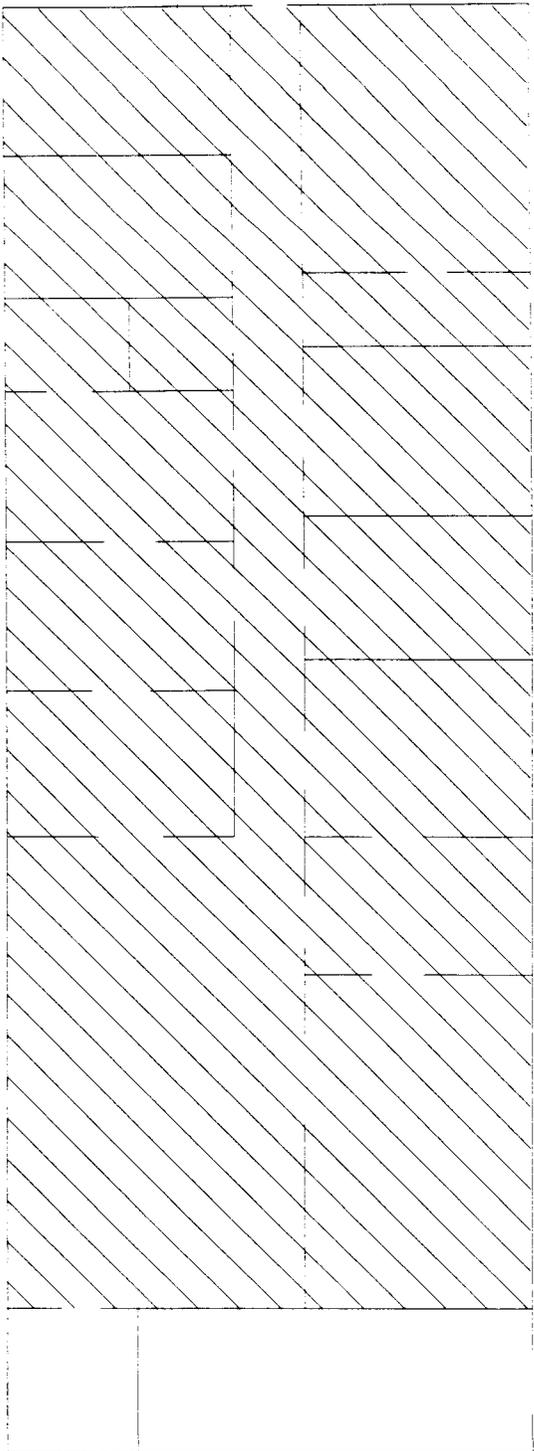
**SELECTED ACM LOCATION PLANS**

12x12 Floor Tile  
(Assumed ACM)

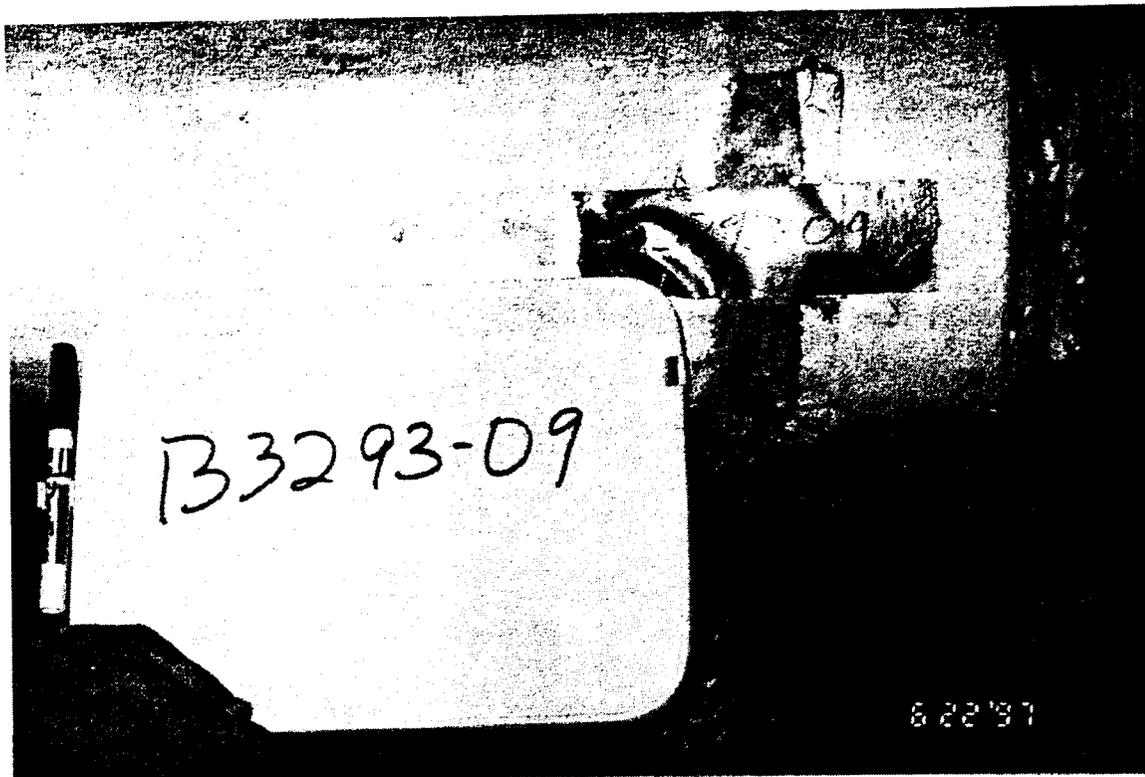
B3293-09: White powdery asbestos containing pipe insulation.
