**LEAD BASED PAINT
SURVEY REPORT**

BUILDING(S): 3401, 3402, 3403, 3407, and 3409

**LEAD-BASED PAINT SURVEY REPORT
LITTLEBRANT FAMILY HOUSING GROUP
BUILDINGS 3400 - 3411
FT. McCLELLAN, ALABAMA**

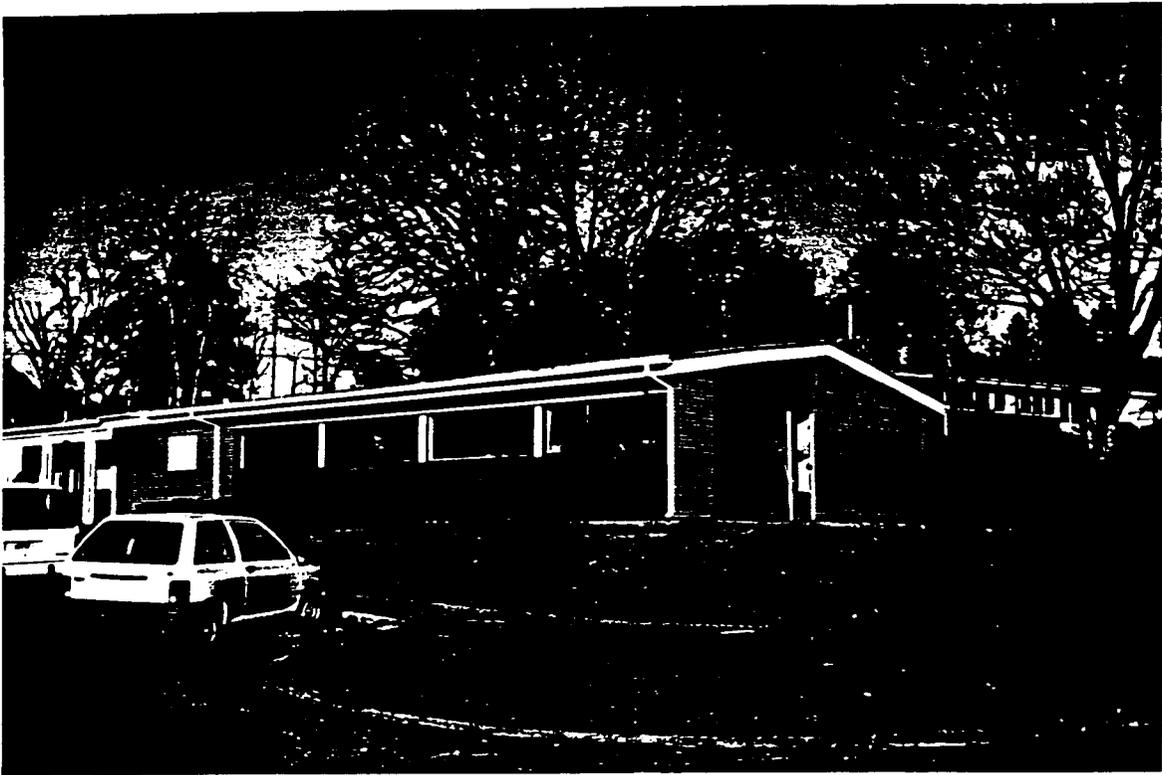
Figure 1. Front view of Building 3527.

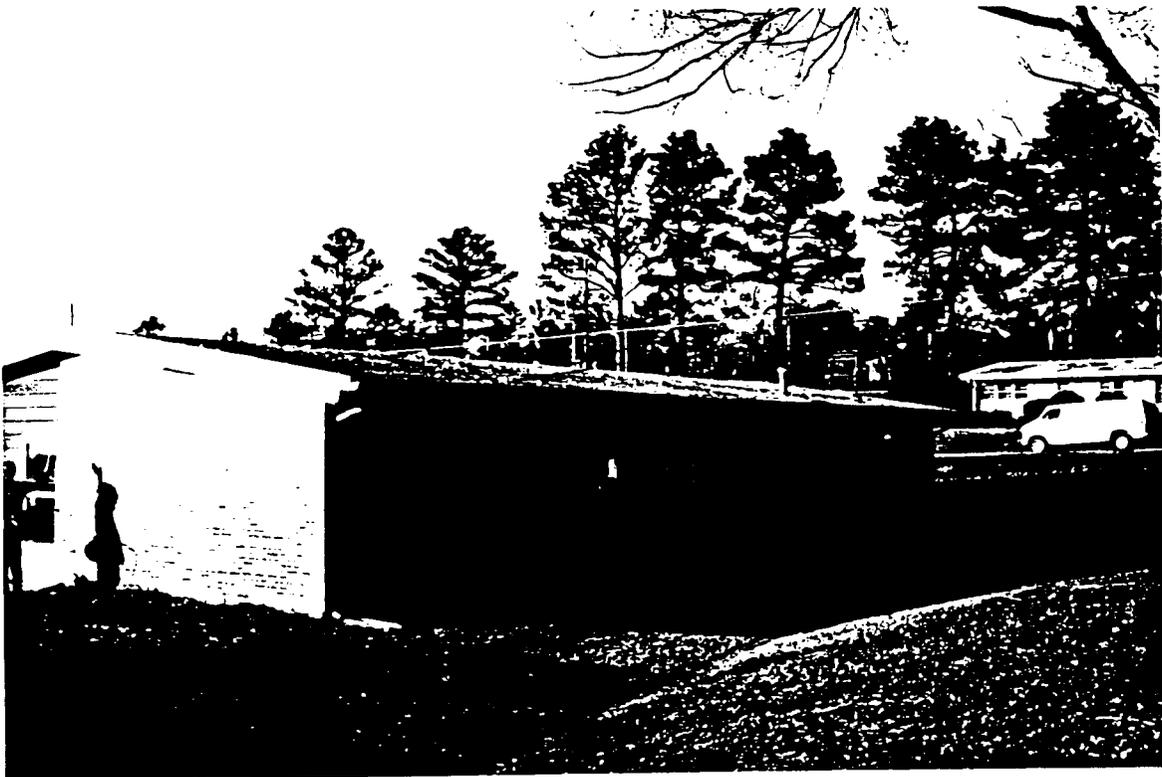
Figure 2. Rear view of Building 3527.

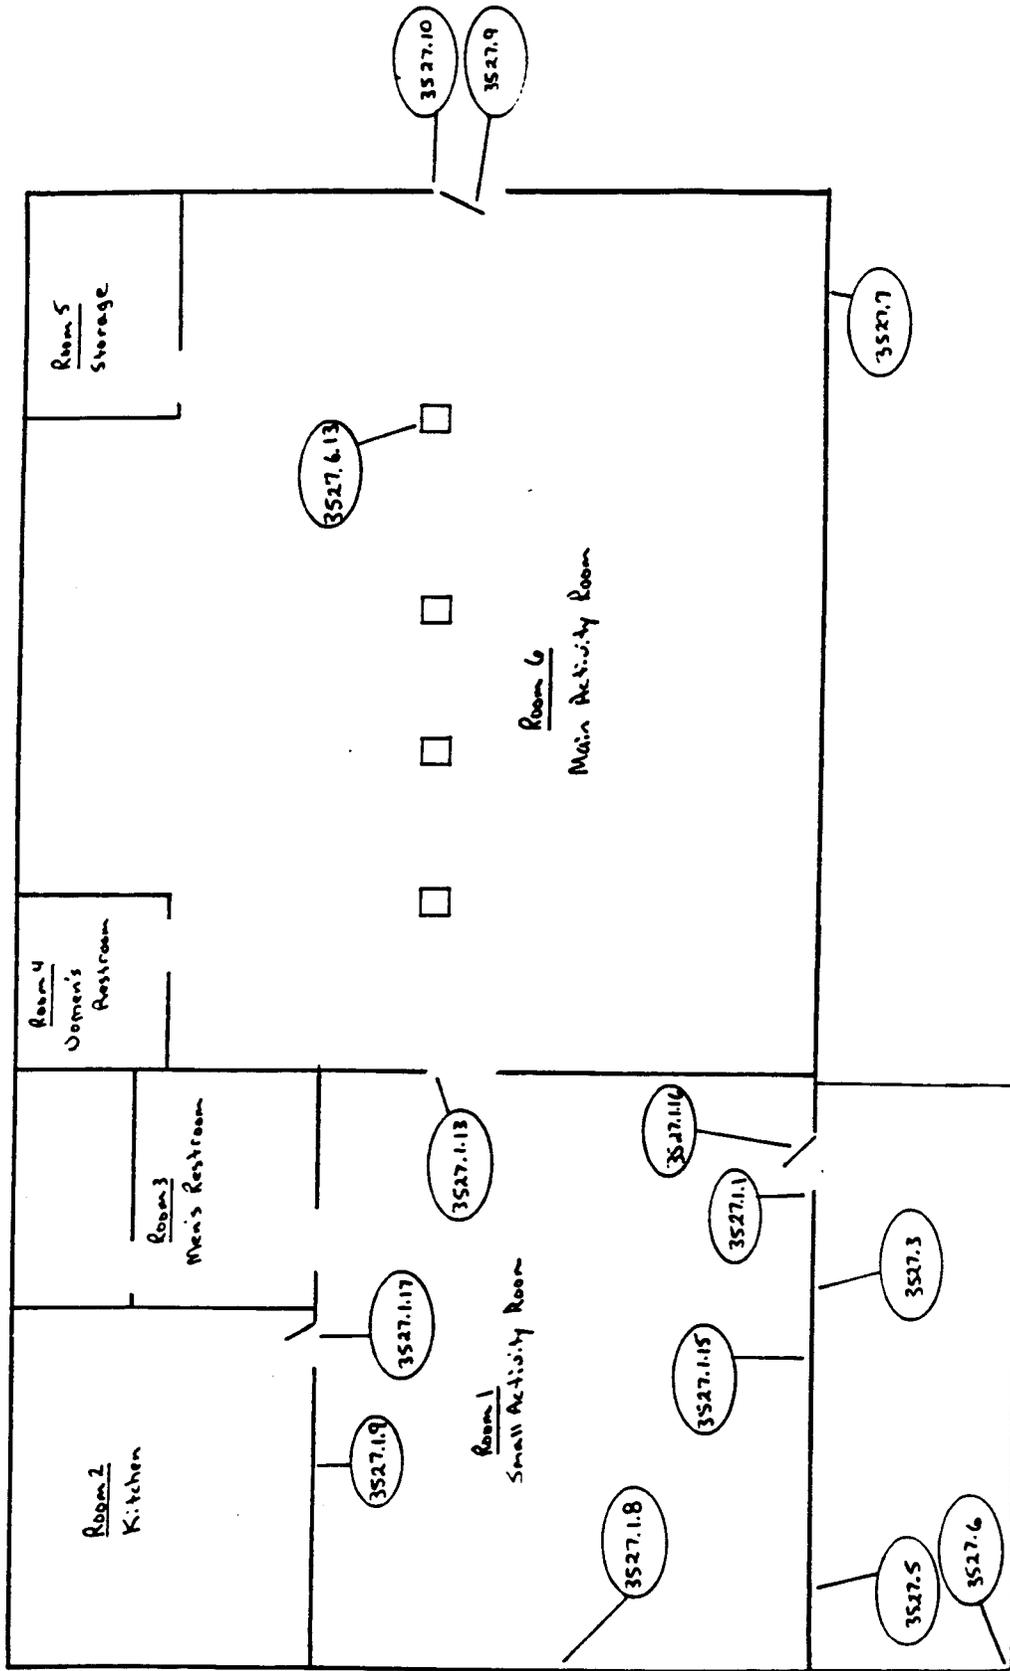
Unit No. 3527
 Plate No. 1

Generalized Floorplan - Not to Scale
 Only Locations of Positive XRF Readings (if any) Are Shown
