**LEAD BASED PAINT
SURVEY REPORT**

BUILDING: 3681

**LEAD-BASED PAINT SURVEY
 REPORT FOR BUILDING NO. 3681, ELEMENTARY SCHOOL
 FORT McCLELLAN, ALABAMA**

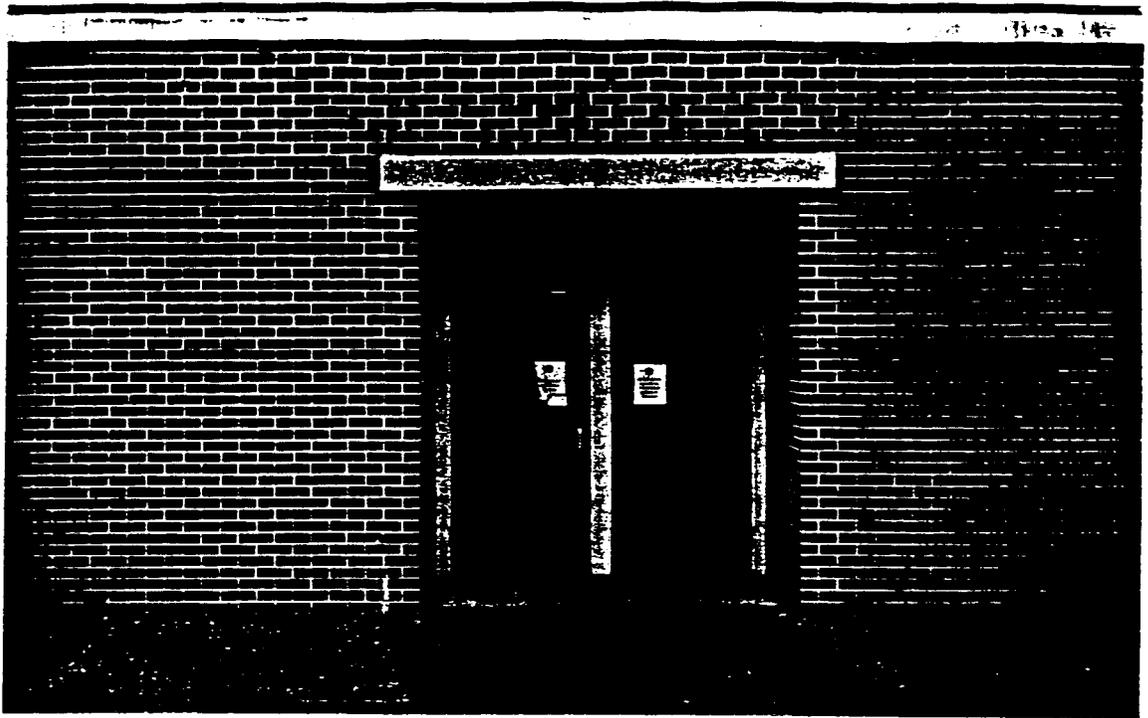
9. With the exception of the old pink wooden door jambs at the rear and side entryways of this building, no lead-based paint detected.

Figure 3. View of one of the entryways in which the door jamb contains positive levels of lead-based paint. (Bldg. No. 3681)

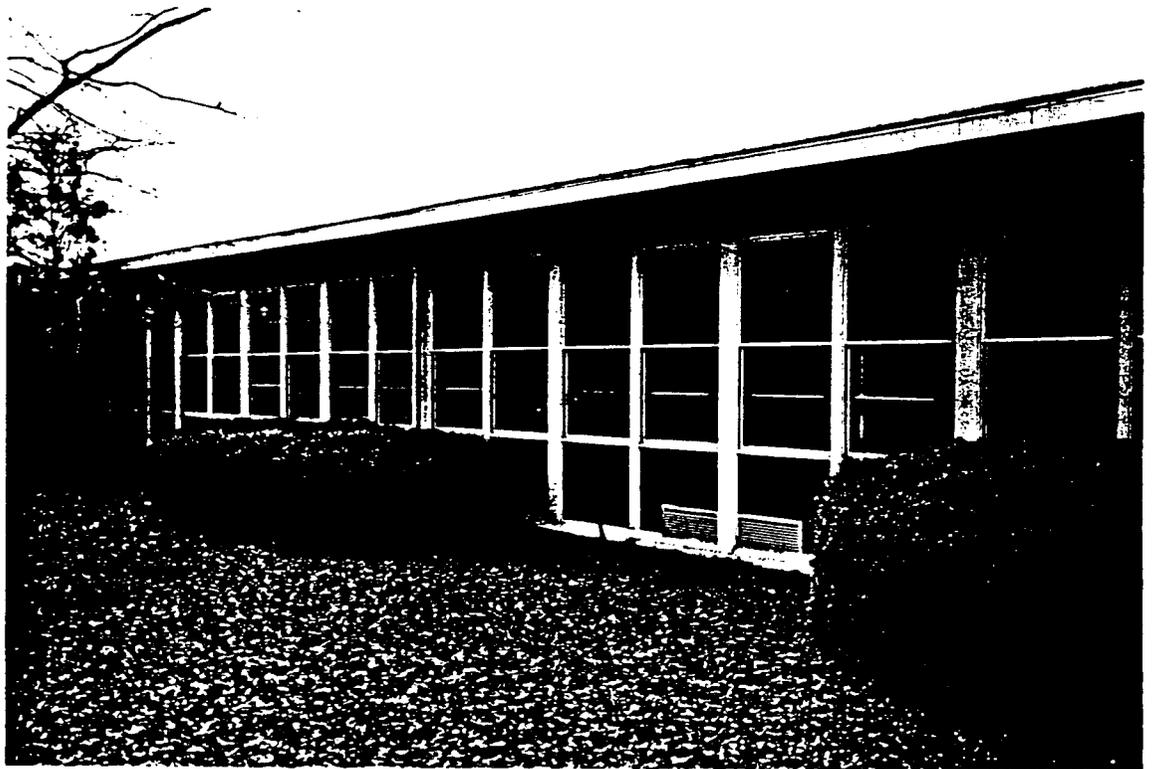
10. Lead-based paint is present on the soffits, lower metal window panels, (See Figure 4) and the wooden door components at the entryways. No LBP was found at the main entrance as it appears to have been replaced with newer metal framed members.

11. All positive lead-based detected was in good condition.

Figure 4. Lower window panels and soffits also tested positive for LBP.

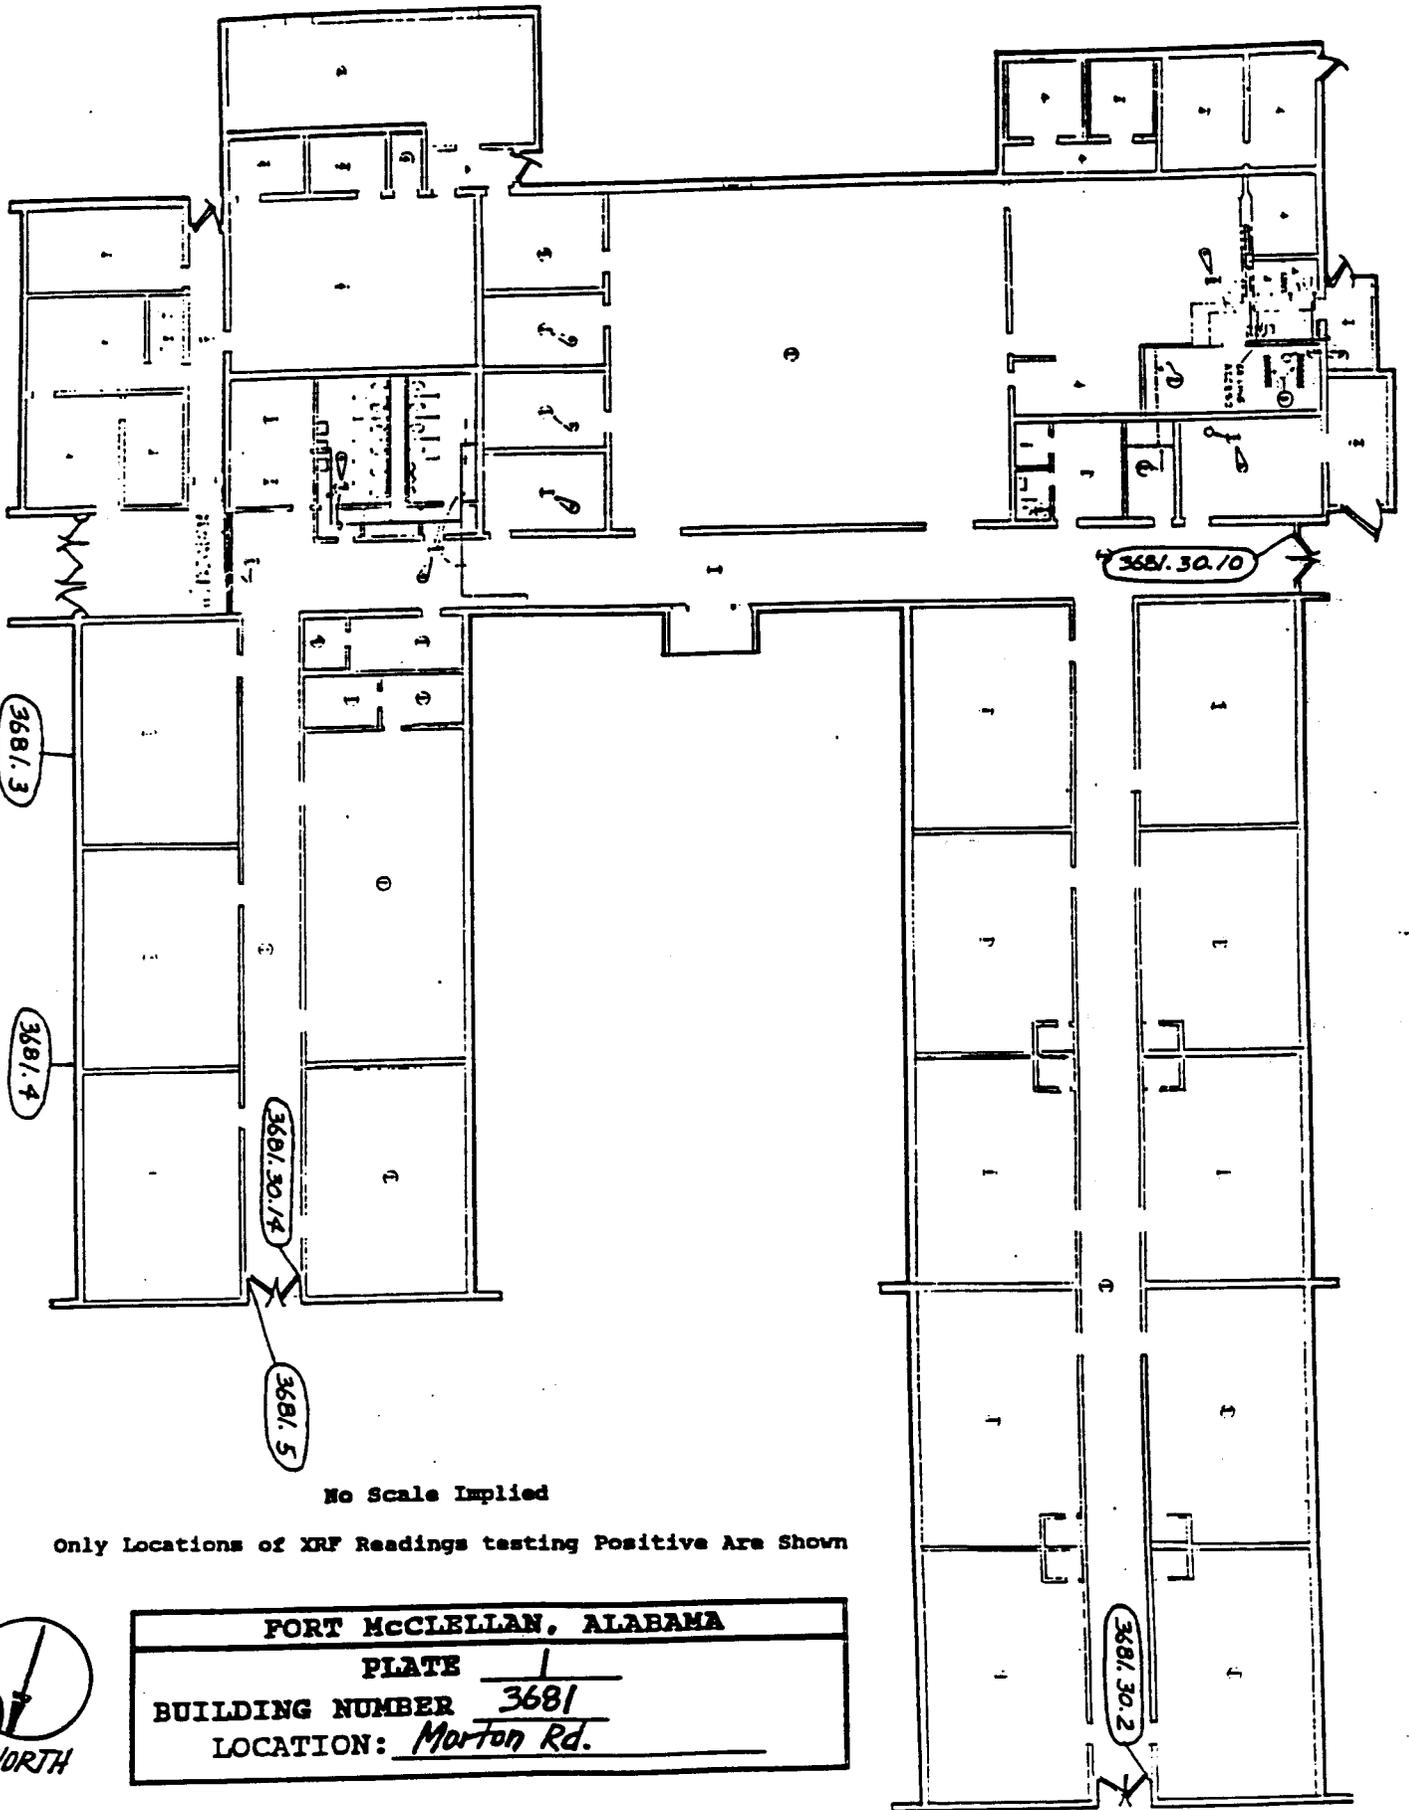
Only Locations of XRF Readings testing Positive Are Shown
