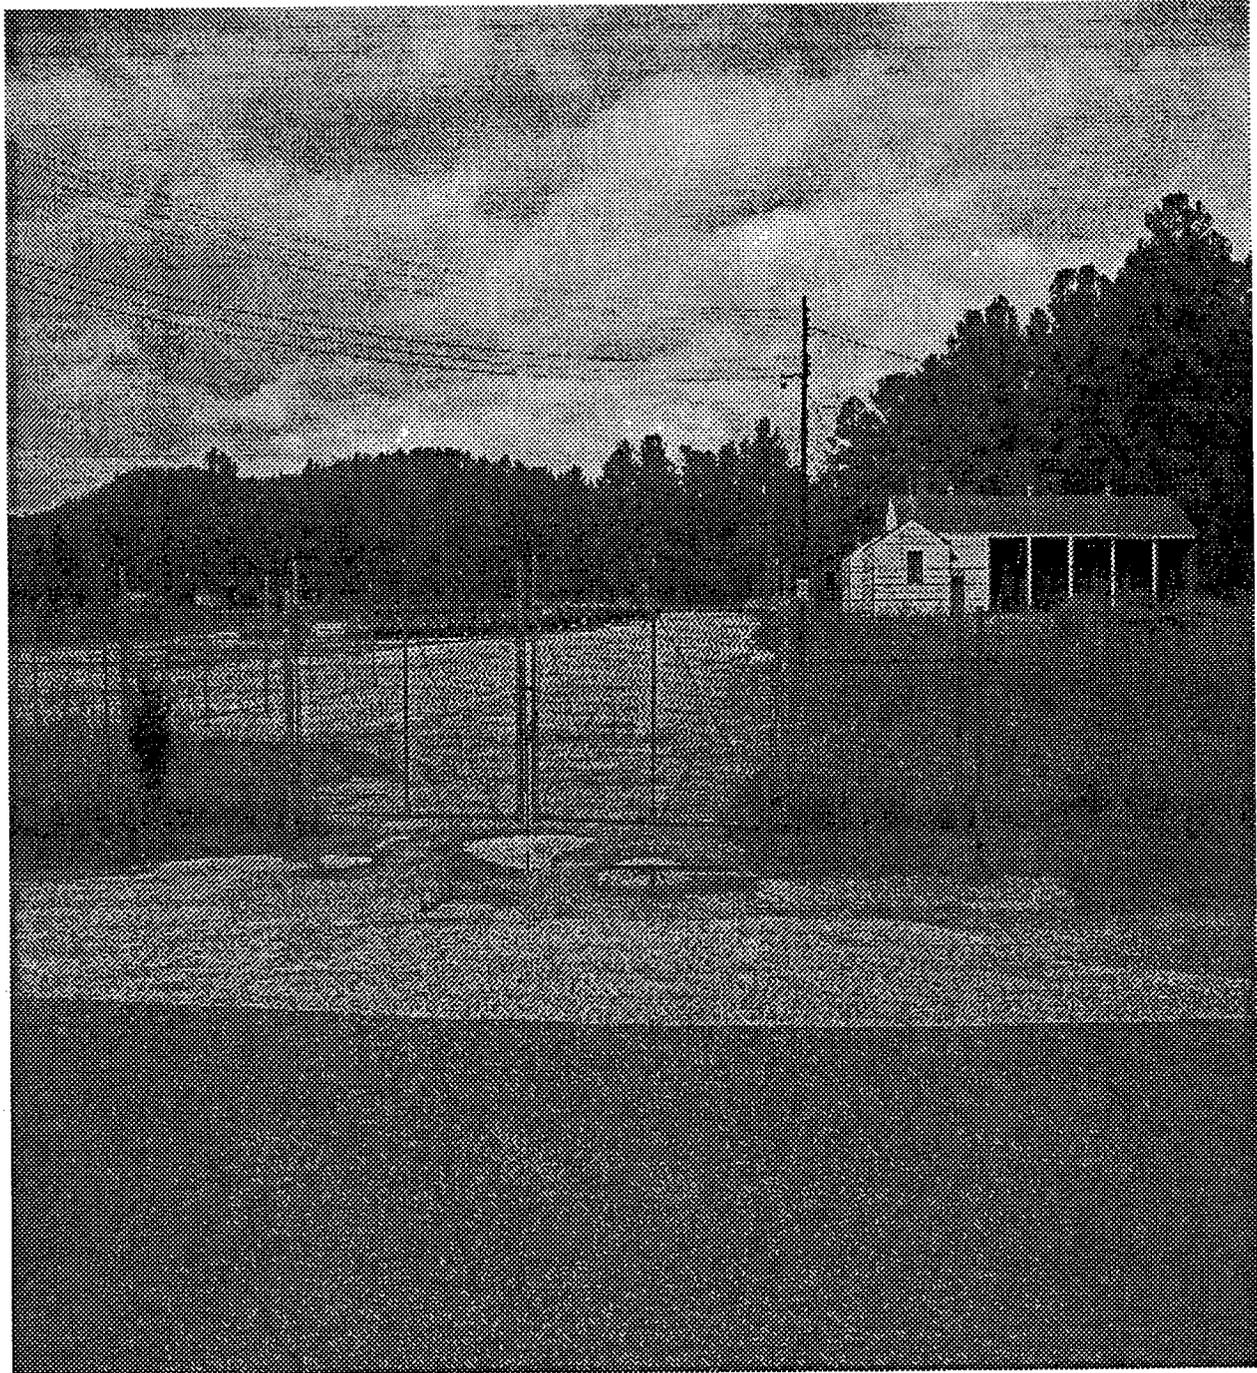
Photo B1 [3/3/98 - 2:06]

Area of Site 164(7) also contains Sites 68(7), 12(7), 11(7); photo faces NE direction, looks through the entrance gate into the southern corner of the Area 800 Motor Pool yard. The SW fenceline in the background, left of center, runs parallel to the road on the far left of view.

The immediate area is highly altered/developed with minimal grass area within the fence. Large, open paved areas with a few structures characterize this site. Habitat on site is extremely poor. However, the area is surrounded on three sides (SE, NE, and (to a lesser extent) the NW) by unaltered, natural terrain. The small creek running parallel to the SE fenceline is natural and protected by heavy deciduous forest with thick understory.

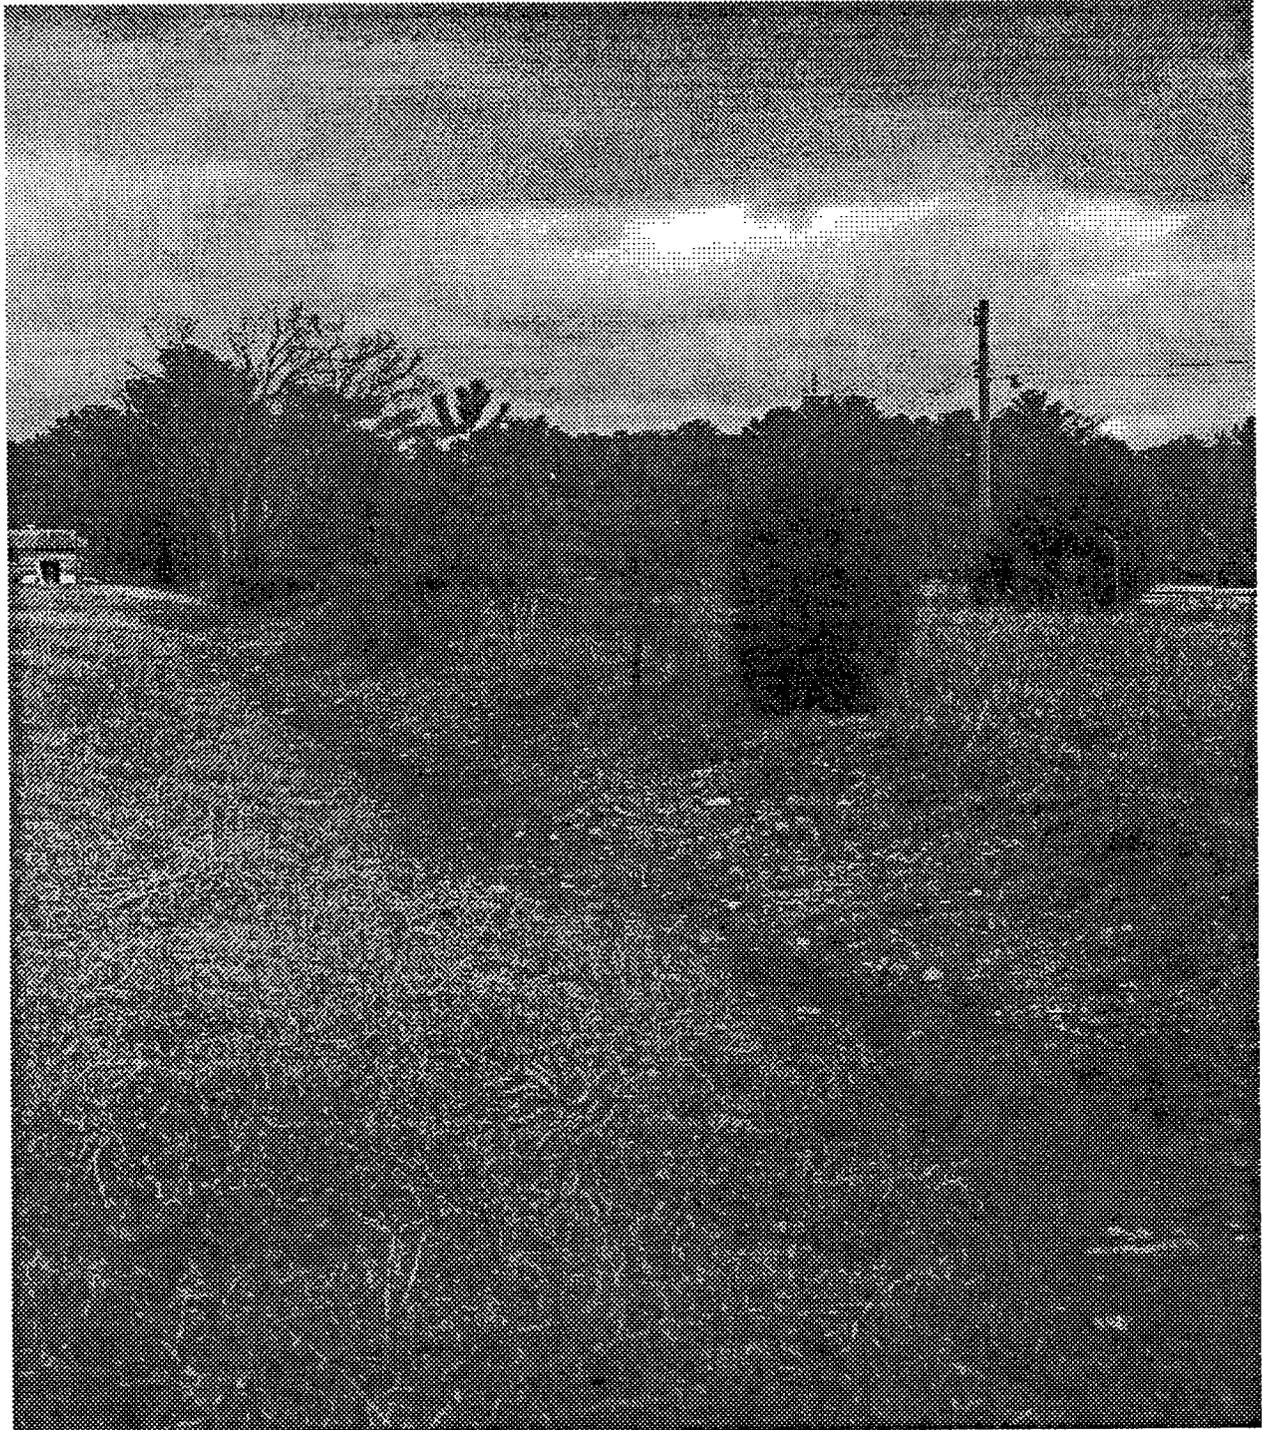
Photo B3 [3/3/98 - 2:20]

Area Site 164(7) also contains Sites 68(7), 12(7), 11(7); photo faces the NE direction. The photo views the NW fence line with a drainage ditch running parallel to the NW fence and flowing toward the viewer in a SW direction.

The natural drainage channel runs through an open, grassy field separating the Site 164(7) fence from several "barreck"-type buildings, just out of view to the left of the viewer. The drainage creek shows evidence of consistent or frequent drainage. This drainage path is not recorded on the CERFA Parcel Map.

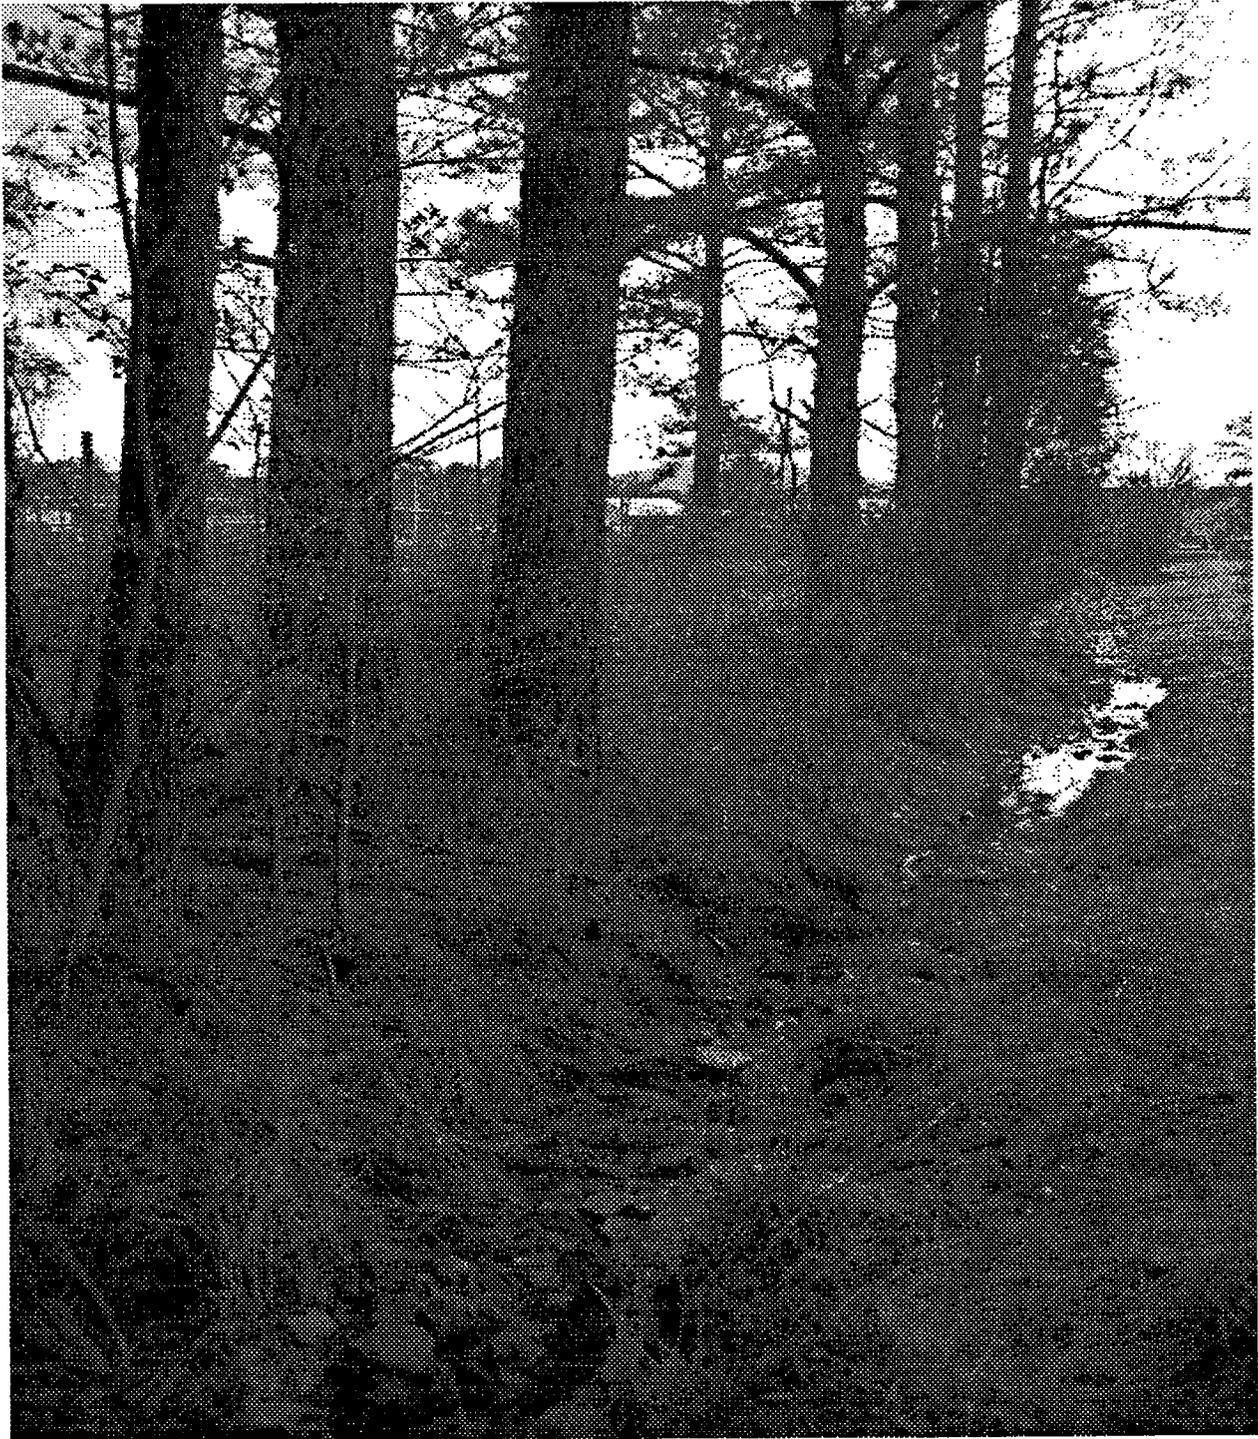
Photo B4 [3/3/98 - 2:25]

Area Site 164(7) also contains Sites 68(7), 12(7), 11(7); photo faces the SW direction, and shows the opposite view of Photo B3. A 4 inch discharge pipe emmenates from the NW corner fence (from under the second large tree from the left) adjacent to a wash rack (or oil/water separator) designated as Site 68(7).

Algae growth within the creek is most prominent beginning at the pipe discharge point. Algal growth decreases dramatically 5-10 yards upstream of pipe, but more gradually over a distance of about 40 yards downstream. Pipe empties oil/water separator on inside of fence.

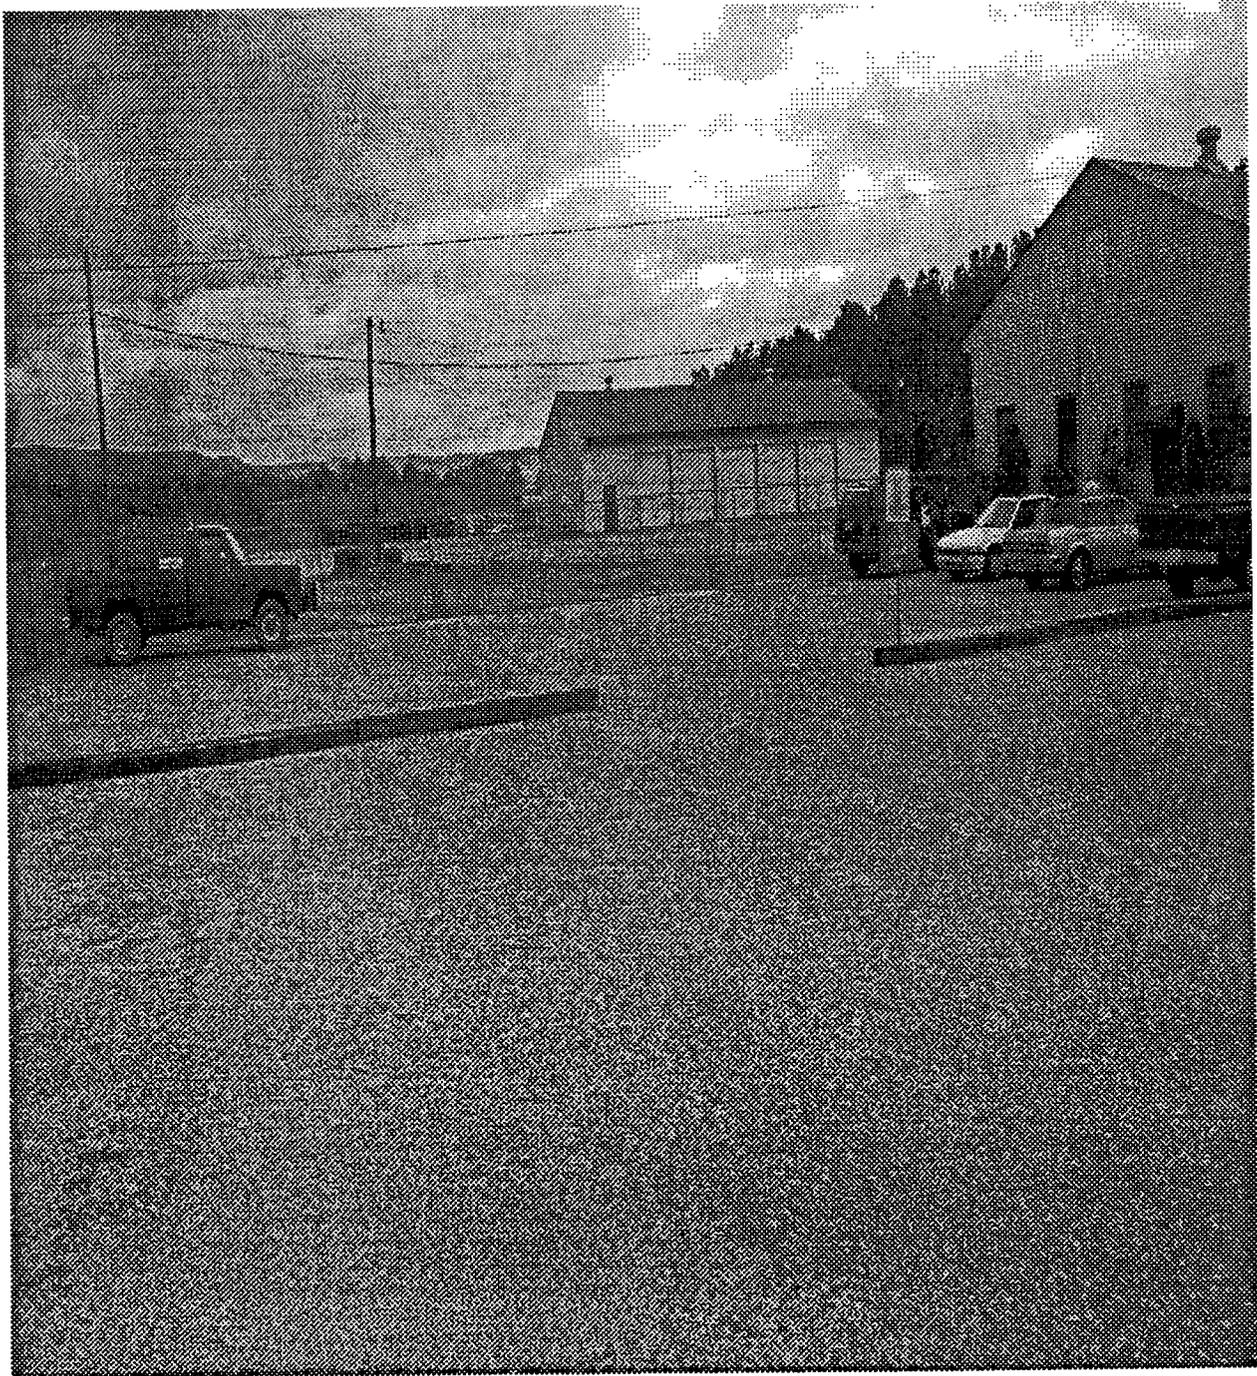
Photo B5 [3/3/98 - 2:40]

Location of Area 149(7) also contains Site 136(7); photo faces the S direction and looks over the approximately location of a former gas station.

Two small buildings (pictured; building on far right of view is Ron Smith's office) stand in the FMP 600 area. The site is completely devoid of any natural vegetation or artifacts, and is entirely paved by gravel and asphalt. The lot is bounded along the SW by an area of unaltered trees (deciduous; with moderate to light understory) through which a natural creek flows. Top of tree line is visible behind and above view of buildings in photo. The NE and SE boundaries consist of road and another open (parking?) lot. To the NW is a small area covered by forest vegetation.

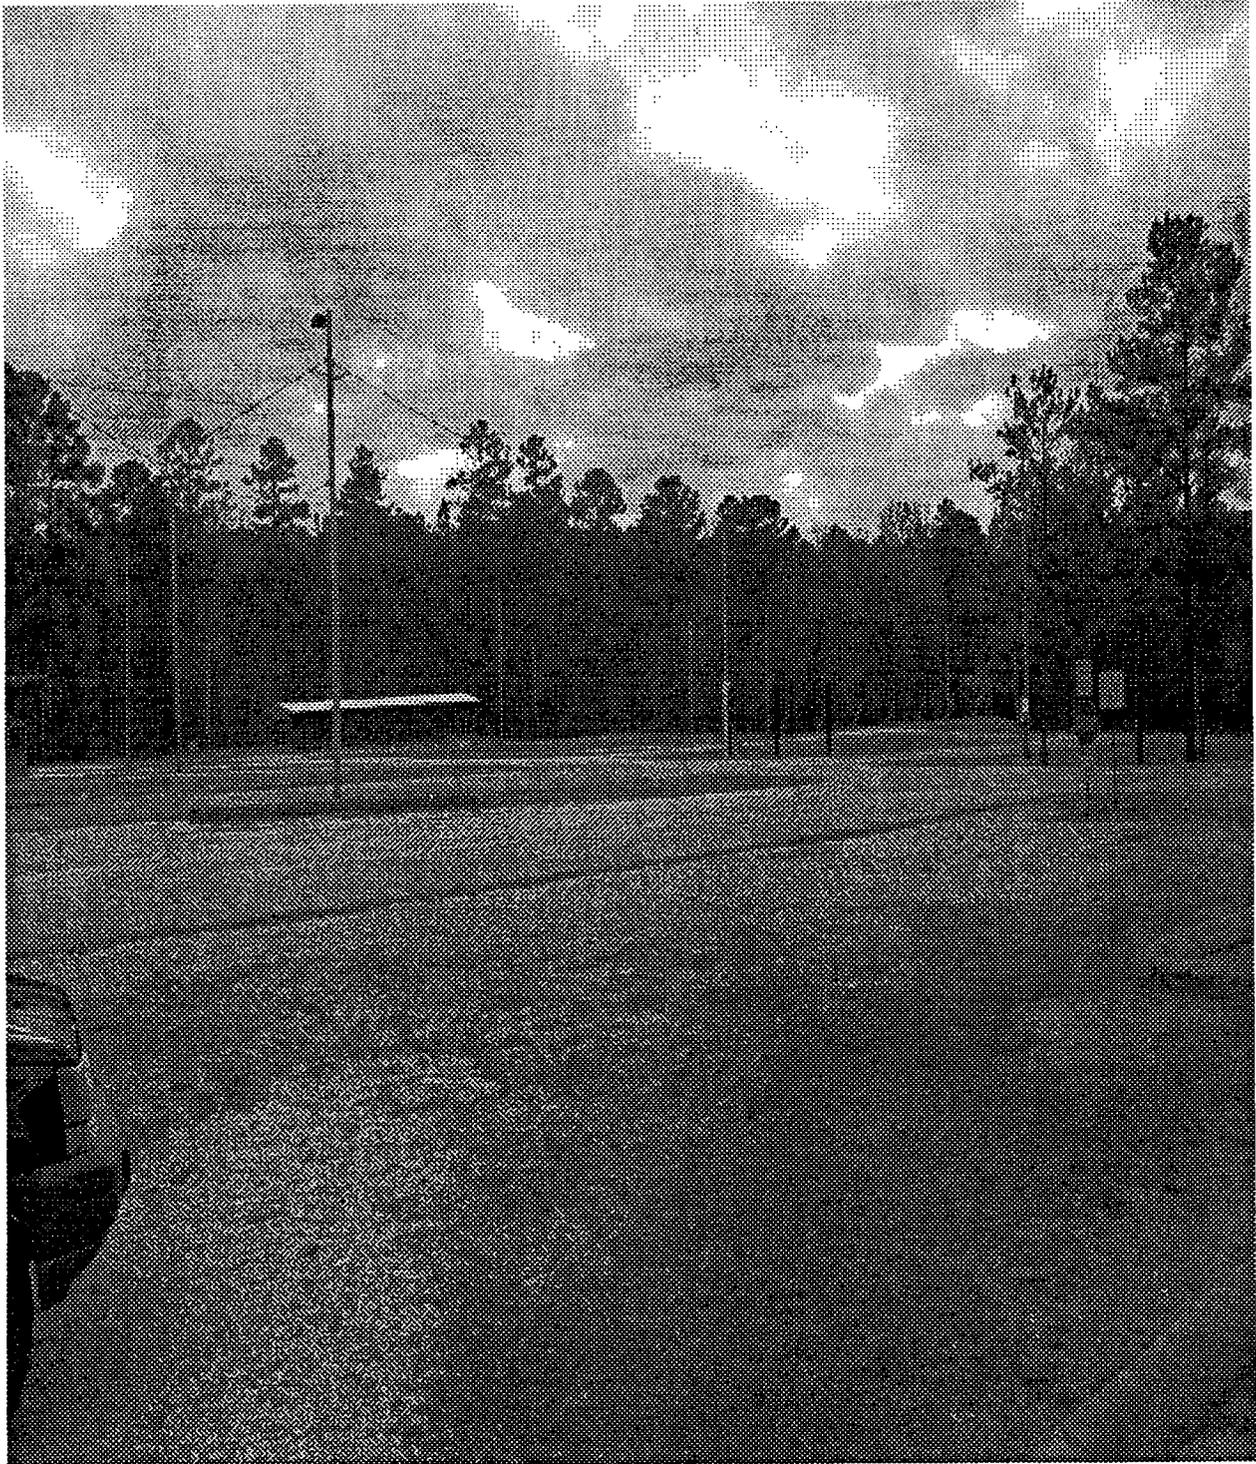
Photo B6 [3/3/98 - 3:06]

Area is designated as Site 200(7); photo faces the SW direction into the open ground scar/pit area.

Immediate area is primarily paved road situated between mounded land covered with grass. Surrounding area to all four sides is forest and brush. A small tributary to Ingram Creek (which is itself a tributary to Cane Creek) runs along the S of the area. A foot-search for this tributary was not initiated.

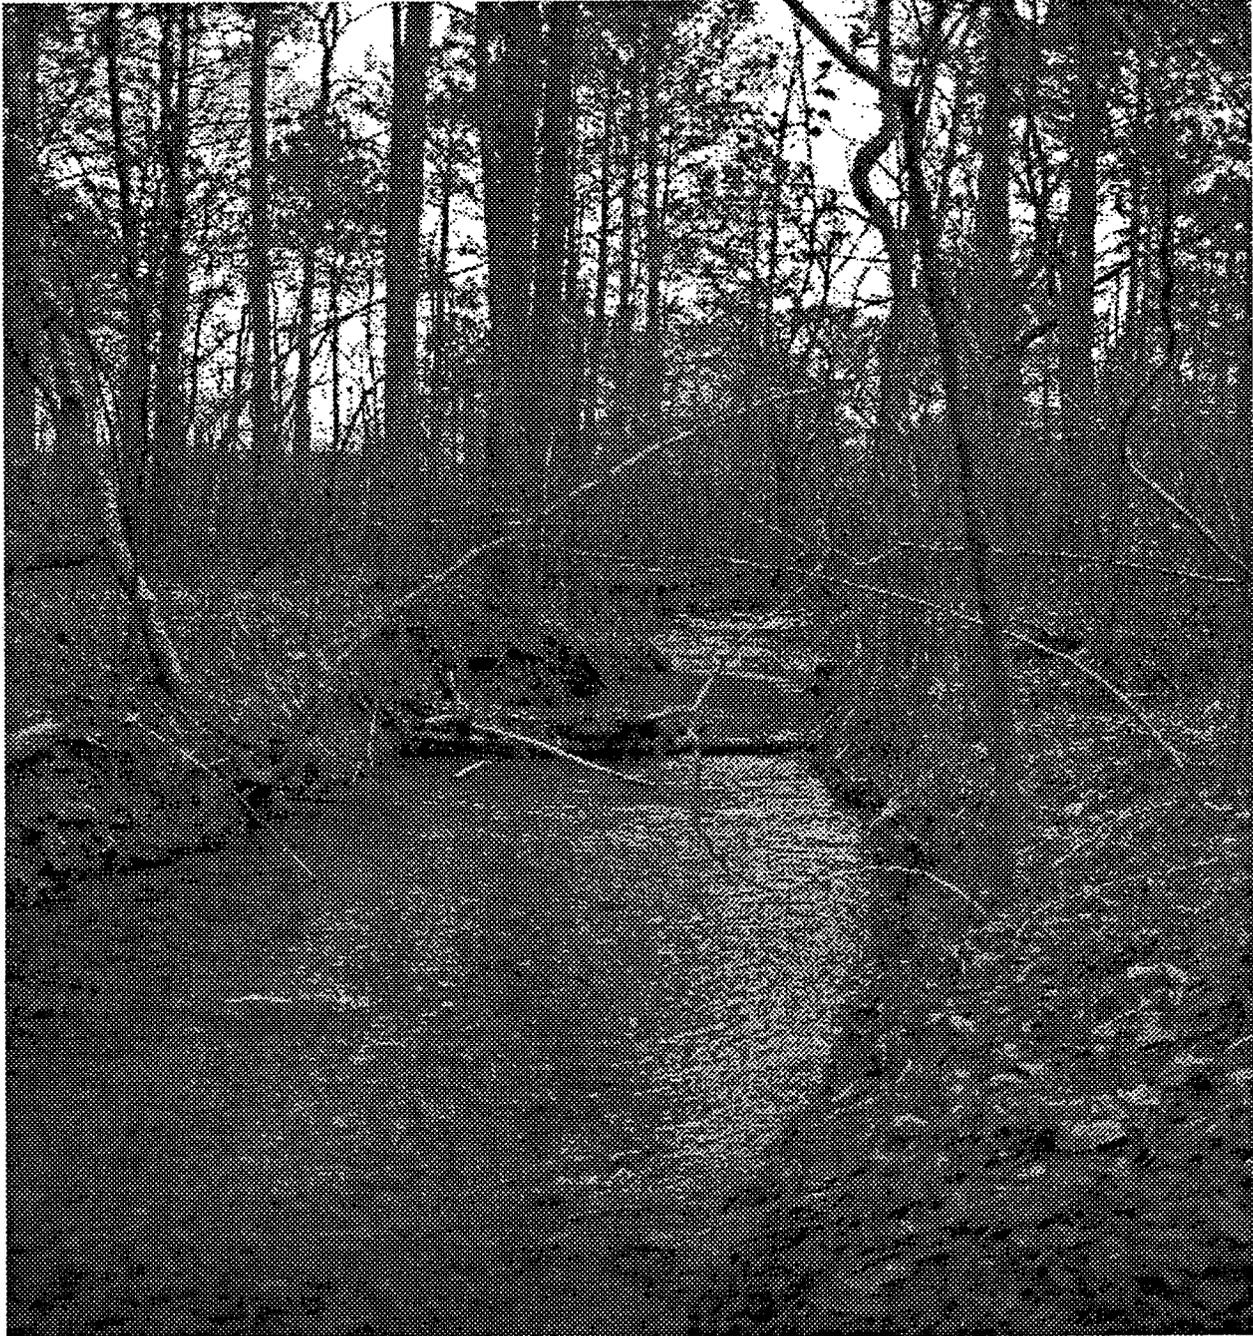
Photo B7 [3/3/98 - 3:20]

Former Chemical Laundry, Gas Station, and Motor Pool 1500 [CERFA Parcel Map: 22-23, 29-30]
The area designated as Site 94(7) contains Sites 132(7), 133(7), and 134(7). The photo faces SE direction looking upstream into Ingram Creek, located about 75-100 yards NE of the site.

The entire area of interest (Site 94(7)) is one continuous paved lot with no standing structures, natural or man-made. Concrete foundations were noted throughout the area, especially along the NE boundary. The NE boundary and Ingram Creek are separated by a strip of land about 75-100 yards in width. The paved lot sits about 30-40 feet above the sparsely forested area. Several car paths (e.g., tire ruts) and storm channels line this area parallel to both the Area 94(7) and Ingram Creek. Several obvious drainage ditches connect the Site 94(7) lot to the lower forested area and ultimately to Ingram Creek.

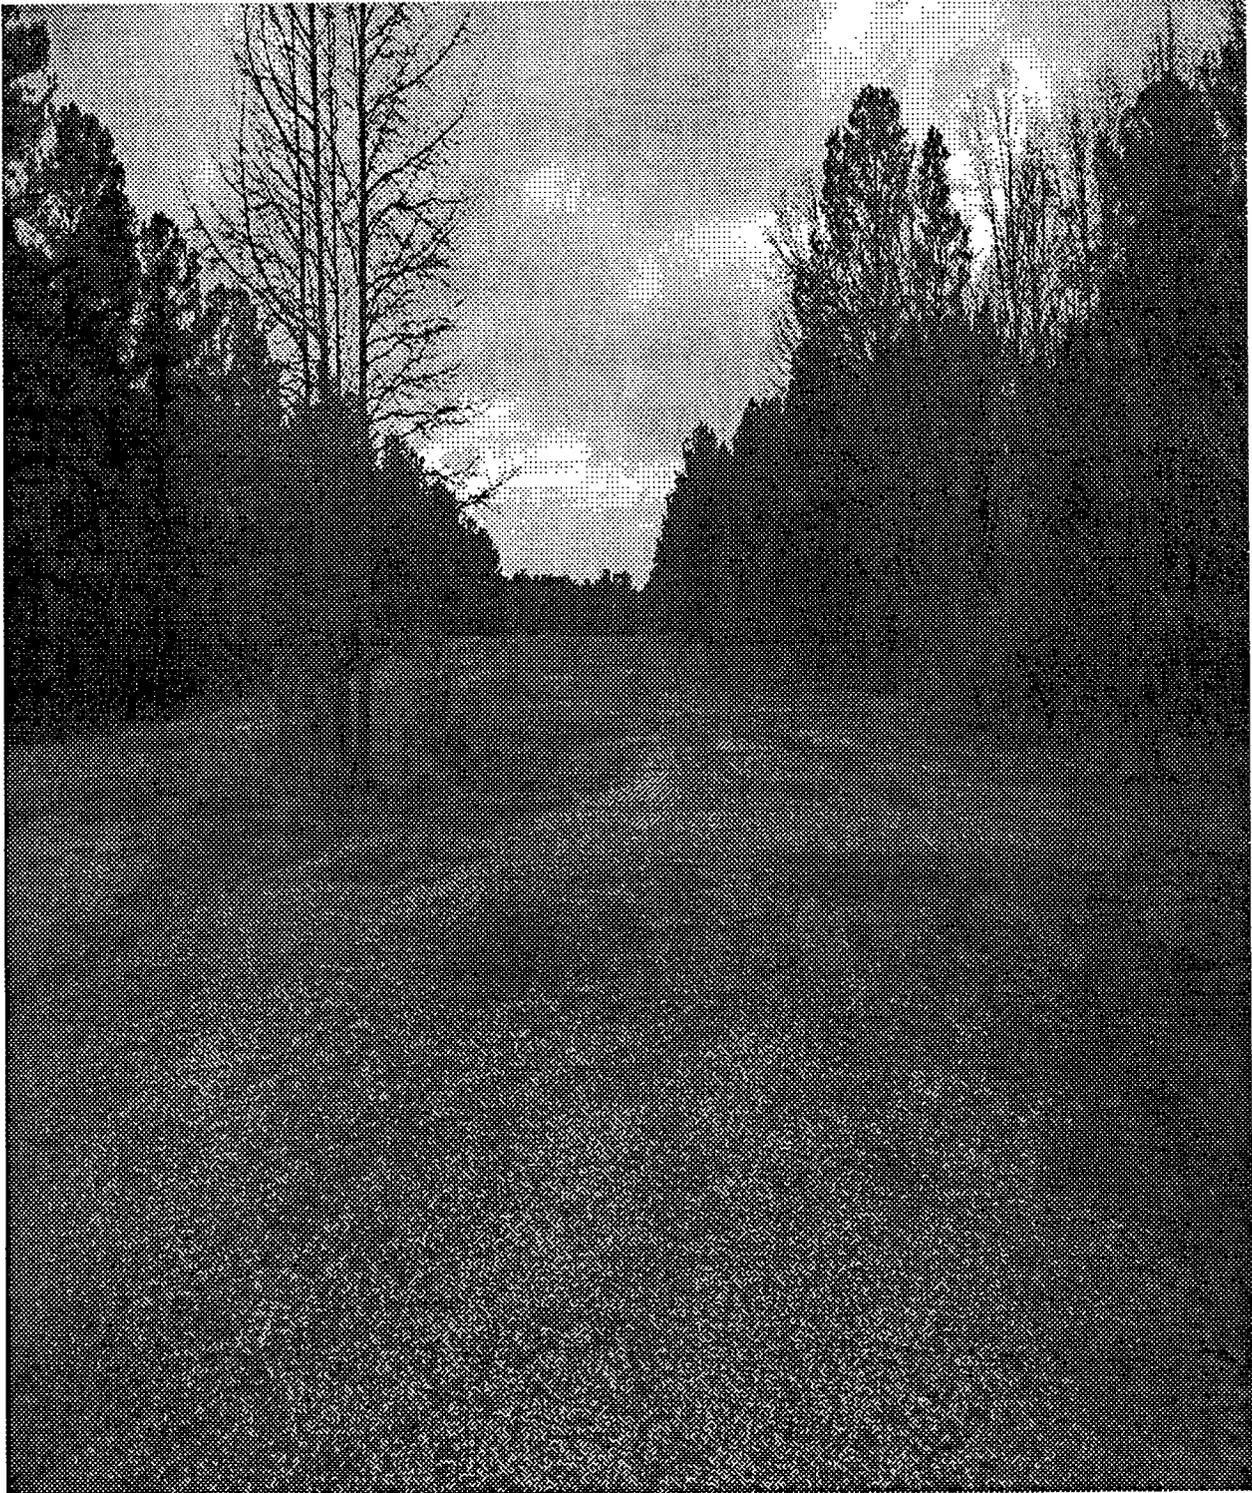
Photo B8 [3/3/98 - 3:30]

Former Chemical Laundry, Gas Station, and Motor Pool 1500 [CERFA Parcel Map: 22-23, 29-30]
The area designated as Site 94(7) contains Sites 132(7), 133(7), and 134(7). The photo faces NW direction into Site 94(7). Ingram Creek is out of view to the right of the viewer (about 75-100 yards downhill).

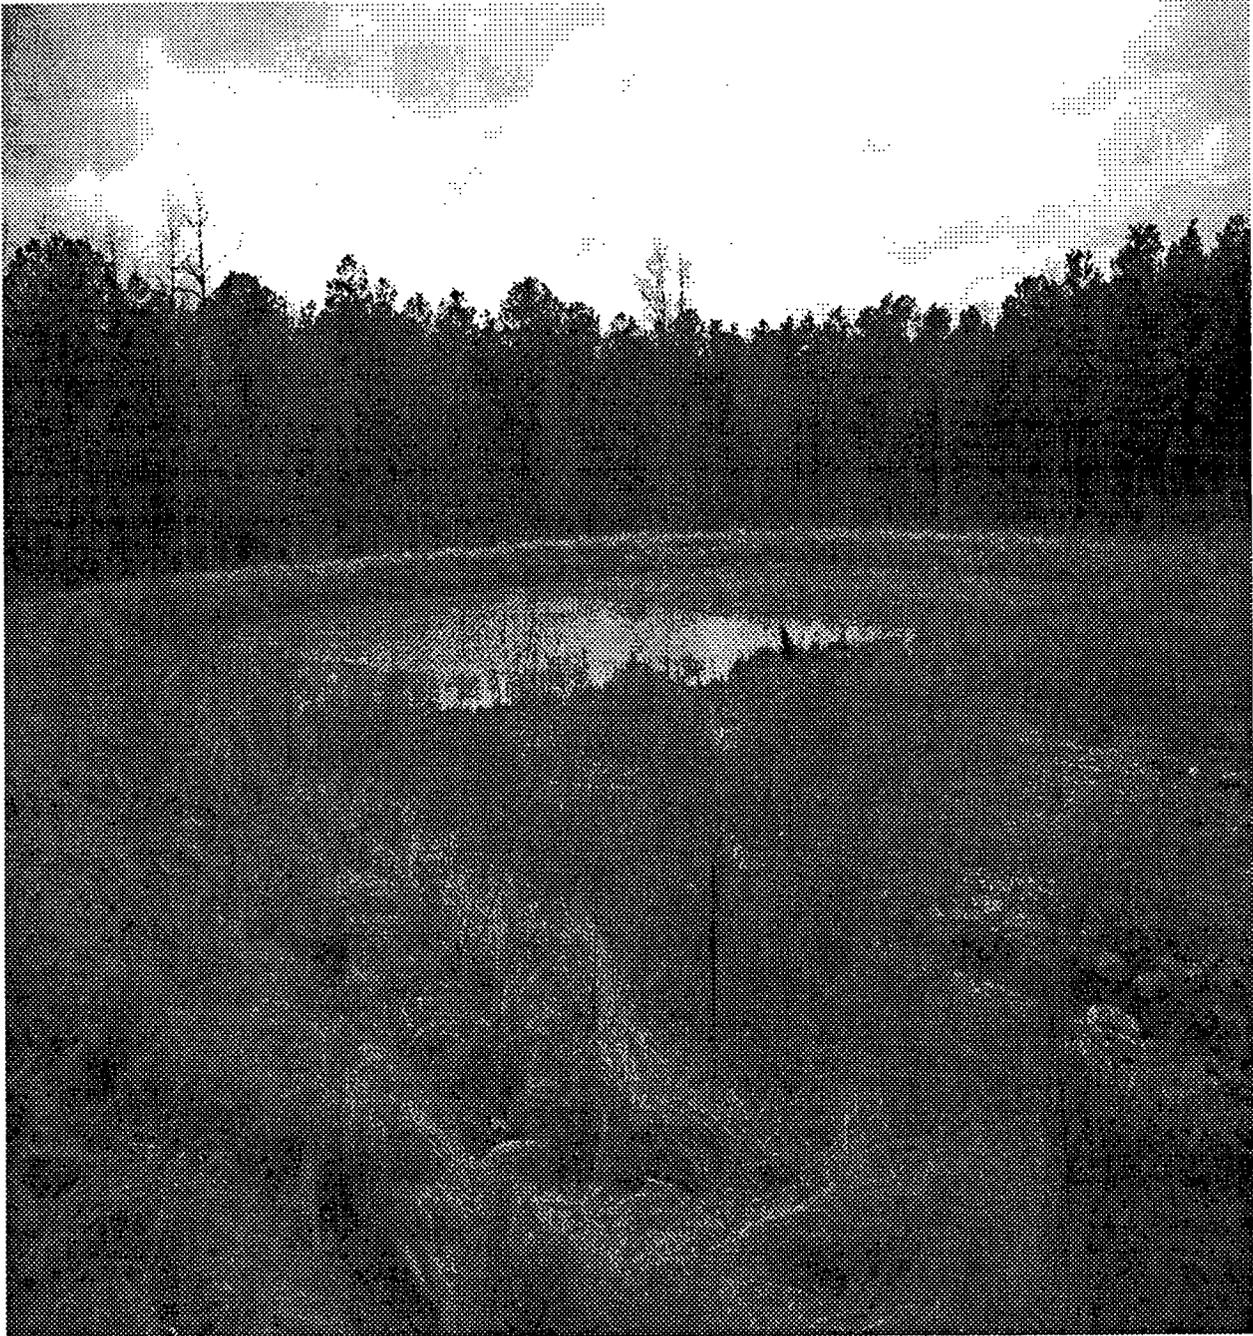
Photo B9 [3/3/98 - 3:40]

Area 82(7) consists of a series of landfill areas that are no longer in use, and associated retention ponds; photo faces NW direction toward one of several retention ponds located adjacent to the landfill mounds.

The landfill(s) were used to dump tree stumps, yard trash, batteries, tires, paint cans, and various forms of construction debris. The immediate area is devoid of trees, but covered in tall grass. Area surrounding the mounds is deciduous forest and shrub. The retention pond pictured is one of two located to the SSW of the western-most landfill mound ("West-mound"). The pond pictured receives runoff directly; while the adjacent pond (to the north of the first, just out of view to the right of photo) receives overflow from the first. A fairly deep, ephemeral water channel runs along the base to the S of this West-mound.

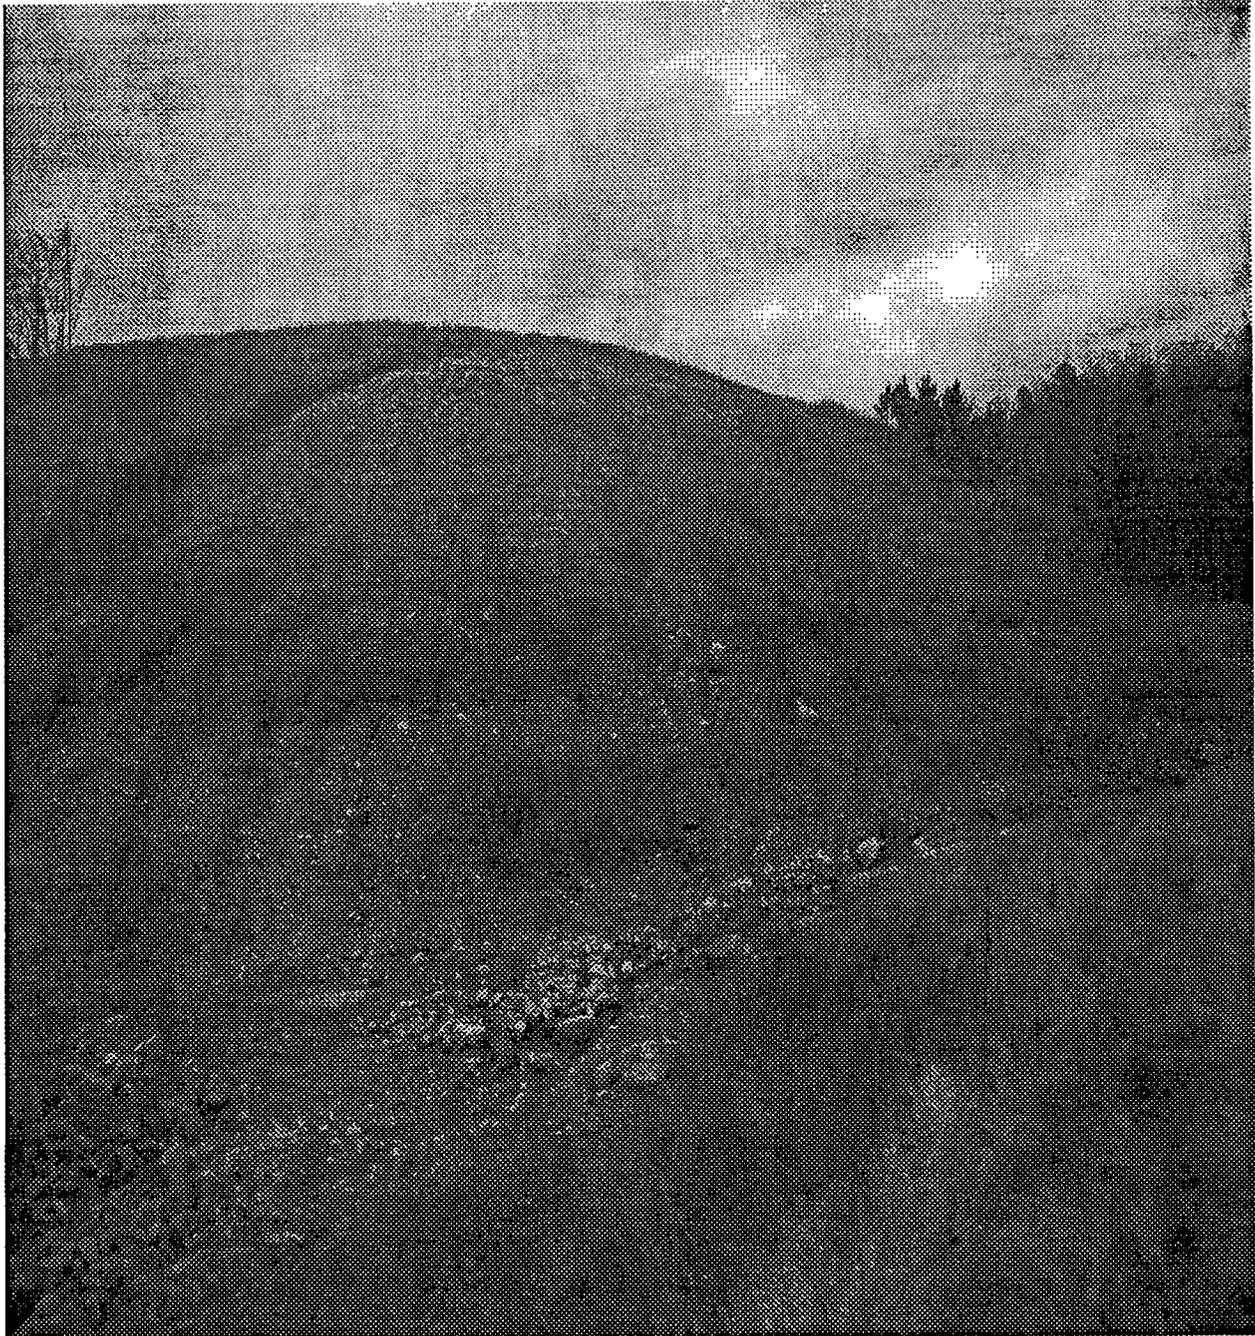
Photo B10 [3/3/98 - 3:41]

Area 82(7) consists of a series of landfill areas that are no longer in use, and associated retention ponds; photo faces NE direction toward West-mound. Photo was taken from exact location as Photo B9.

The landfill(s) were used to dump tree stumps, yard trash, batteries, tires, paint cans, and various forms of construction debris. The immediate area is devoid of trees, but covered in tall grass. Area surrounding the mounds is deciduous forest and shrub. The retention pond pictured is one of two located to the SSW of the western-most landfill mound ("West-mound"). The pond pictured receives runoff directly; while the adjacent pond (to the north of the first, just out of view to the right of photo) receives overflow from the first. A fairly deep, ephemeral water channel runs along the base to the S of this West-mound. Other mounds are located behind the mound in view.

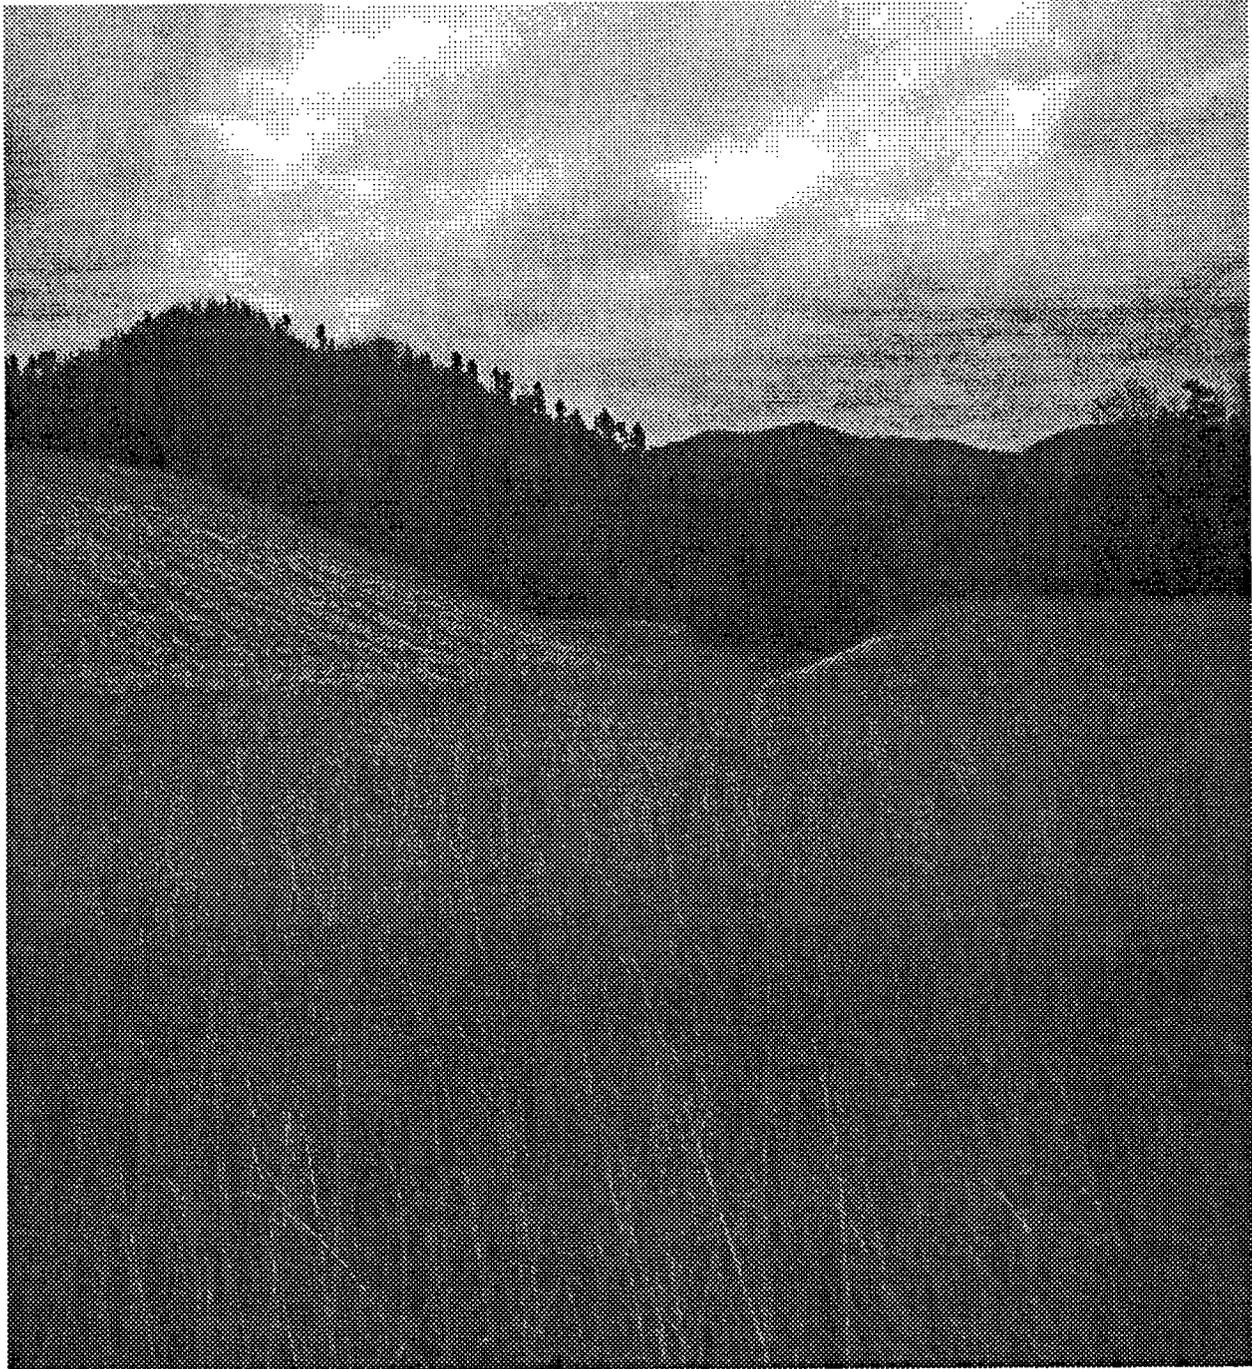
Photo B11 [3/3/98 - 3:45]

Area 82(7) consists of a series of landfill areas that are no longer in use, and associated retention ponds; photo faces NE direction from atop the West-mound.

In view from atop the West-mound are two other mounds within the Stump Dump area. The forested perimeter is clearly visible in the background. Tall grasses covering the West-mound are shown in the foreground. Deep erosion ditches are visible in on the mound to the left of view. Erosional ditches were also noted on the West-mound, as well. The immediate area is devoid trees, but covered in tall grass. Area surrounding the mounds is deciduous forest and shrub.

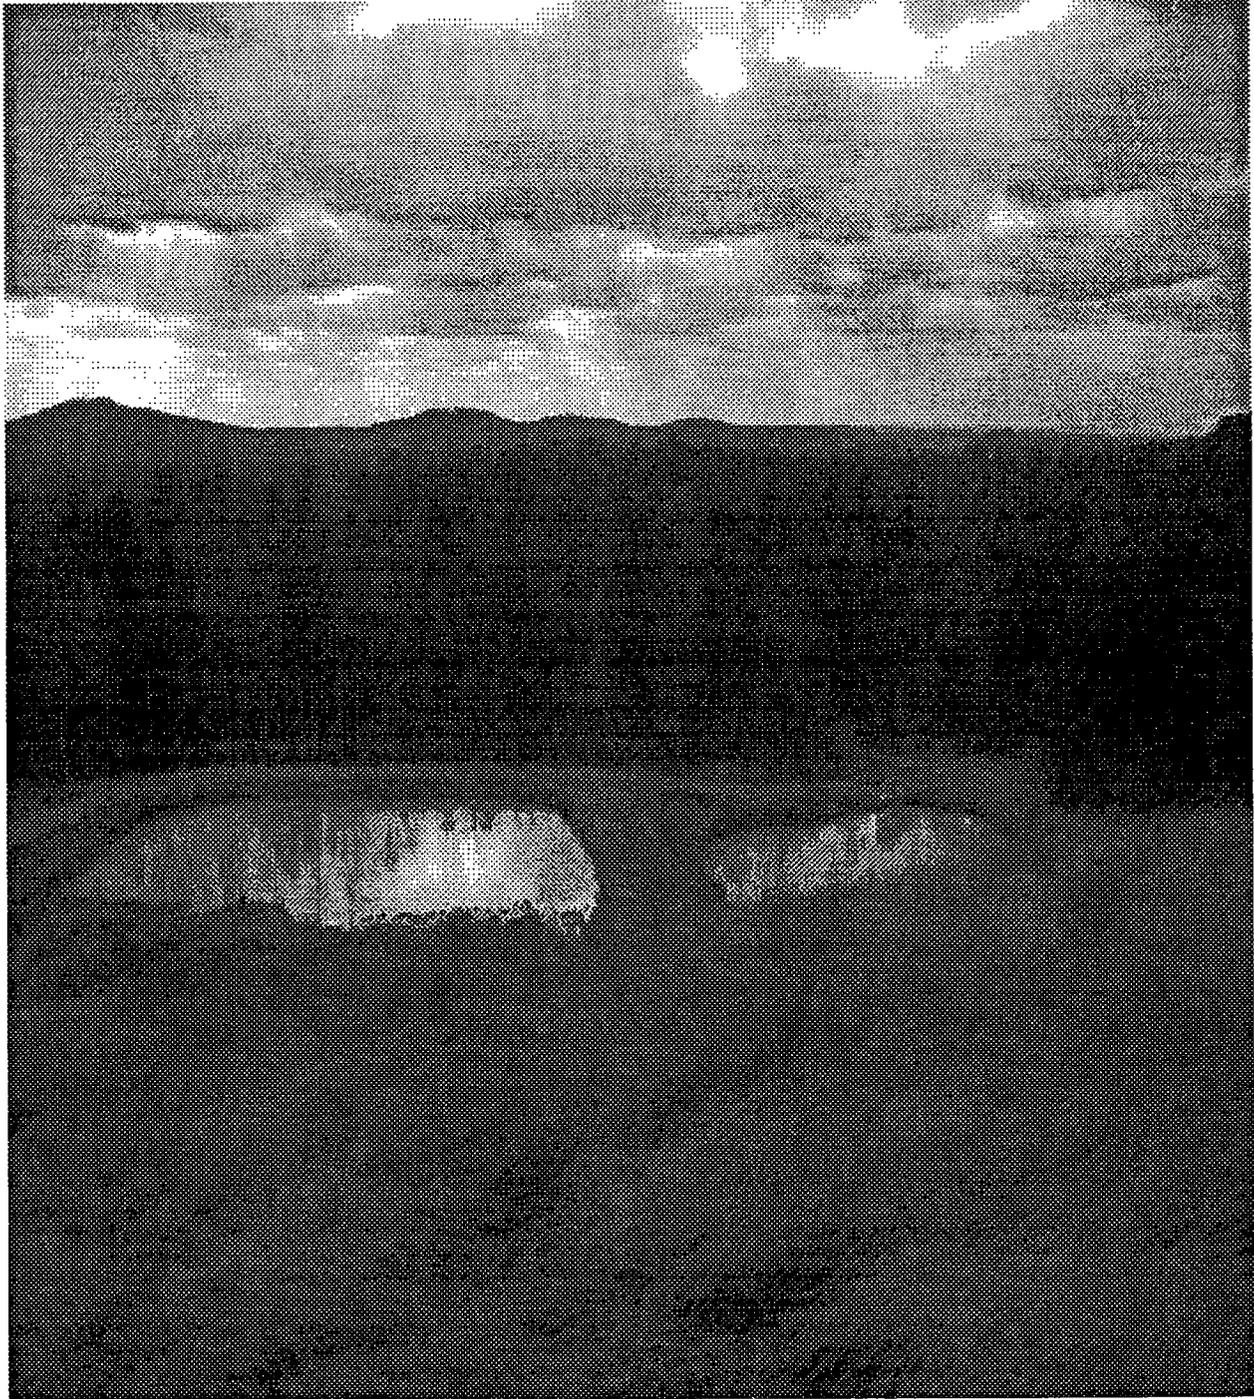
Photo B12 [3/3/98 - 3:45]

Area 82(7) consists of a series of landfill areas that are no longer in use, and associated retention ponds; photo faces NW direction from atop the West-mound.

From top of stump dump looking down over two ponds to west of the West-mound. View in Photo B10 is to the rear of the viewer. The left-most pond receives runoff directly; the pond to the right of view receives overflow from the first pond. To the right of the overflow pond (just out of view), a groundwater seep draining to the W of the overflow retention pond was located. No other groundwater seeps or springs were noted on site.
