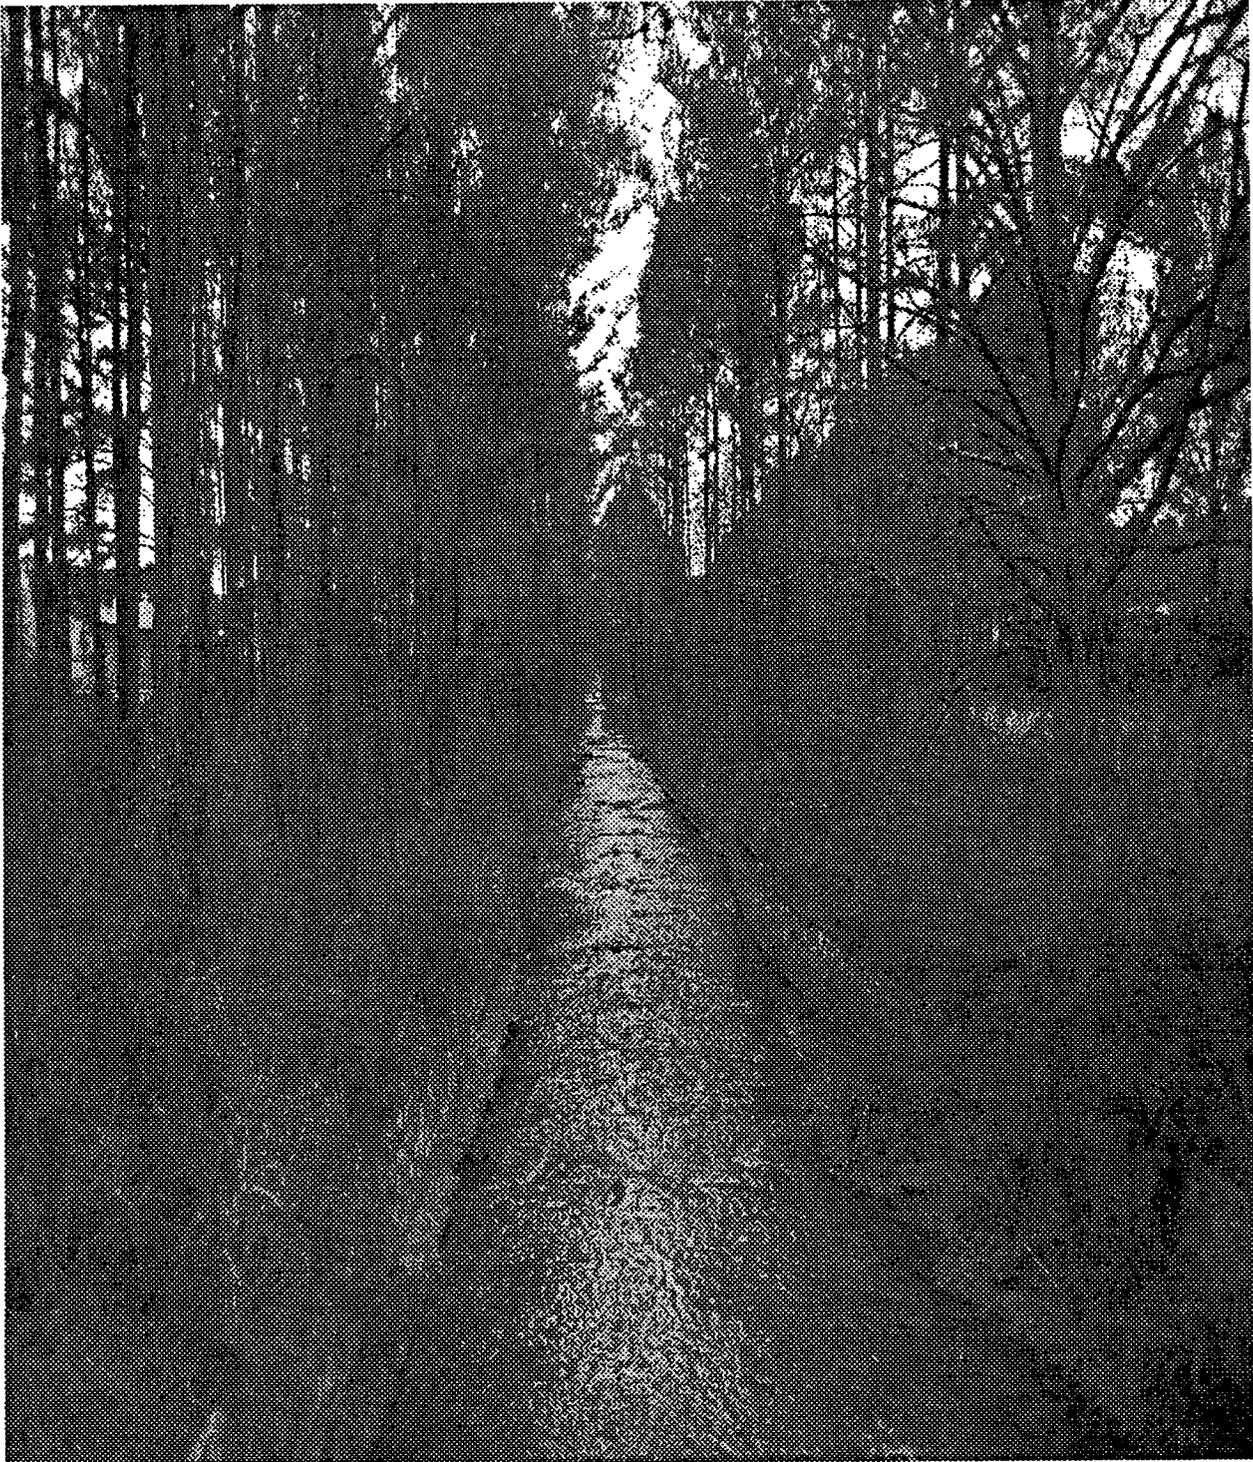
Photo B13 [3/3/98 - 4:35]

View down Cane Creek from bridge at corner of 15th and Howlee Road (Bridge No. 4306); photo faces NW direction.

View clearly shows several important and typical characteristics of Cane Creek within this reach: highly channelized and altered; rock and cement walls line creek; substrate consists of a mix of natural and artificial substances; creek is relatively shallow (i.e., less than 1 foot deep in most parts); creek is lined by trees and sparse understory.

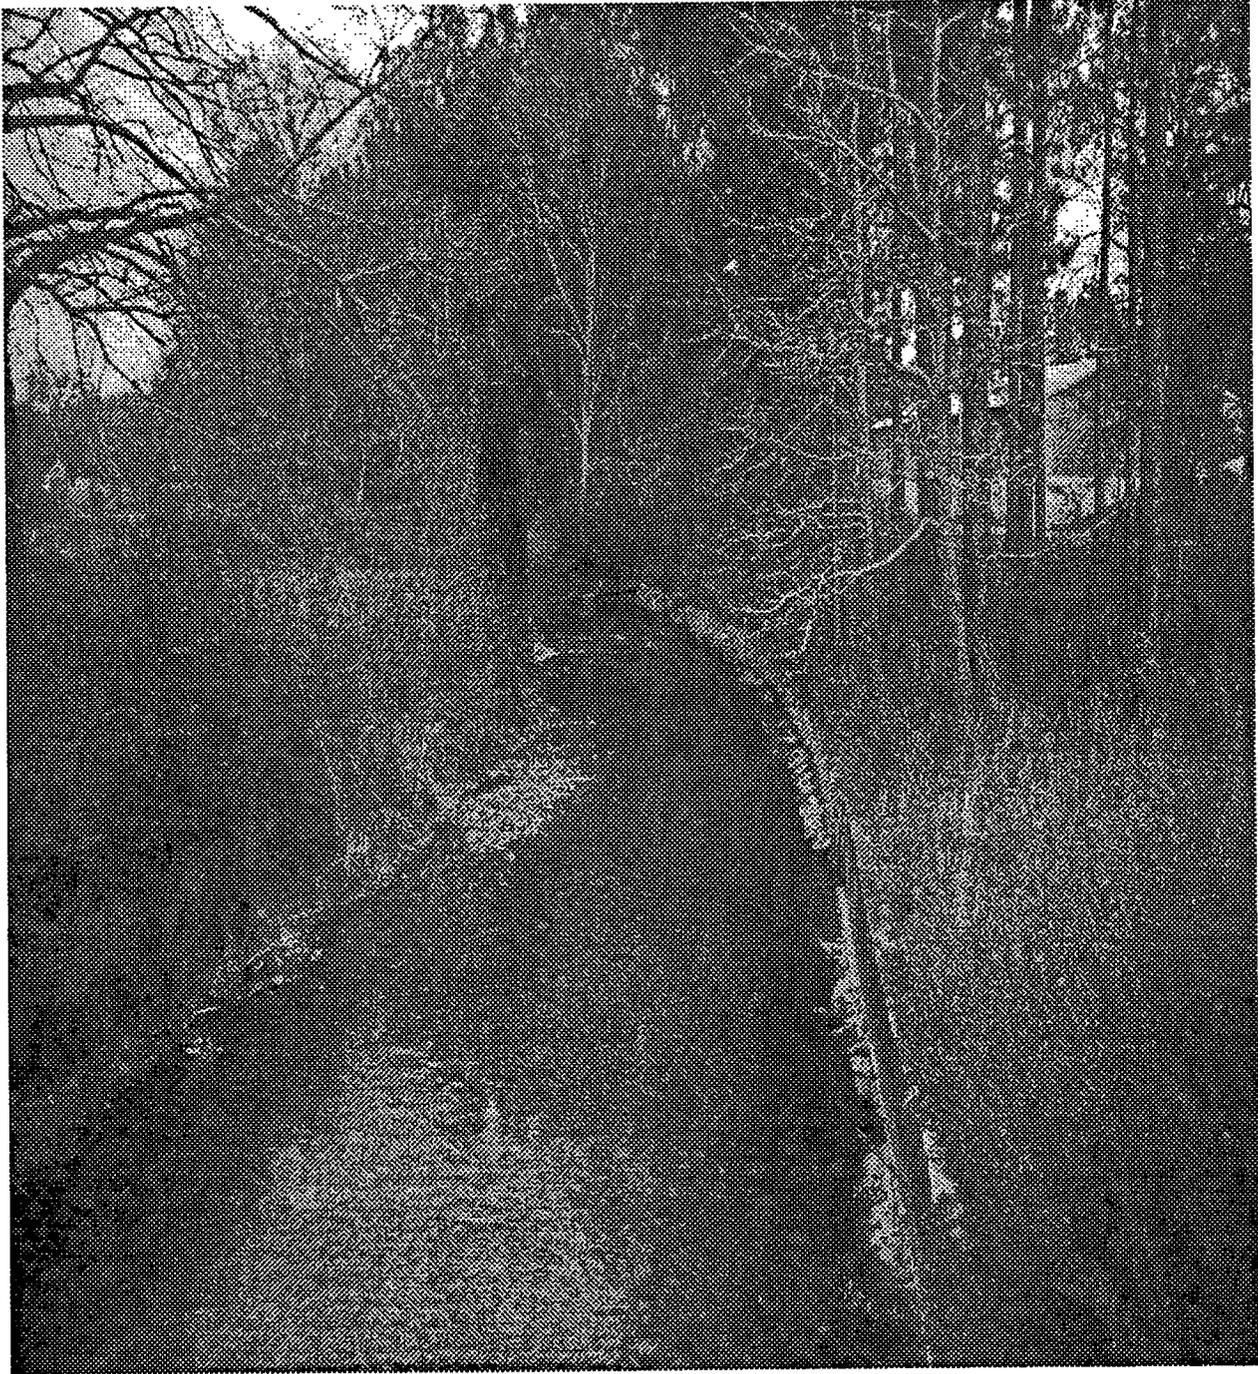
Photo B14 [3/3/98 - 4:39]

View up Cane Creek from bridge at corner of 15th and Howlee Road (Bridge No. 4306); photo faces SE direction.

View is from the opposite side of the same bridge as Photo B13, this time looking upstream into Cane Creek. This side of the creek is less altered than the reach pictured in Photo B13. The right bank (as viewed in the photo) is walled, however, the left bank is not. The left bank runs adjacent to a grass/shrub field. Cane Creek within this reach turns N (to the left as viewed in photo) away from the remainder of the GSA area. The creek upstream of the bridge (photo location) appears to be up to 100 yards N of the GSA area, and is surrounded by a more natural setting consisting of trees, shrubs, and grass.

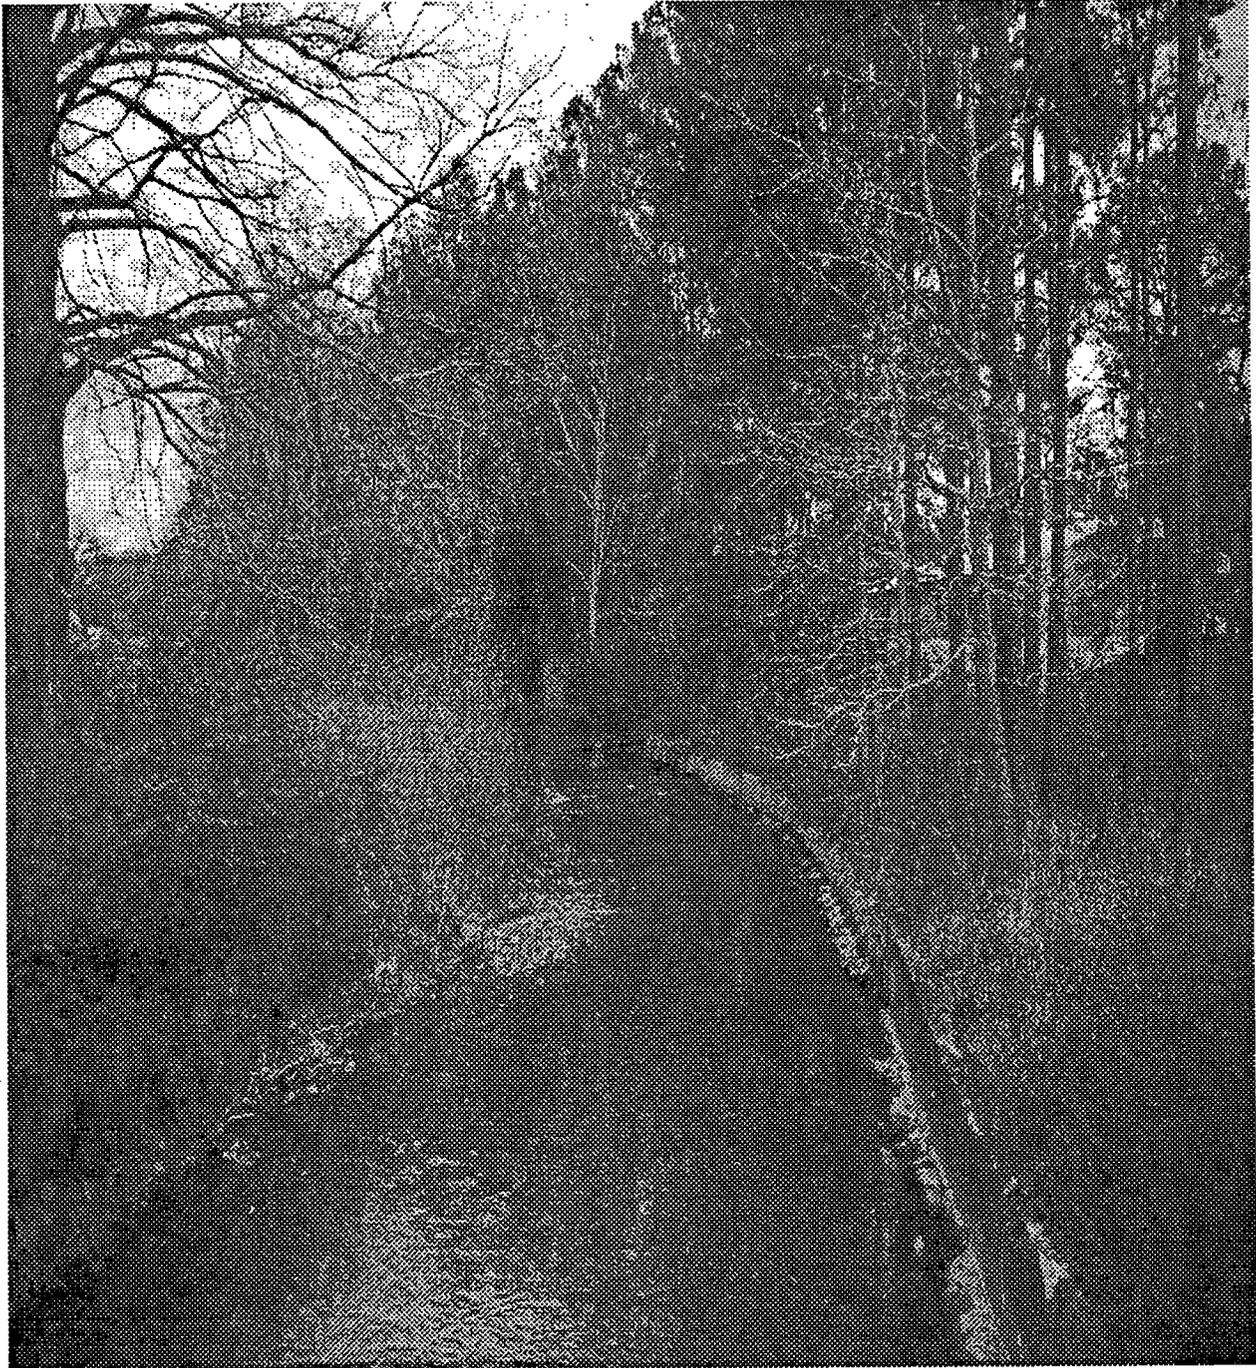
Photo B15 [3/3/98 - 4:40]

View up Cane Creek from bridge at corner of 15th and Howlee Road (Bridge No. 4306); photo faces SE direction.

View is from the opposite side of the same bridge as Photo B13, this time looking upstream into Cane Creek. This side of the creek is less altered than the reach pictured in Photo B13. The right bank (as viewed in the photo) is walled, however, the left bank is not. The left bank runs adjacent to a grass/shrub field. Cane Creek within this reach turns N (to the left as viewed in photo) away from the remainder of the GSA area. The creek upstream of the bridge (photo location) appears to be up to 100 yards N of the GSA area, and is surrounded by a more natural setting consisting of trees, shrubs, and grass.

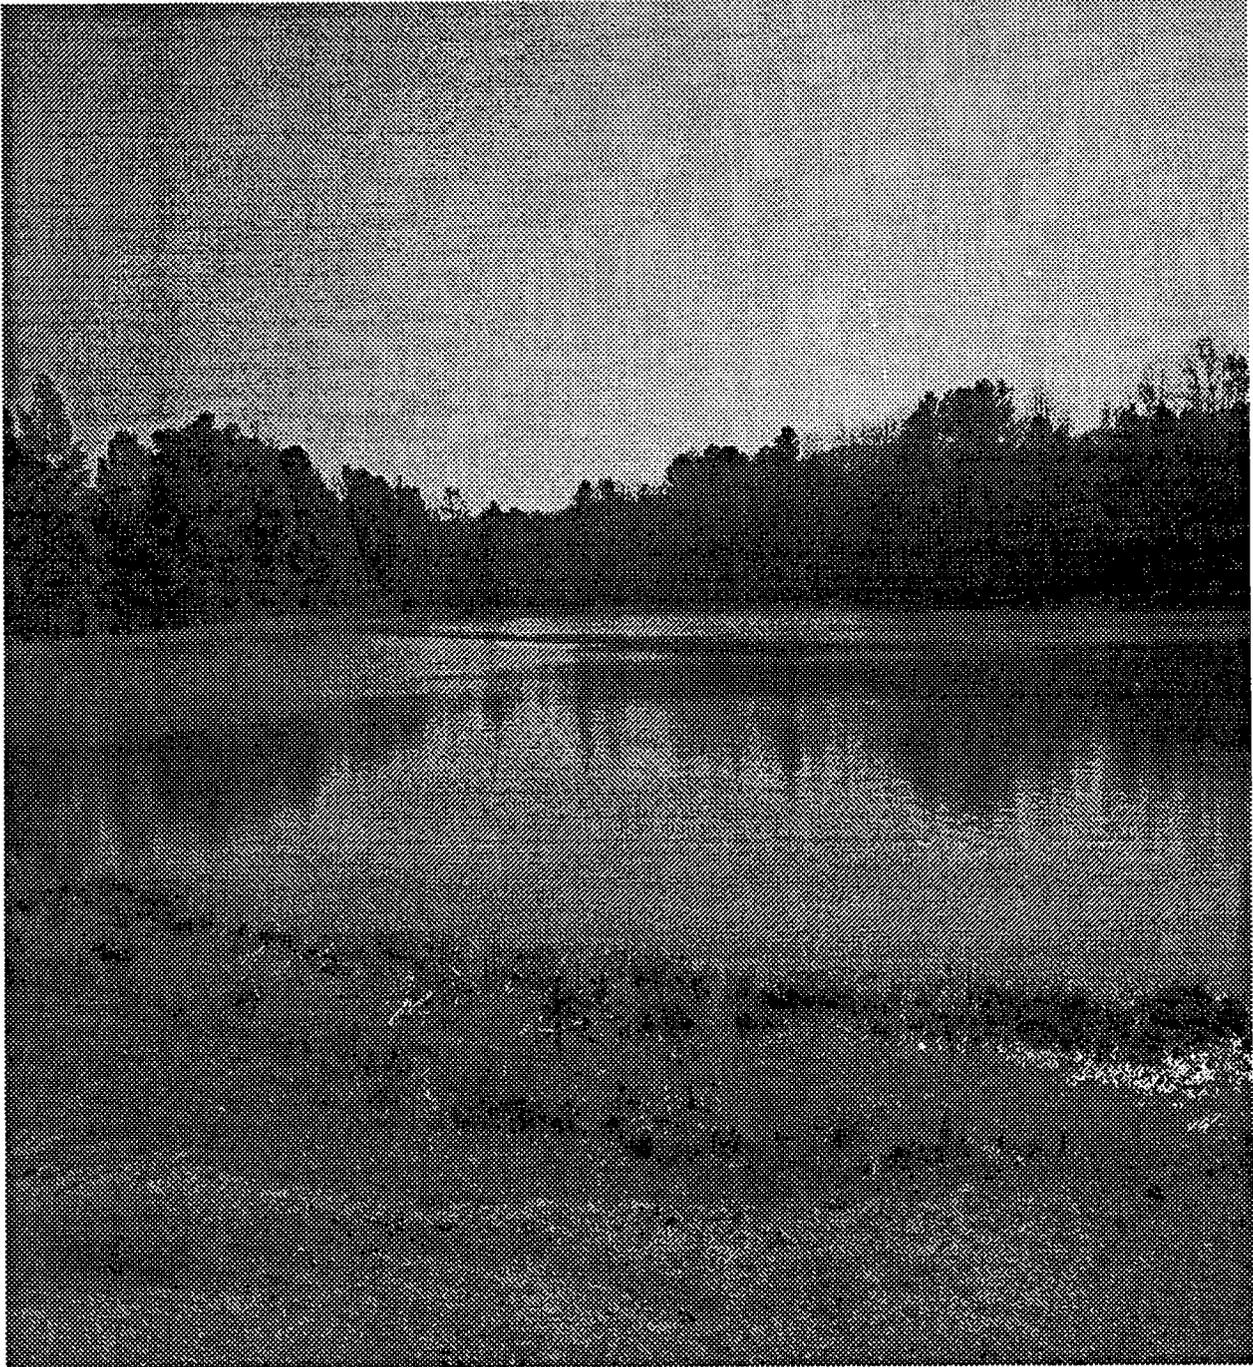
Photo B16 [3/4/98 - 9:05]

View of Lake Reilly; photo faces NE direction over lake. Photo was taken from the berm/road running along the western edge.

In the background, to the right of center, is the inlet to the lake, fed by a wetlands area (see Photos B17, B20, and B21). The lake is completely surrounded by land that is wooded and/or vegetated to various degrees. To the S is a campground area with gravel roads and woods; along the N is a creek running along the entire N edge after entering the northern boundary of Main Post just to the NE of the lake; to the E is a large wetland area; and to the W is a large natural area containing another wetland/creek system.

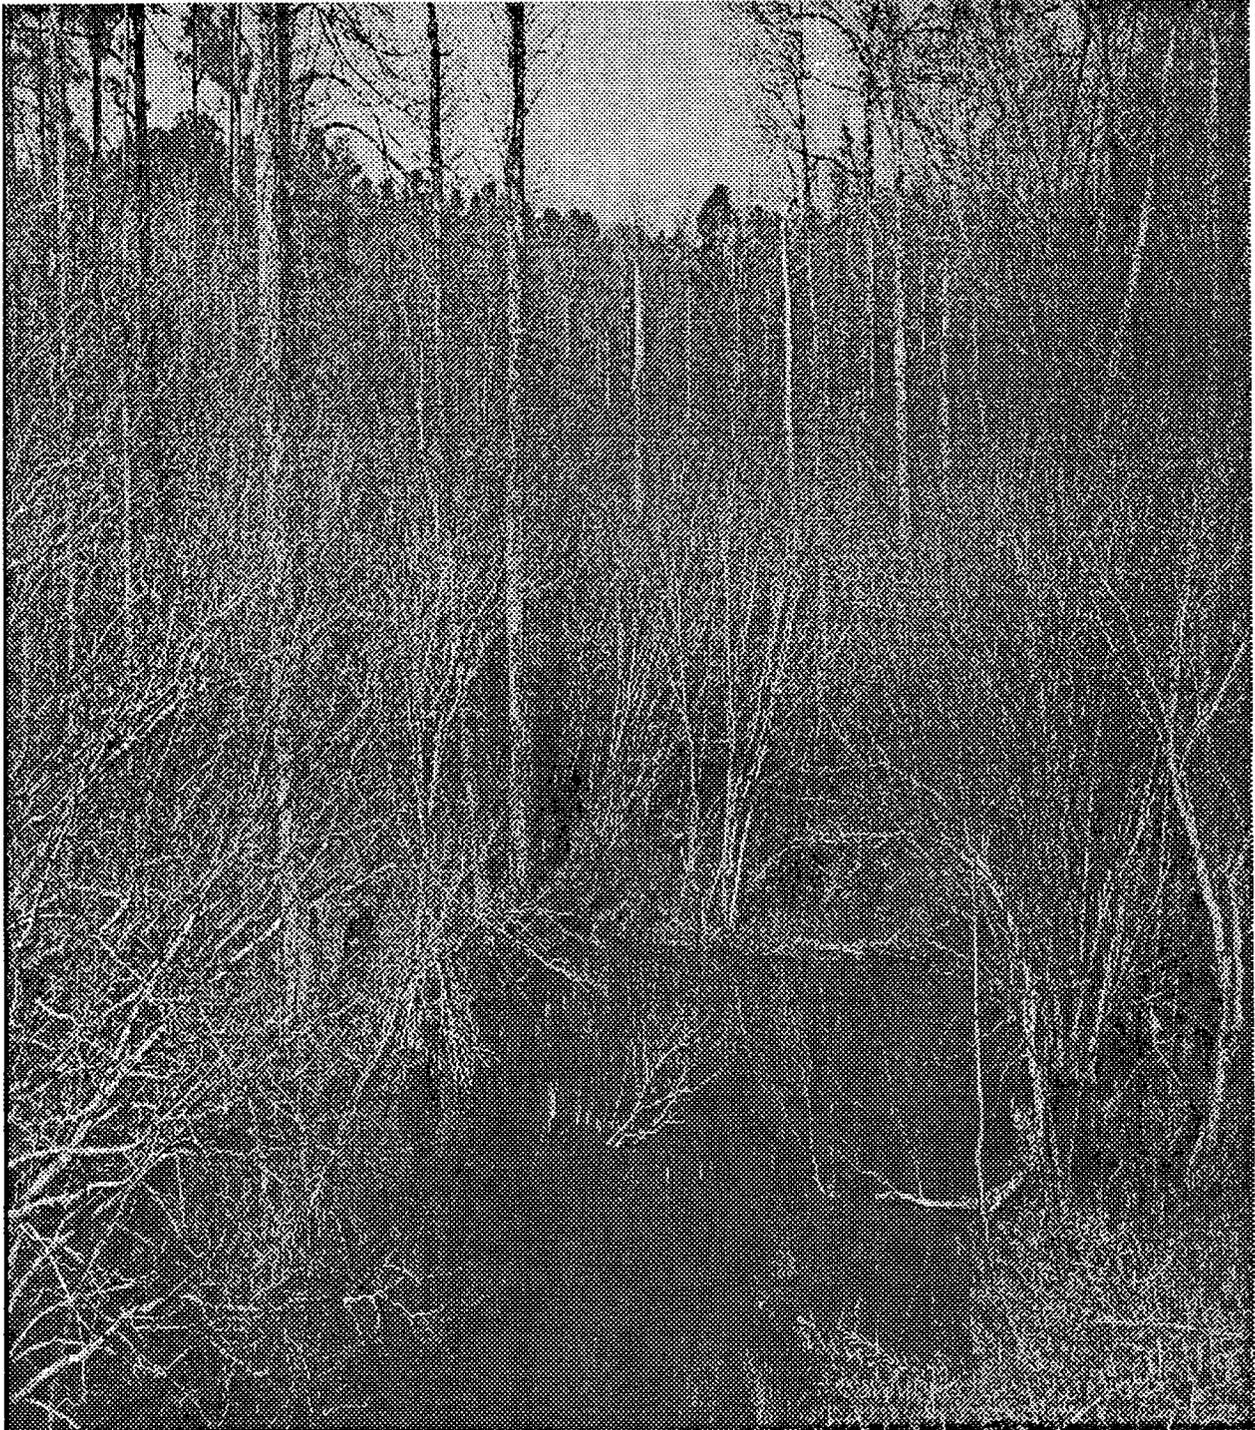
Photo B17 [3/4/98 - 9:08]

Swampy area immediately to the E of Lake Reilly; photo faces W direction.

Soil along the eastern edge of the lake and farther inland to the E is hydric and soft. Water to the lake originates from the wetland area farther E of the swampy land. Examples of the type of wildlife observed (directly or indirectly) in this area are: kingfishers, small fish in the lake (minnow?), tadpoles in the lake, small omnivorous birds, deer (tracks), Canadian geese, beaver (lodge in wetland areas E and W of the lake).

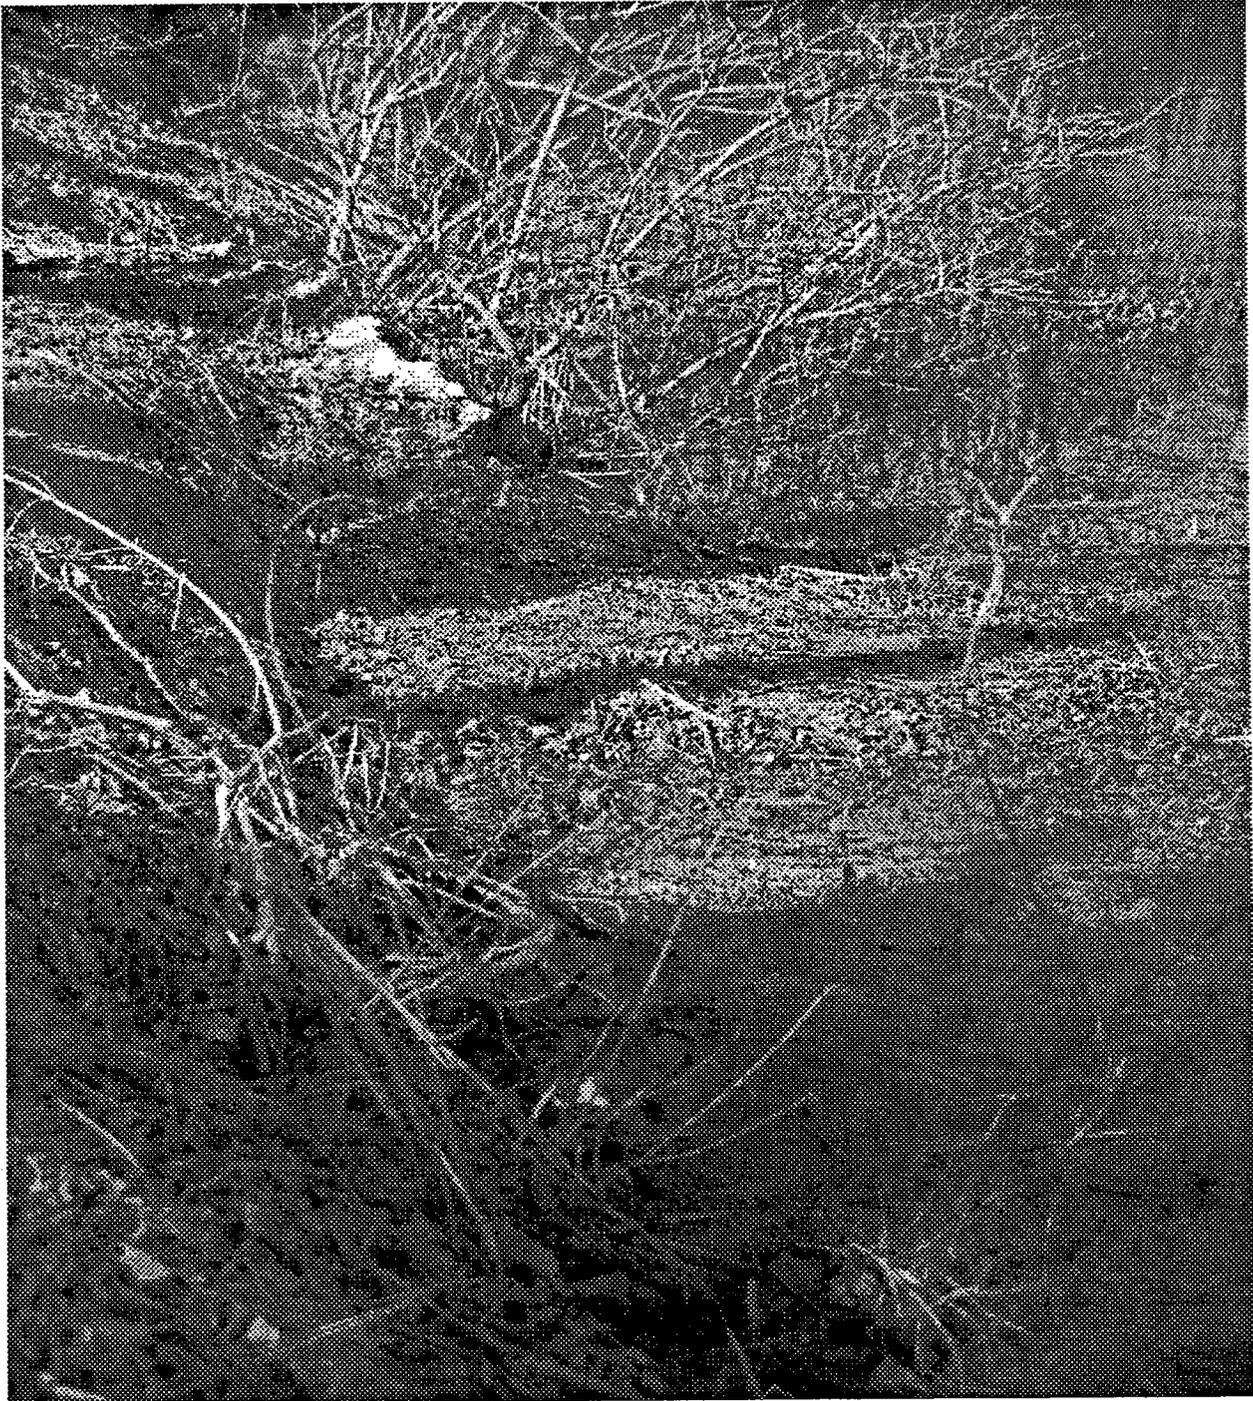
Photo B18 [3/4/98 - 9:12]

Two seeps going into Lake Reilly near southeastern shore, contribute to the swampy area immediately to the E of Lake Reilly; photo faces W direction.

Soil along the eastern edge of the lake and farther inland to the E is hydric and soft. Water to the lake originates from the wetland area farther E of the swampy land. Examples of the type of wildlife observed (directly or indirectly) in this area are: kingfishers, small fish in the lake (minnow?), tadpoles in the lake, small omnivorous birds, deer (tracks), Canadian geese, beaver (lodge in wetland areas E and W of the lake).

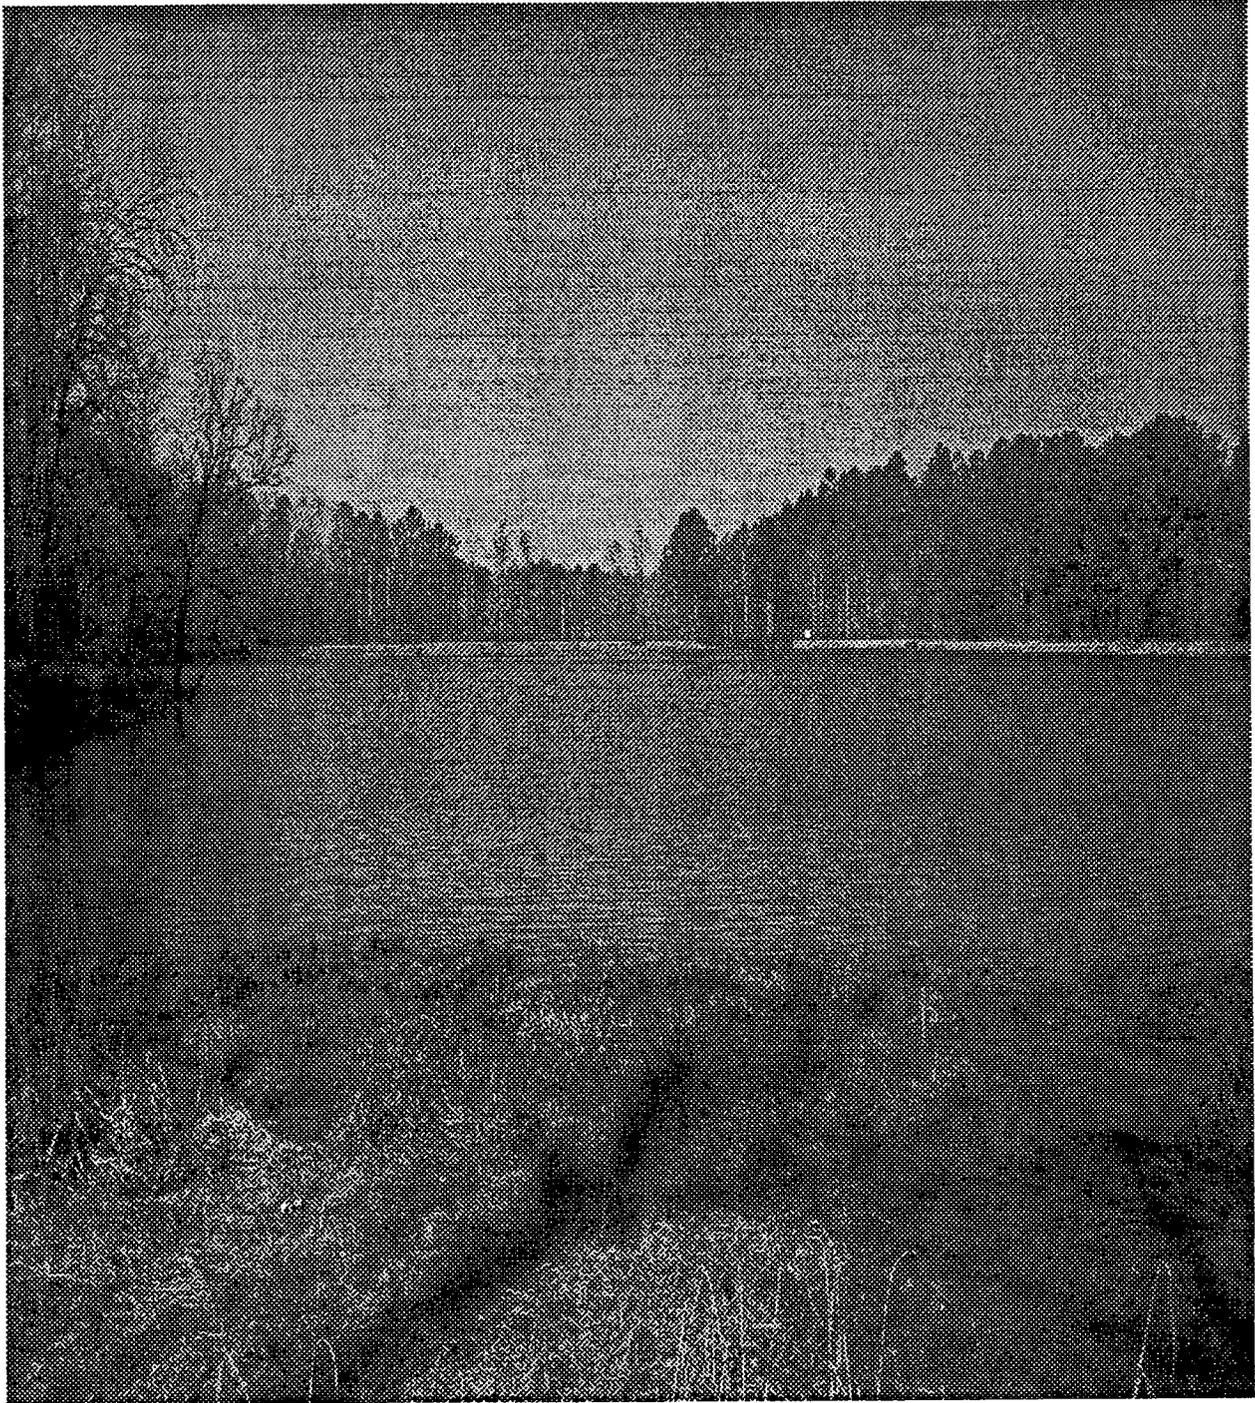
Photo B19 [3/4/98 - 9:20]

View of Lake Reilly, opposite view of Photo B16; photo faces SW direction, and was taken from the eastern shoreline.

Soil along the eastern edge of the lake and farther inland to the E is hydric and soft. Water to the lake originates from the wetland area farther E of the swampy land. Examples of the type of wildlife observed (directly or indirectly) in this area are: kingfishers, small fish in the lake (minnow?), tadpoles in the lake, small omnivorous birds, deer (tracks), Canadian geese, beaver (lodge in wetland areas E and W of the lake).

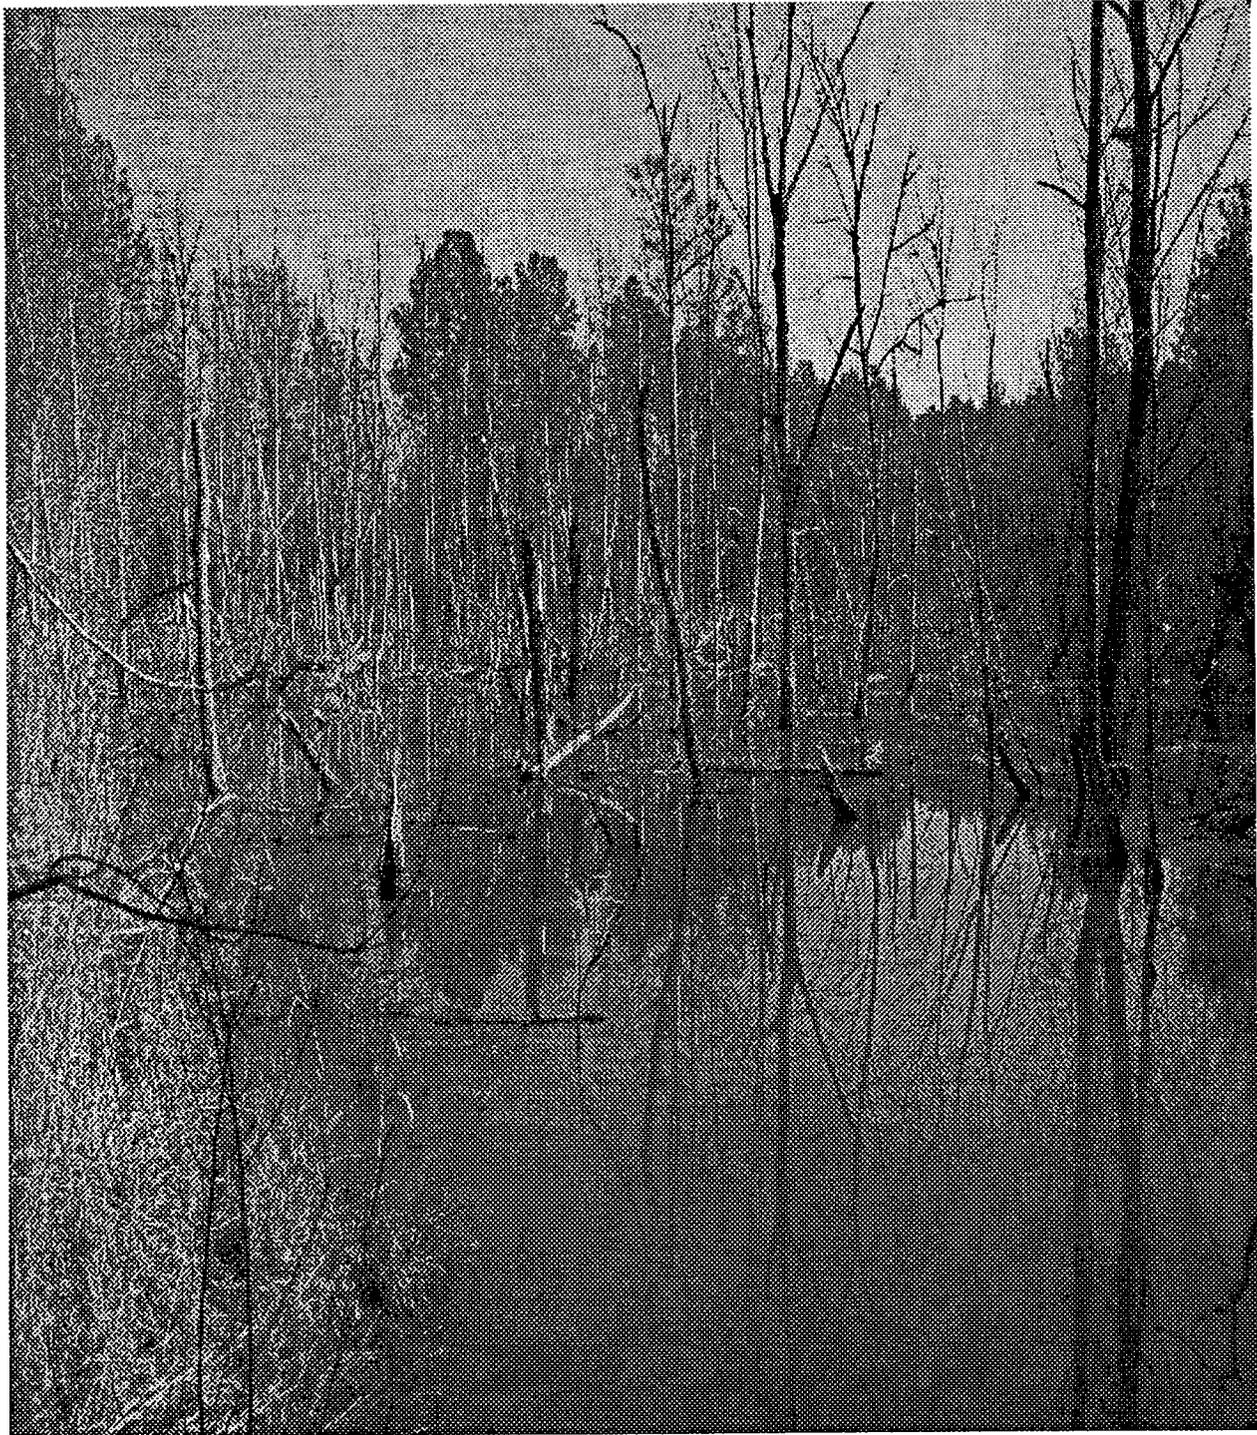
Photo B20 [3/4/98 - 9:30]

Wetlands associated with, and feeding, Lake Reilly [CERFA Parcel Map: 22,50]
View of wetlands E of Lake Reilly, and W of Site 126(7) (the Former Post Garbage Dump); photo faces NE direction into the western edge of the wetlands area.

This wetland area lies about 50 yards E of eastern edge of the lake. The area is secluded from vehicles and heavy pedestrian traffic, completely surrounded by vegetated land (trees, shrubs, and grass), and contains an extraordinarily high density of wildlife as suggested by the diverse types of songs heard in this area during the site reconnaissance.

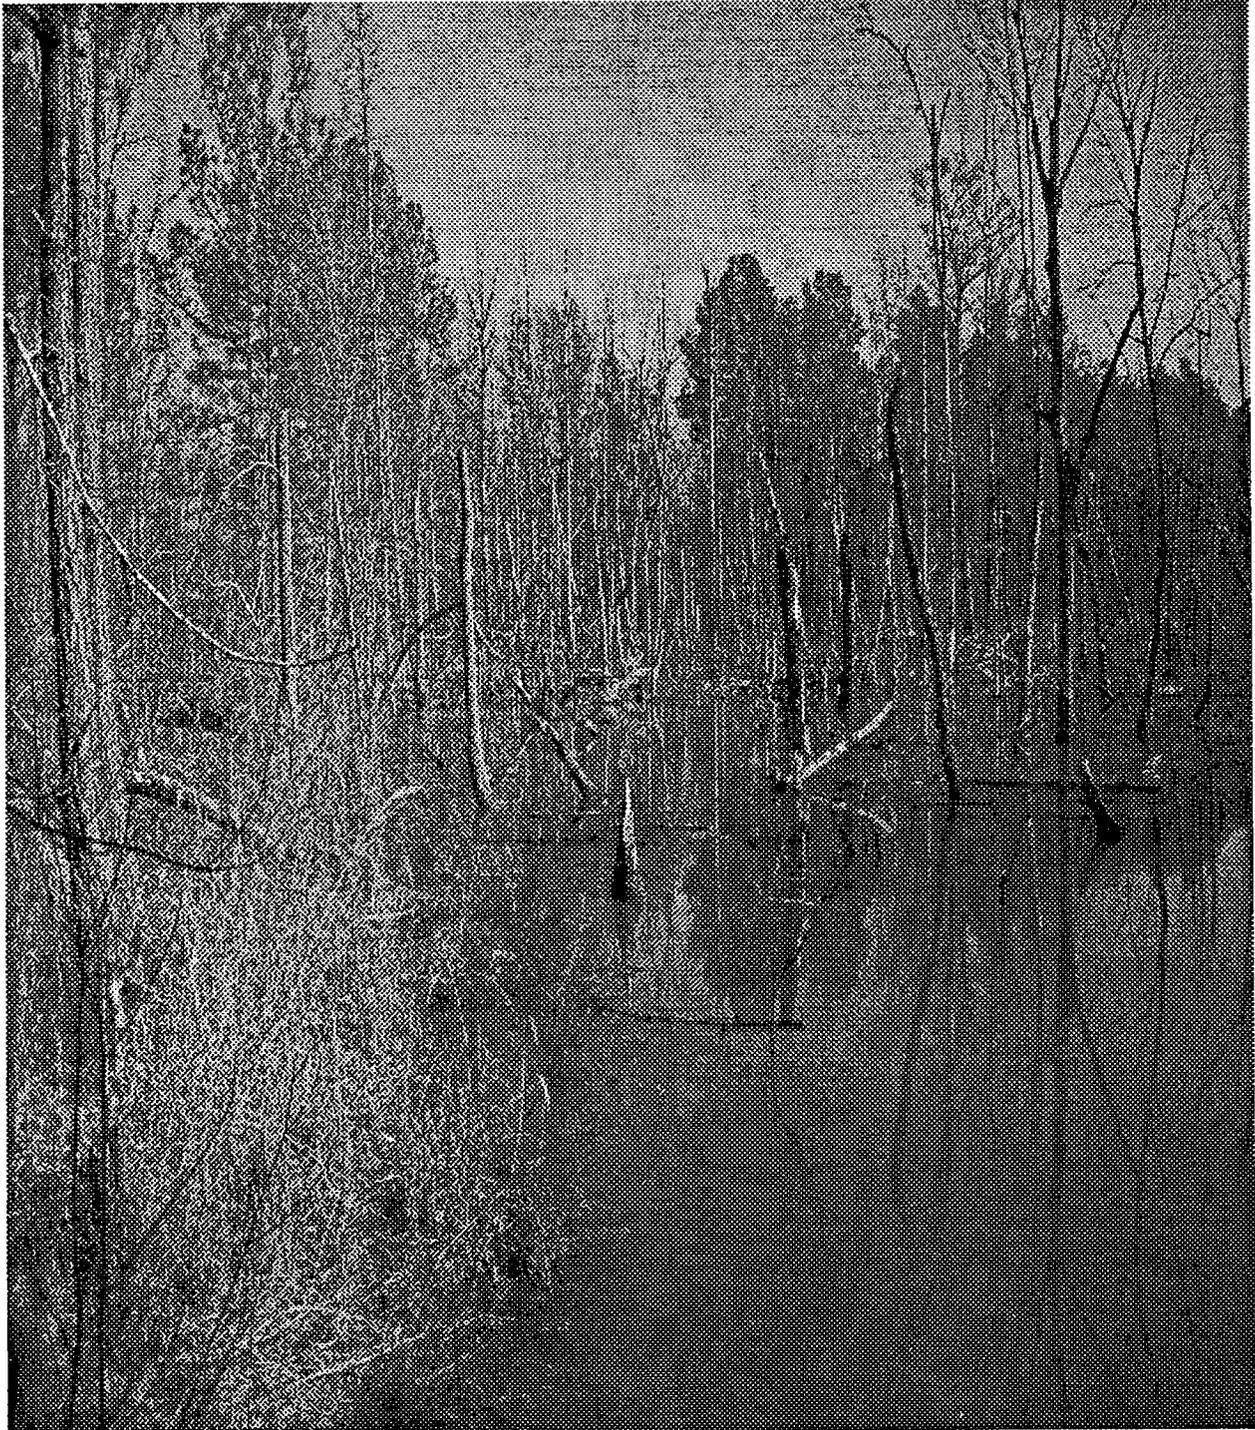
Photo B21 [3/4/98 - 9:30]

Wetlands associated with, and feeding, Lake Reilly [CERFA Parcel Map: 22,50]
View of wetlands E of Lake Reilly, and W of Site 126(7) (the Former Post Garbage Dump); photo faces NE direction
into the western edge of the wetlands area.

This wetland area lies about 50 yards E of eastern edge of the lake. The area is secluded from vehicles and heavy pedestrian traffic, completely surrounded by vegetated land (trees, shrubs, and grass), and contains an extraordinarily high density of wildlife as suggested by the diverse types of songs heard in this area during the site reconnaissance.

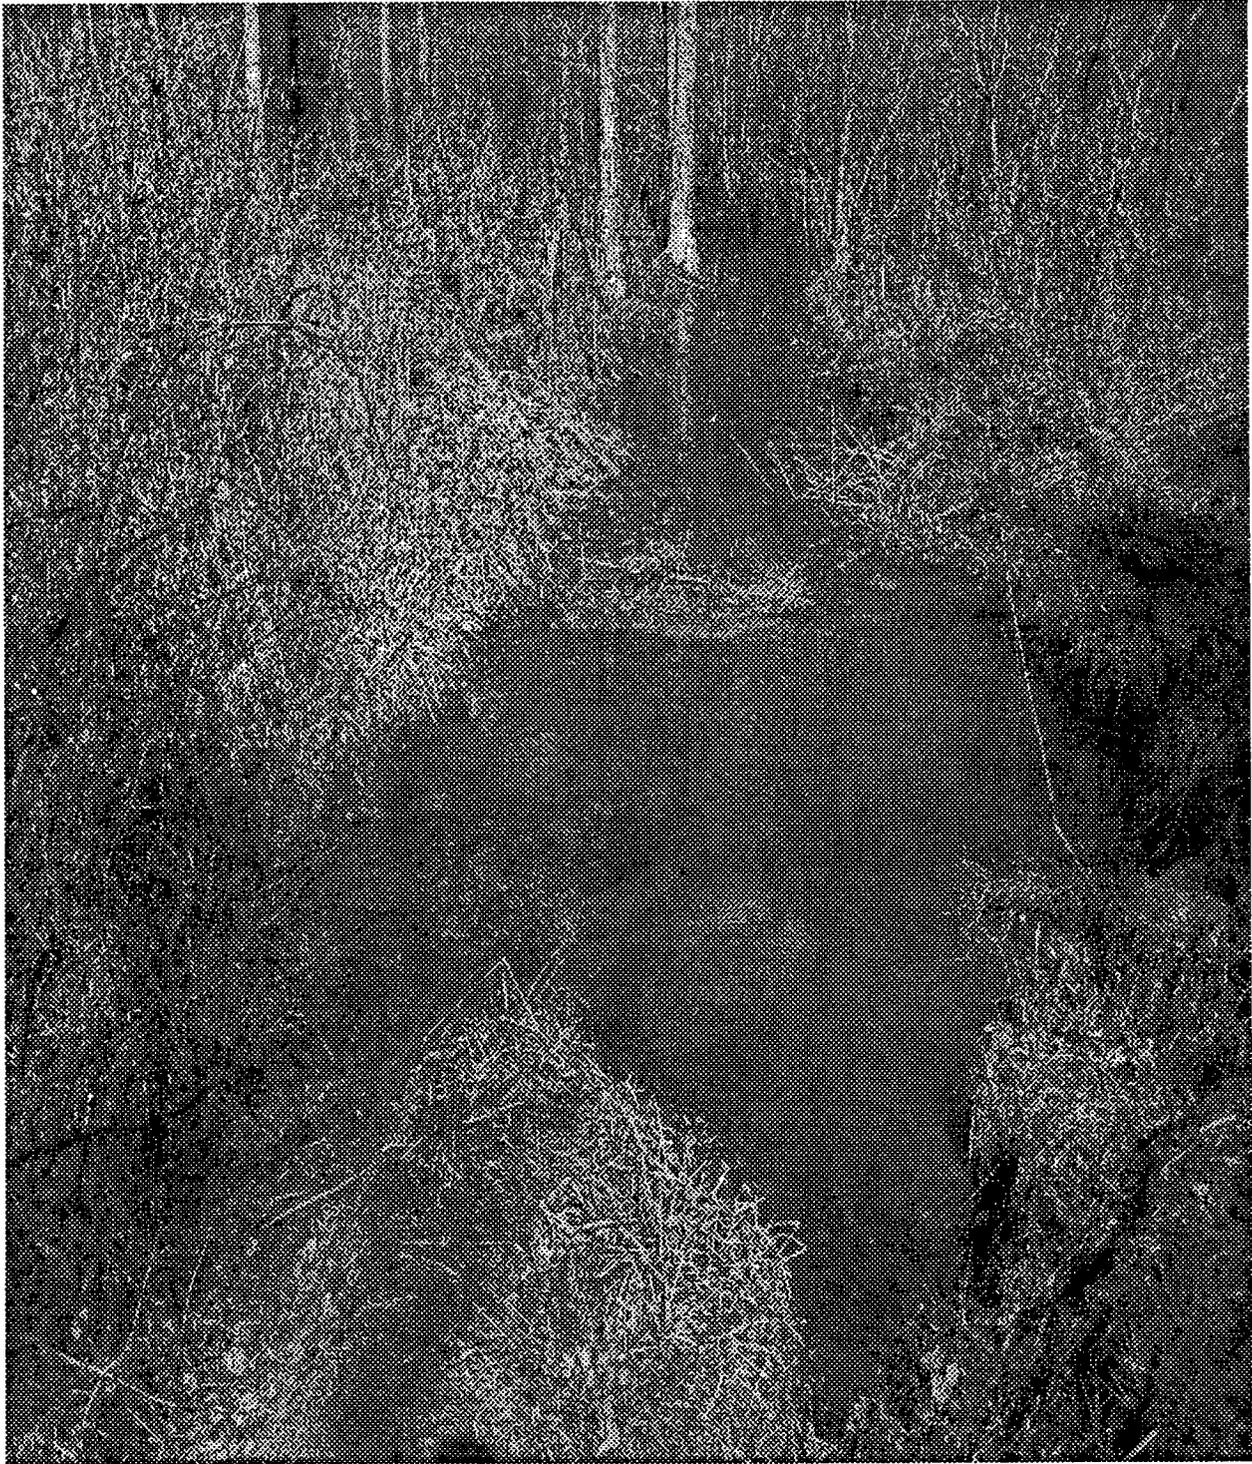
Photo B22 [3/4/98 - 9:40]

Groundwater spring located directly down hill (to the SW) of the berm/road running along the W edge of Lake Reilly; photo faces NW direction.

Spring may be discharge from Lake Reilly under the berm/road. Water flows in a NW direction, eventually mixing with the western wetland/creek system. This area is characterized by heavy vegetation and trees.

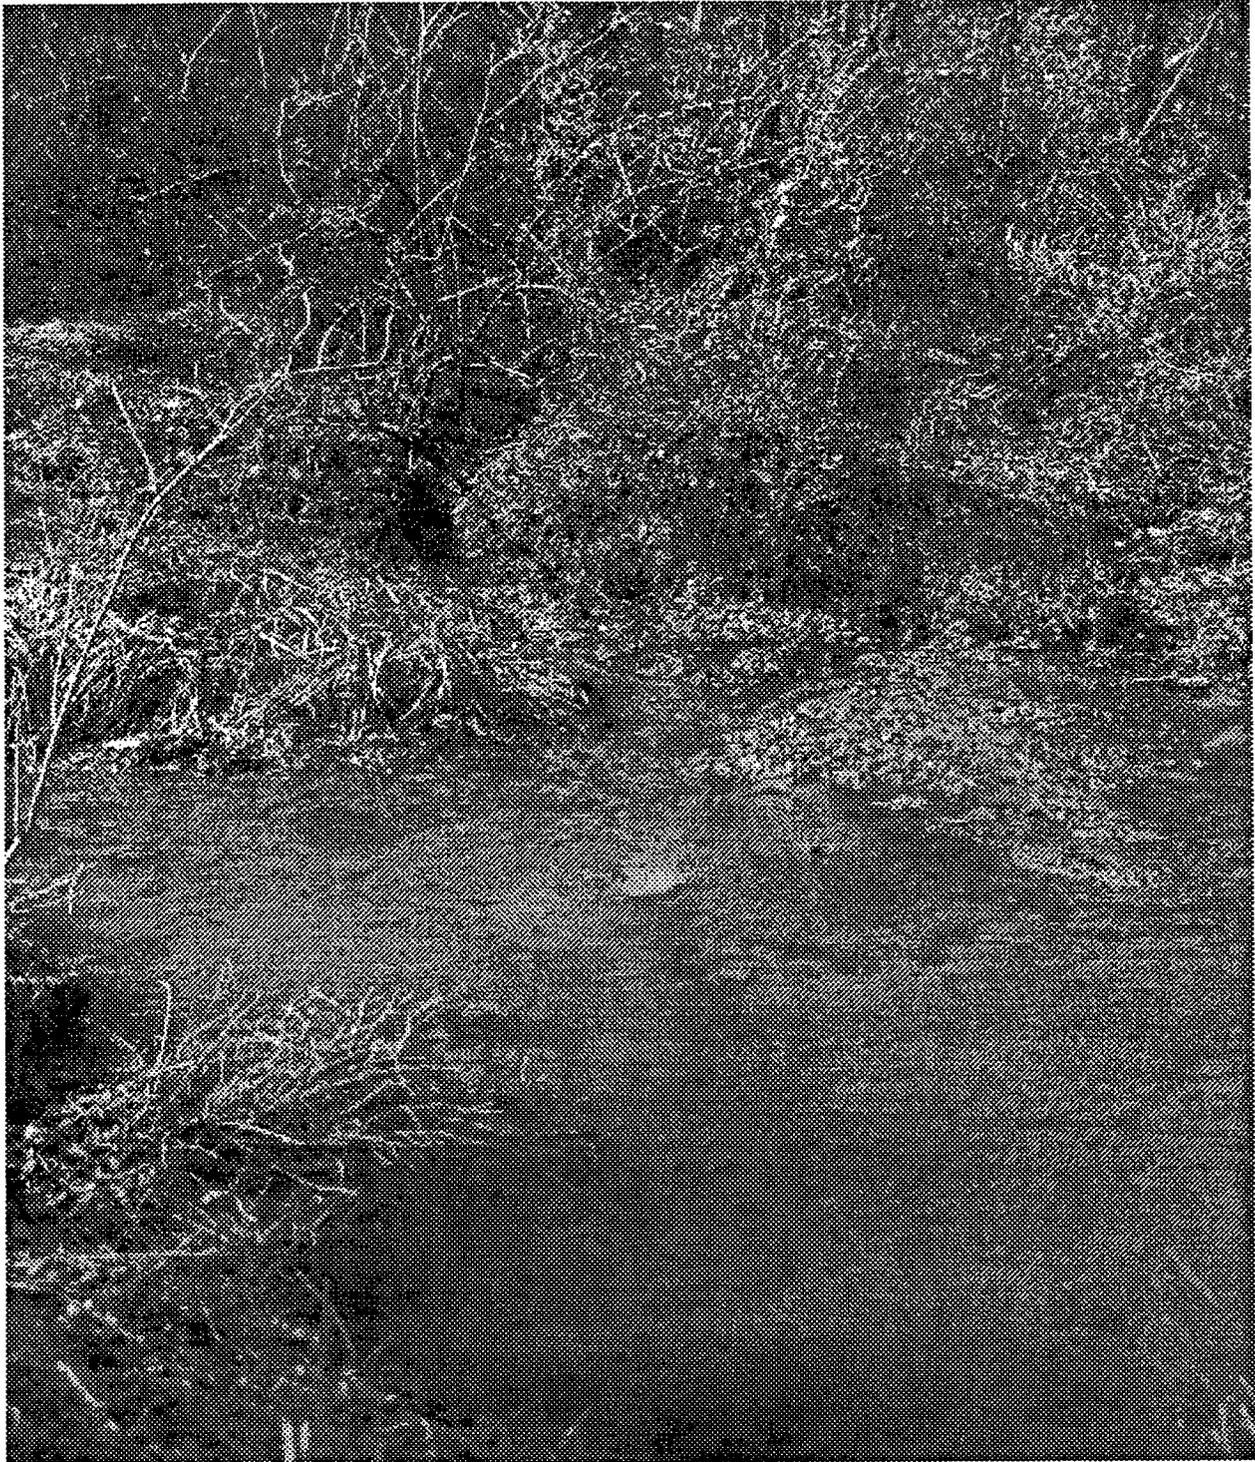
Photo B23 [3/4/98 - 9:40]

Groundwater spring located directly down hill (to the SW) of the berm/road running along the W edge of Lake Reilly; photo faces SW direction. This photo was taken at the same site as was Photo B22, but at a different angle.

Spring may be discharge from Lake Reilly under the berm/road. Water flows in a NW direction, eventually mixing with the western wetland/creek system. This area is characterized by heavy vegetation and trees.

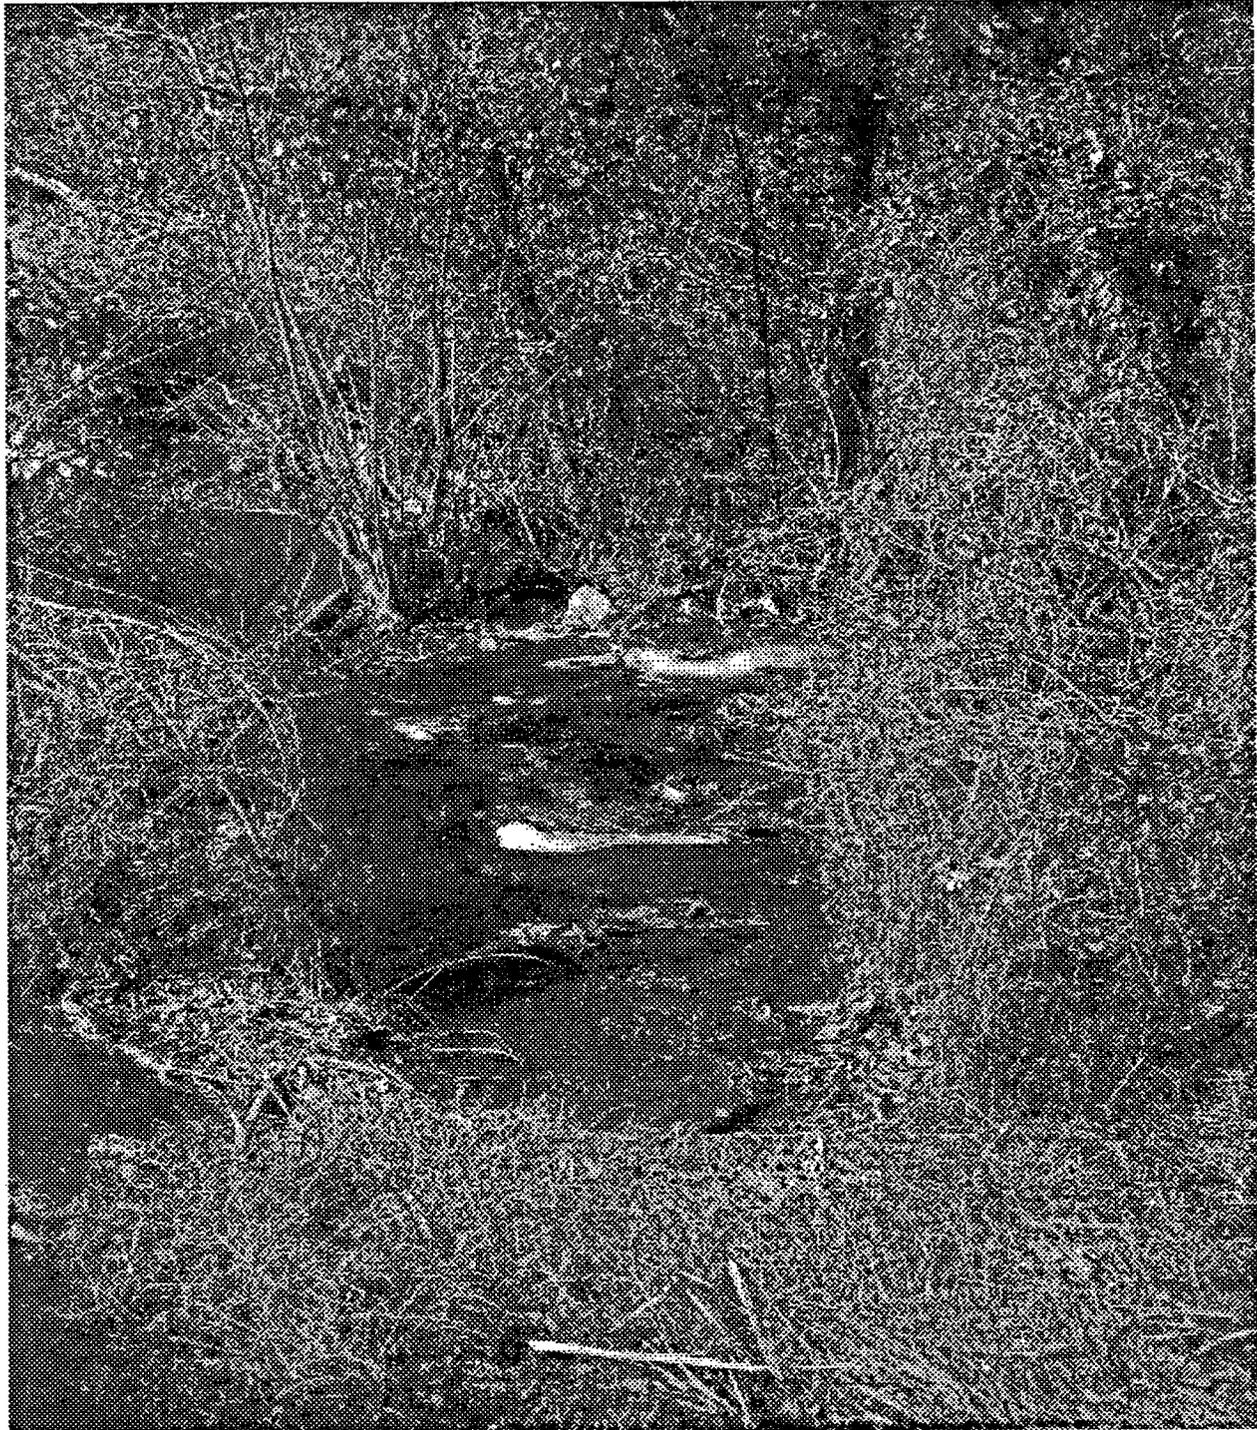
Photo B24 [3/4/98 - 9:50]

Effluent flow from NW corner of Lake Reilly; photo faces W direction, and was taken from the foot bridge at the NW corner of the lake.

The lake empties through a culvert-like, concrete weir. The sloped channel empties to the W where it end adjacent to a natural creek and a wetlands area. The white foam in water was noted in several locations after the lake discharge weir, but not in the lake.
