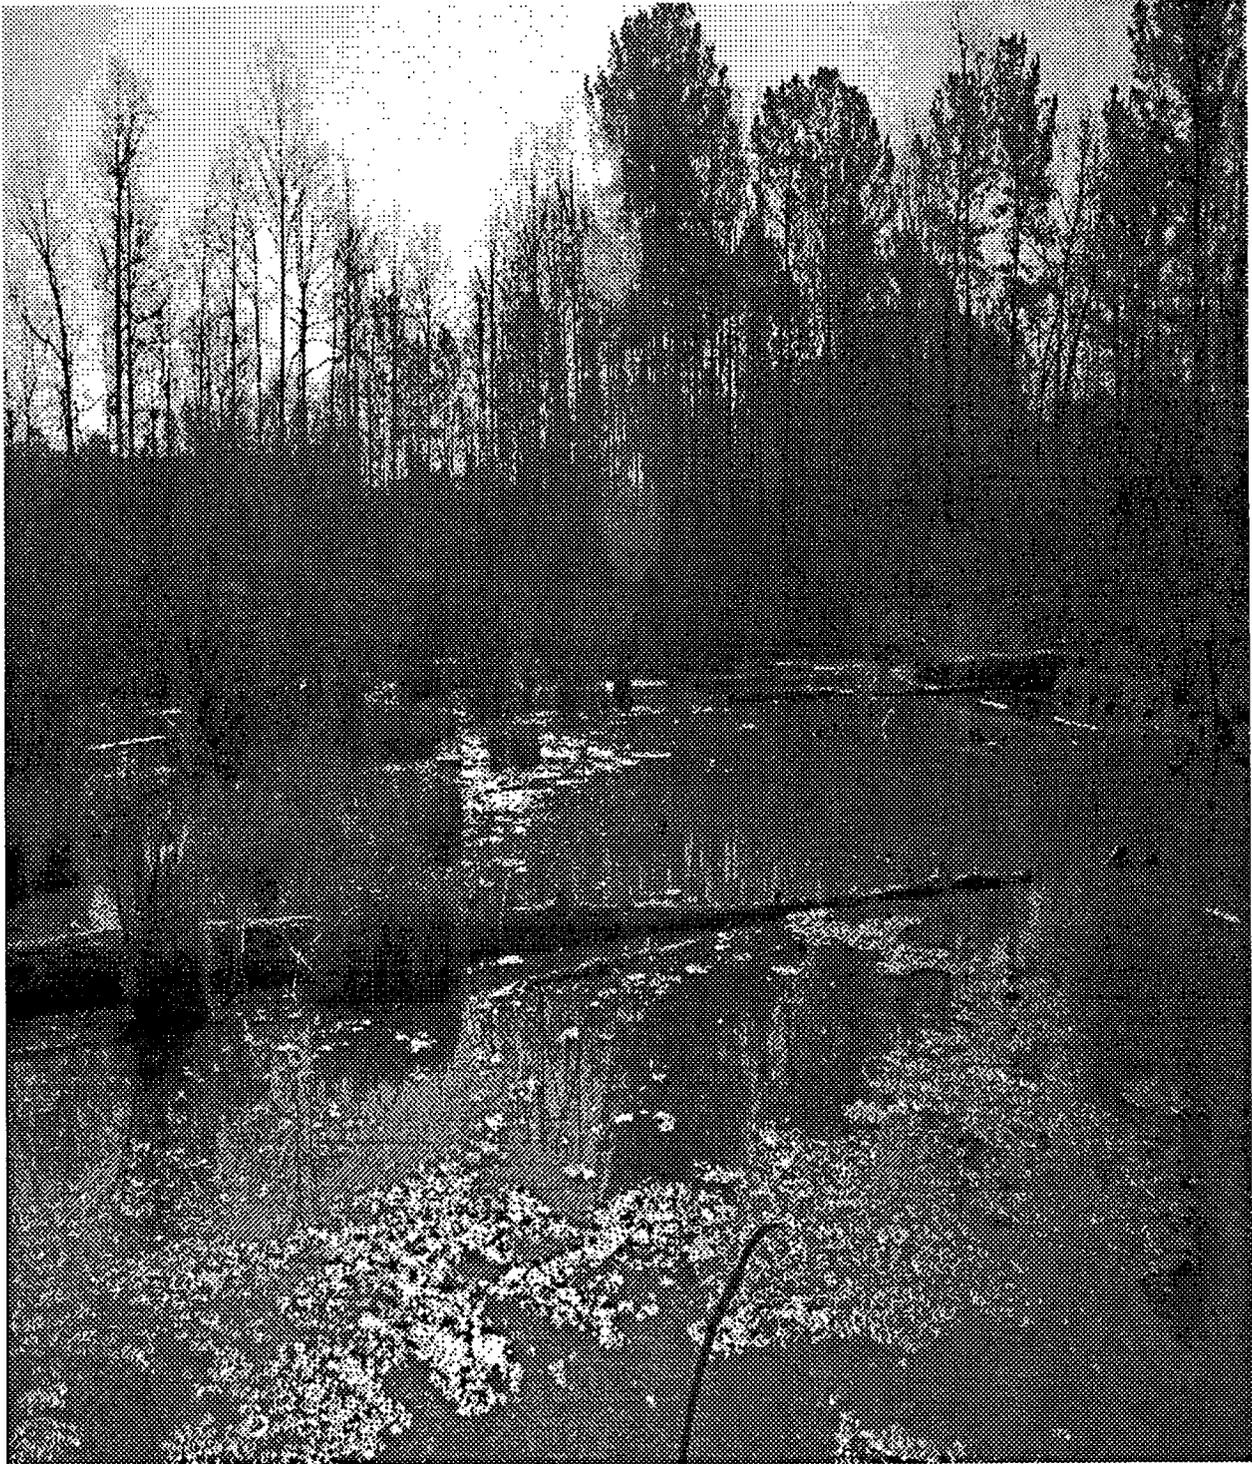
Photo B25 [3/4/98 - 10:00]

Wetlands/marsh area W of lake; photo faces SE direction, and was taken from a second foot bridge west of the first.

The lake empties through a culvert-like, concrete weir. The discharged water flows through a natural creek before reaching the wetlands area (pictured). This area is less vegetated than the eastern wetlands area. This reach of the wetlands/creek system is expected to receive all un-attenuated contamination from upstream sources.

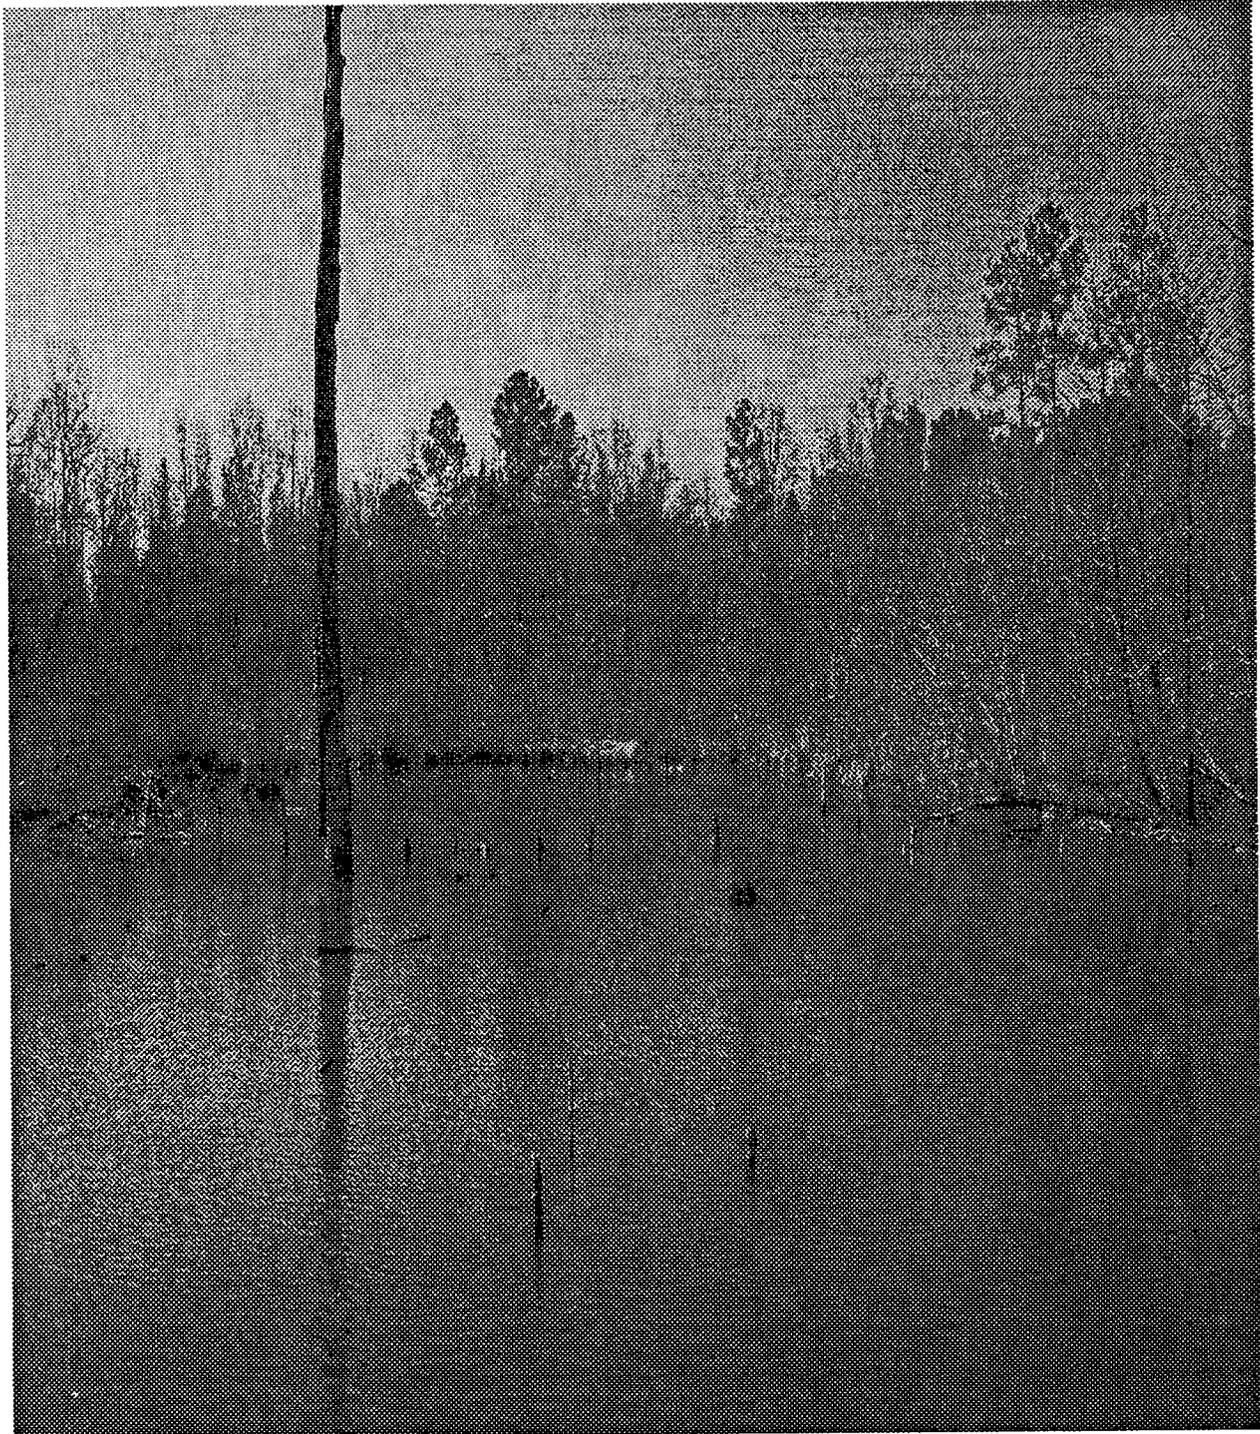
Photo B26 [3/4/98 - 10:01]

Wetlands/marsh area W of lake; photo faces SW direction, and was taken from a second foot bridge west of the first. Same area as Photo B25.

The lake empties through a culvert-like, concrete weir. The discharged water flows through a natural creek before reaching the wetlands area (pictured). This area is less vegetated than the eastern wetlands area. This reach of the wetlands/creek system is expected to receive all un-attenuated contamination from upstream sources.

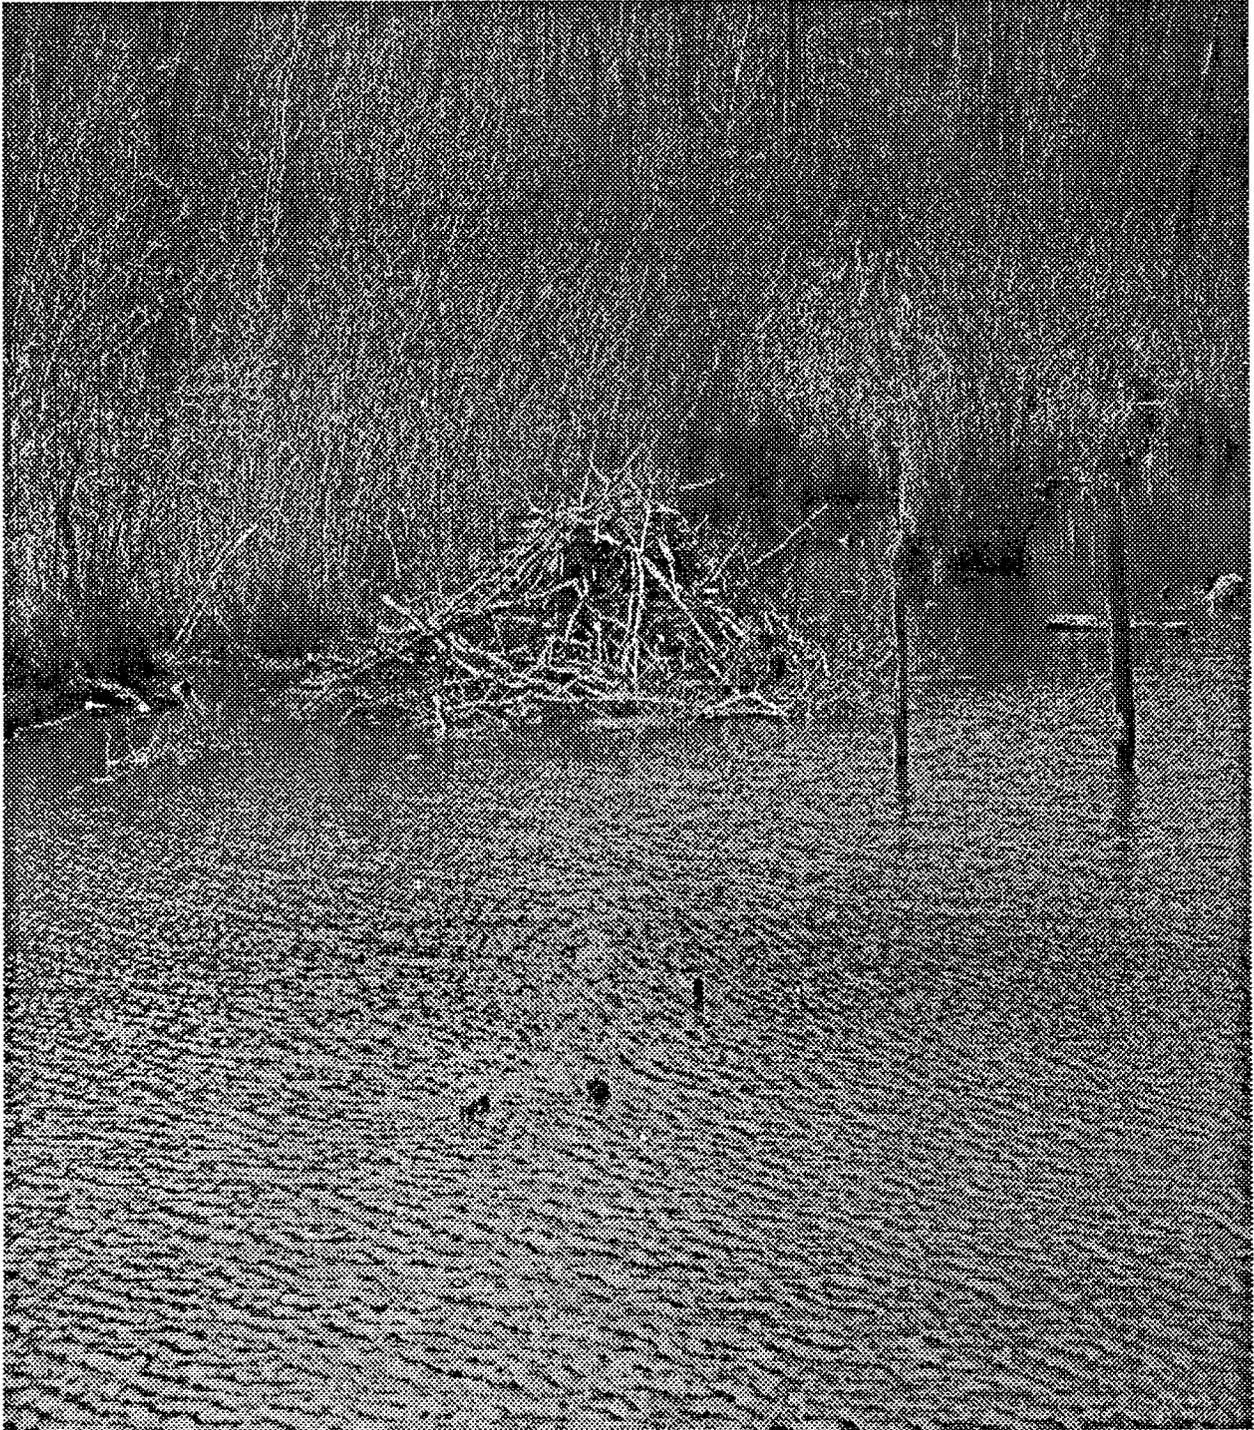
Photo C1 [3/4/98 - 10:03]

Wetlands/marsh area W of lake; photo faces SW direction, and was taken from a second foot bridge west of the first. Same area as Photo B25. Beaver lodge in same area as Photos B25 and B26.

The lake empties through a culvert-like, concrete weir. The discharged water flows through a natural creek before reaching the wetlands area (pictured). This area is less vegetated than the eastern wetlands area. This reach of the wetlands/creek system is expected to receive all un-attenuated contamination from upstream sources.

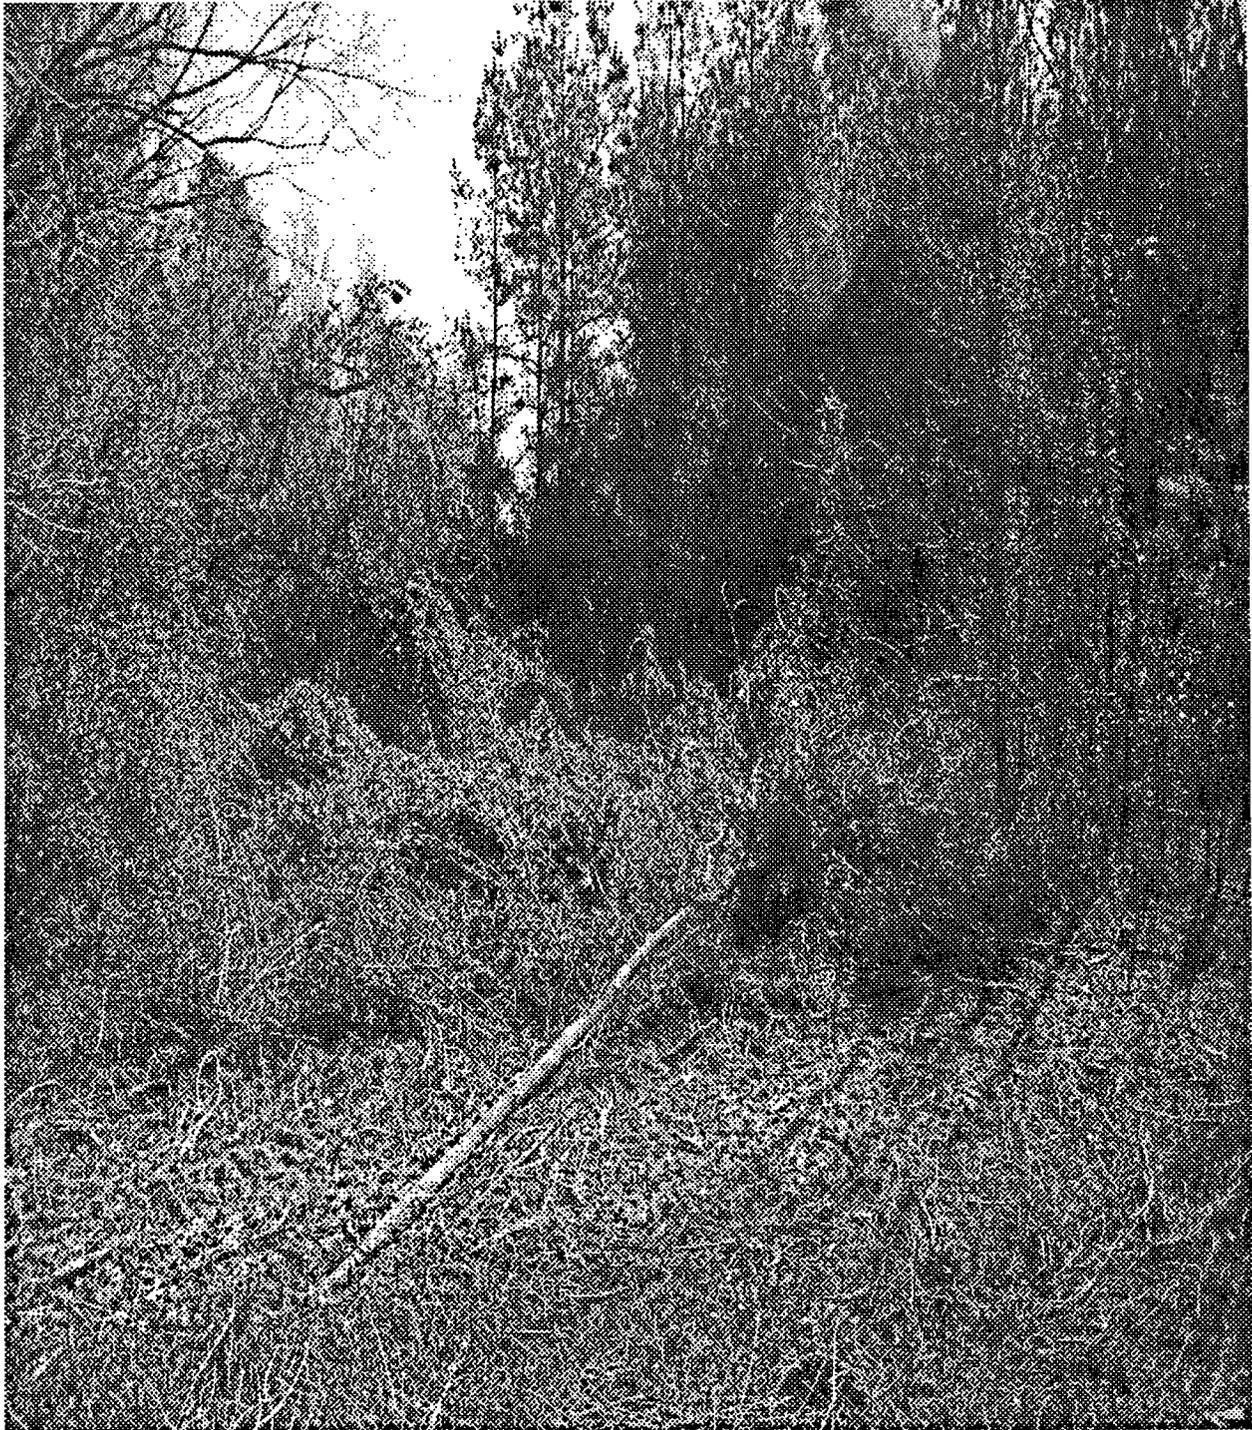
Photo C2 [3/4/98 - 10:15]

Site 229(7) is located W of Lake Reilley and Reilley Airfield; photo faces S direction into a densely vegetated area, and was taken from the extreme NW corner of the lot.

This site is poorly characterized, partly because the potential contamination occurred during historical use. The area is completely covered by trees and brush. No attempt was made to locate structures related to the potential site. A creek is shown to pass through the extreme NE corner of the property (as per CERFA Parcel Map). No water body was noted.

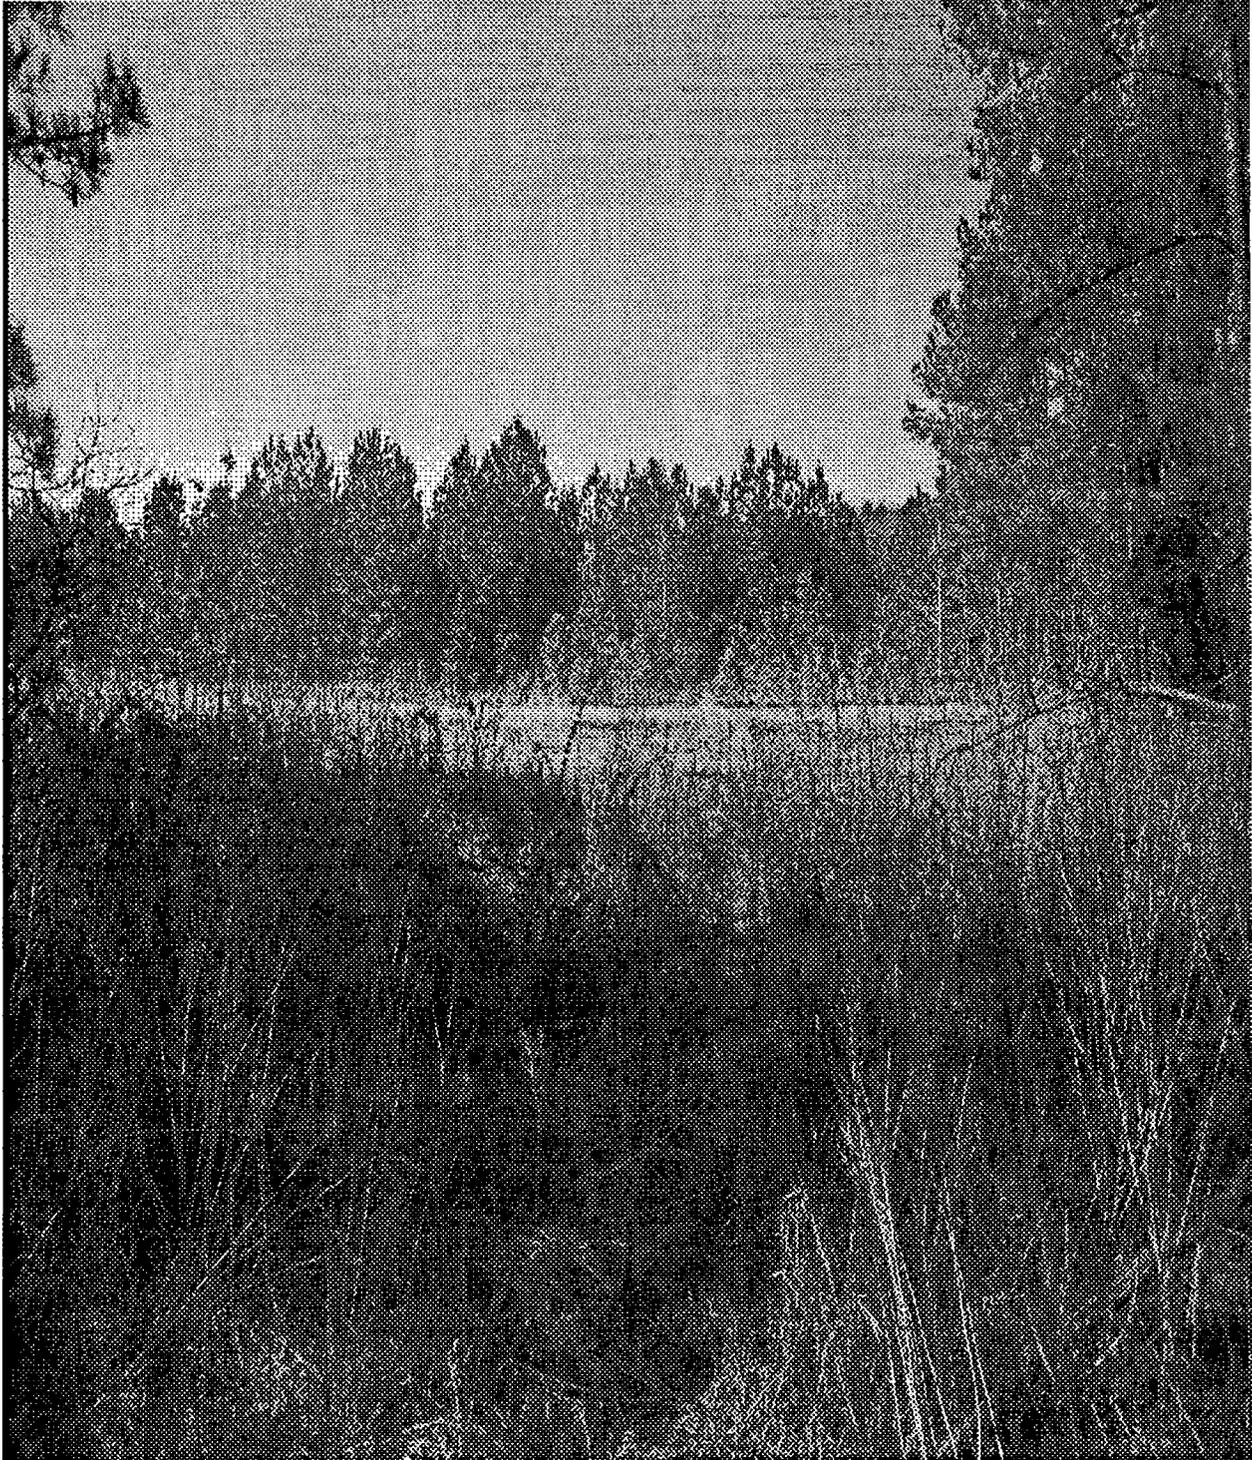
Photo C3 [3/4/98 - 10:16]

Site 155(7) consists of an open pit and potential ground scar, photo faces W direction. This is a former ESE, Inc. site.

This site is poorly characterized, partly because the potential contamination occurred during historical use. It is designated as an area in need of further assessment. The area is largely an open field of grass (pictured) surrounded by deciduous forest and brush. No aquatic components to this site were noted.

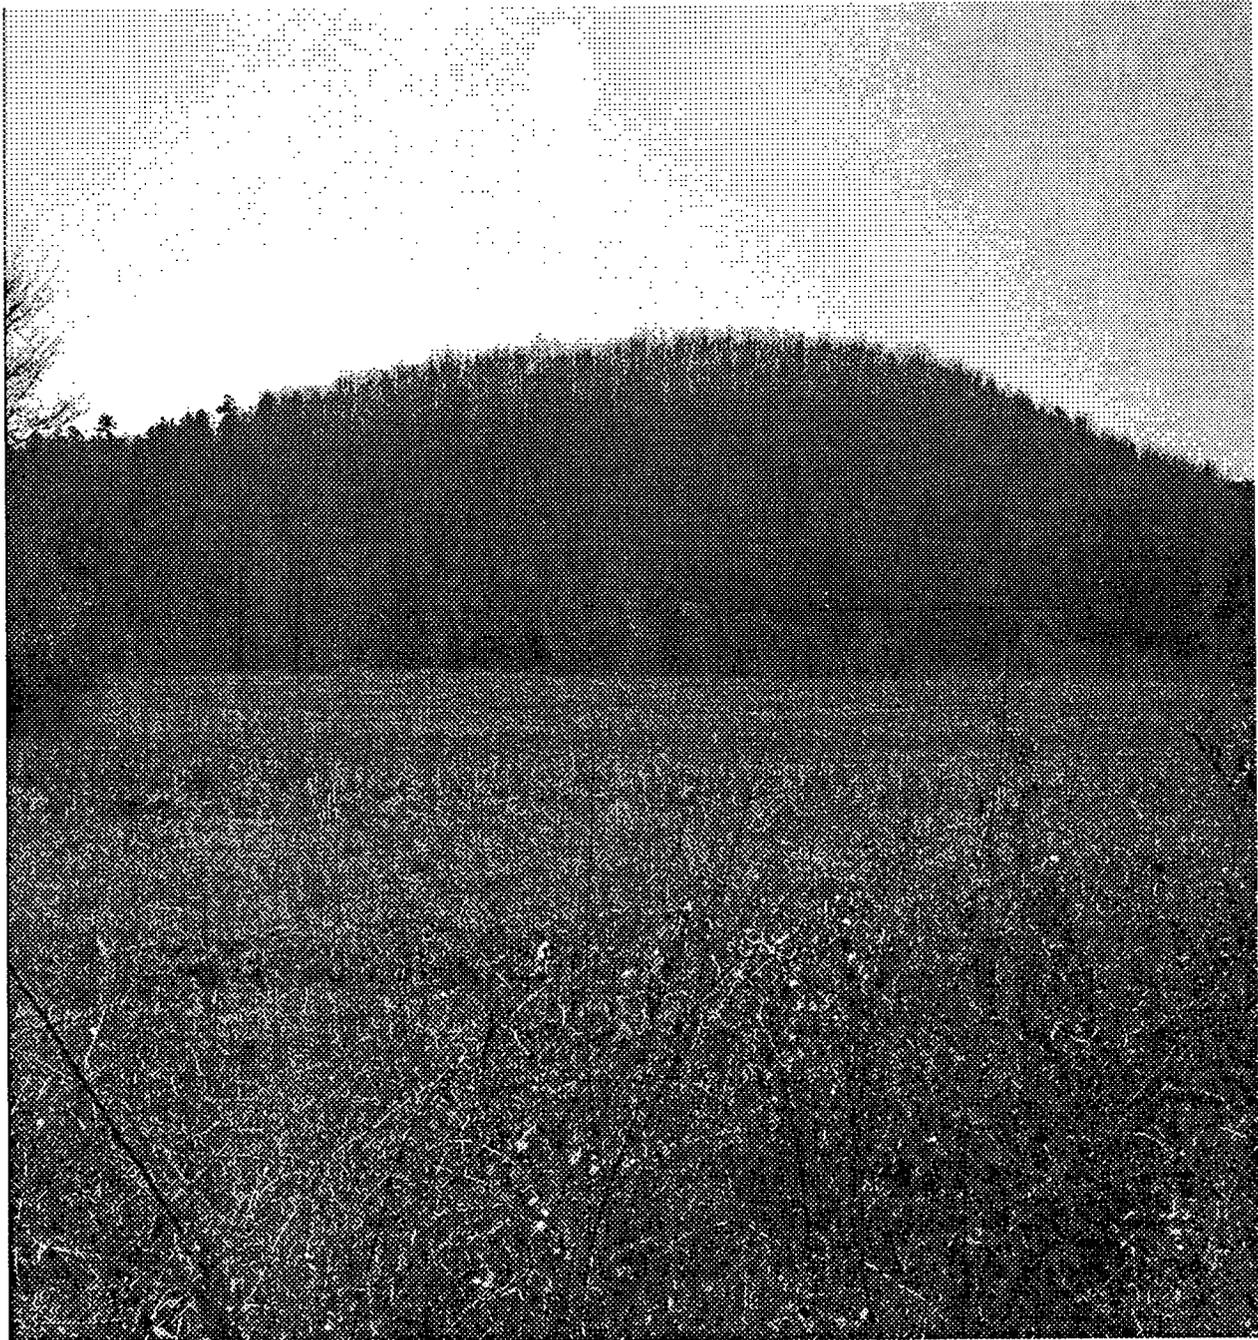
Photo C4 [3/4/98 - 10:30]

Site 231(7) consists of an open field and an excavated hillside (at the base of the hill pictured in the background); photo faces S direction, and was taken from the road running along the NW boundary.

This site is characterized by grossly excavated canyons (see Photo C8), erosion ditches, and barren soil. Several areas were found to contain dumped debris, old military vehicles, and assorted trash. The hillside is capped by tall pine forest with sparse understory (see Photo C6 and C7). The excavated cliffs expose groundwater seeps that discharge water down the cliffsides (see Photo C9 and C10). This groundwater eventually collects into small drainage creeks (see Photo C5). Evidence of continual groundwater seepage, as well as stormwater drainage, is found throughout the site in the form of erosion ditches (see Photo C7, C9, and C10).
