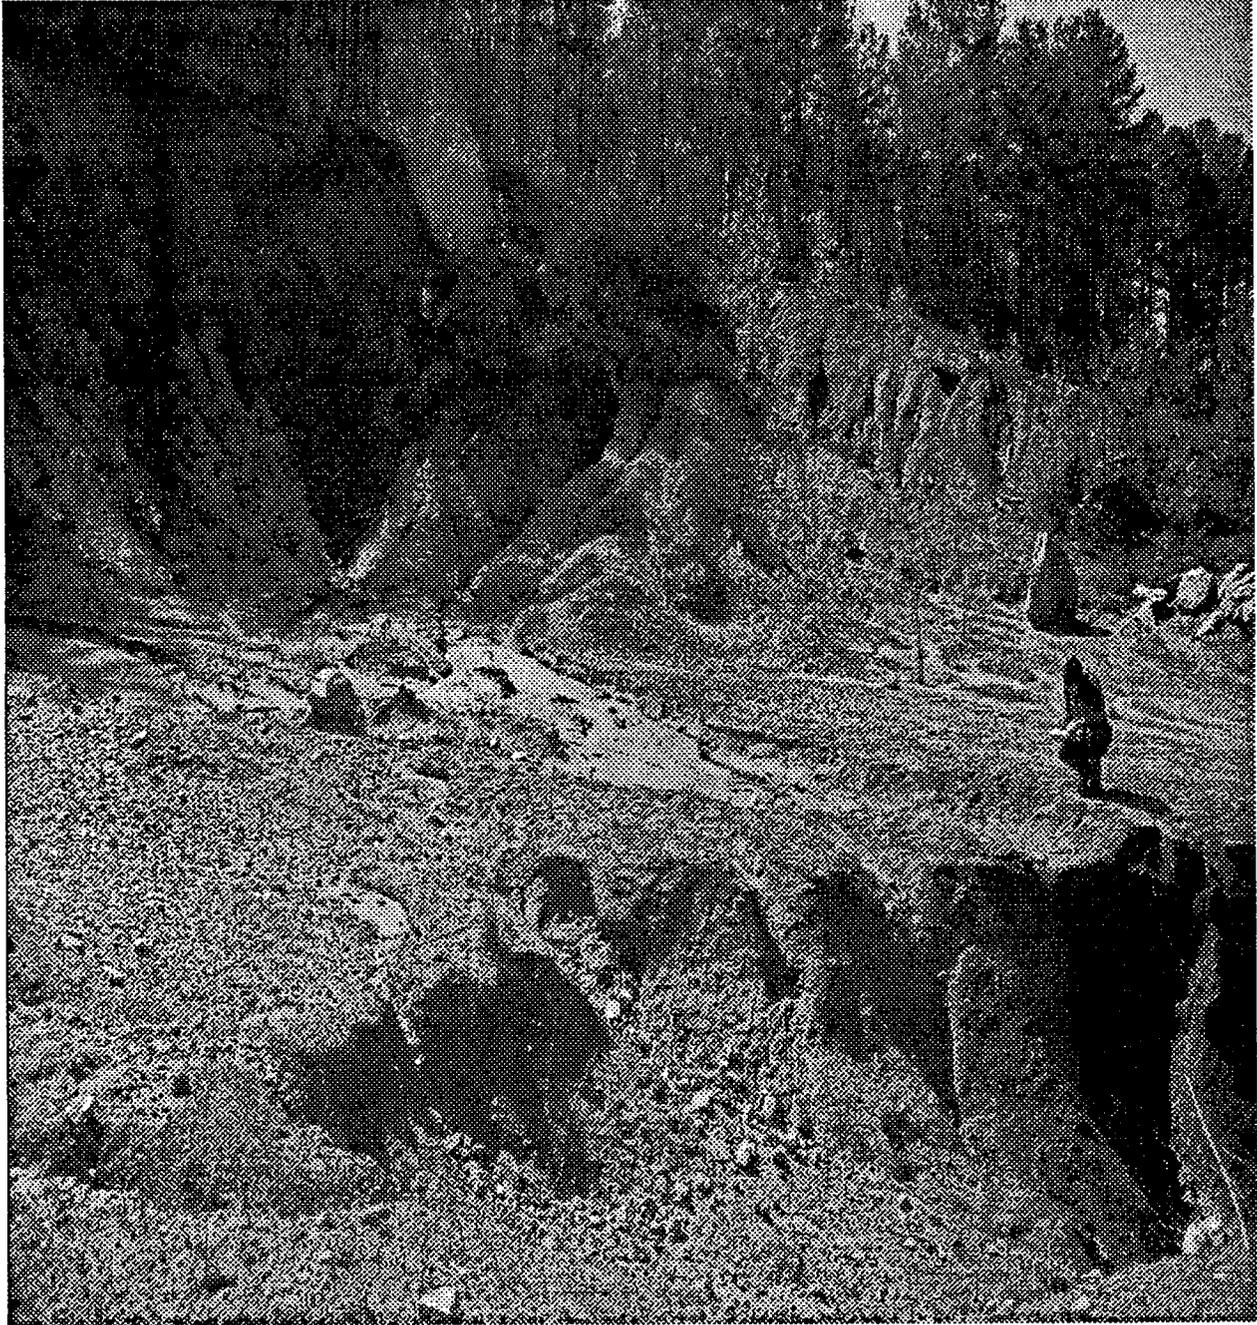
Photo C7 [3/4/98 - 10:42]

Site 231(7) consists of an open field and an excavated hillside (just out of view to the left of view); photo faces SW direction from the same location as Photo C6.

The soil in this area is predominantly moist sandy-clay. The groundwater seeps originate from the cliffs to the left of view. This site is characterized by grossly excavated canyons (see Photo C8), erosion ditches, and barren soil. Several areas were found to contain dumped debris, old military vehicles, and assorted trash. The hillside is capped by tall pine forest with sparse understory (see Photo C6). The excavated cliffs expose groundwater seeps that discharge water down the cliffsides (see Photo C9 and C10). This groundwater eventually collects into small drainage creeks (see Photo C5). Evidence of continual groundwater seepage, as well as stormwater drainage, is found throughout the site in the form of erosion ditches (see Photo C9 and C10).

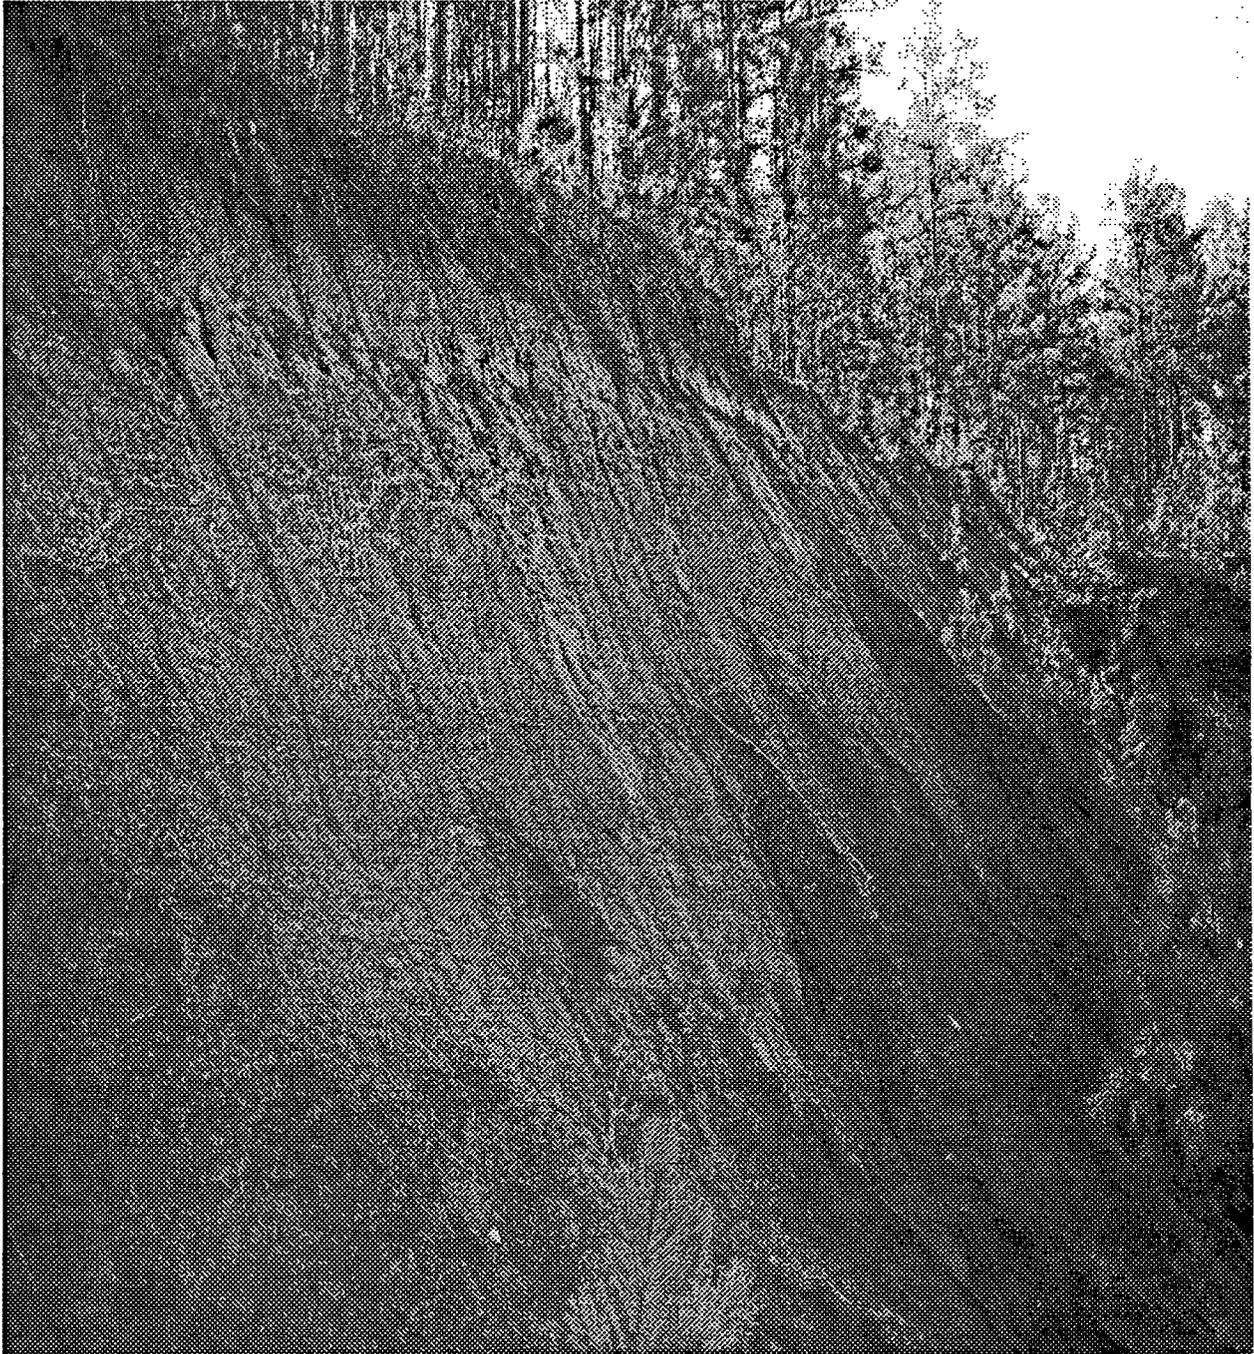
Photo C9 [3/4/98 - 10:49]

Site 231(7) consists of an open field and an excavated hillside; photo faces SW direction, and looks into the excavated hillside and groundwater seeps originating from the cliffs.

This site is characterized by grossly excavated canyons (see Photo C6 and C8), erosion ditches, and barren soil. Several areas were found to contain dumped debris, old military vehicles, and assorted trash. The hillside is capped by tall pine forest with sparse understory (pictured in background above the hill). The excavated cliffs expose groundwater seeps that discharge water down the cliffsides (see Photo C10). This groundwater eventually collects into small drainage creeks (see Photo C5). Evidence of continual groundwater seepage, as well as stormwater drainage, is found throughout the site in the form of erosion ditches (see Photo C7 and C10).

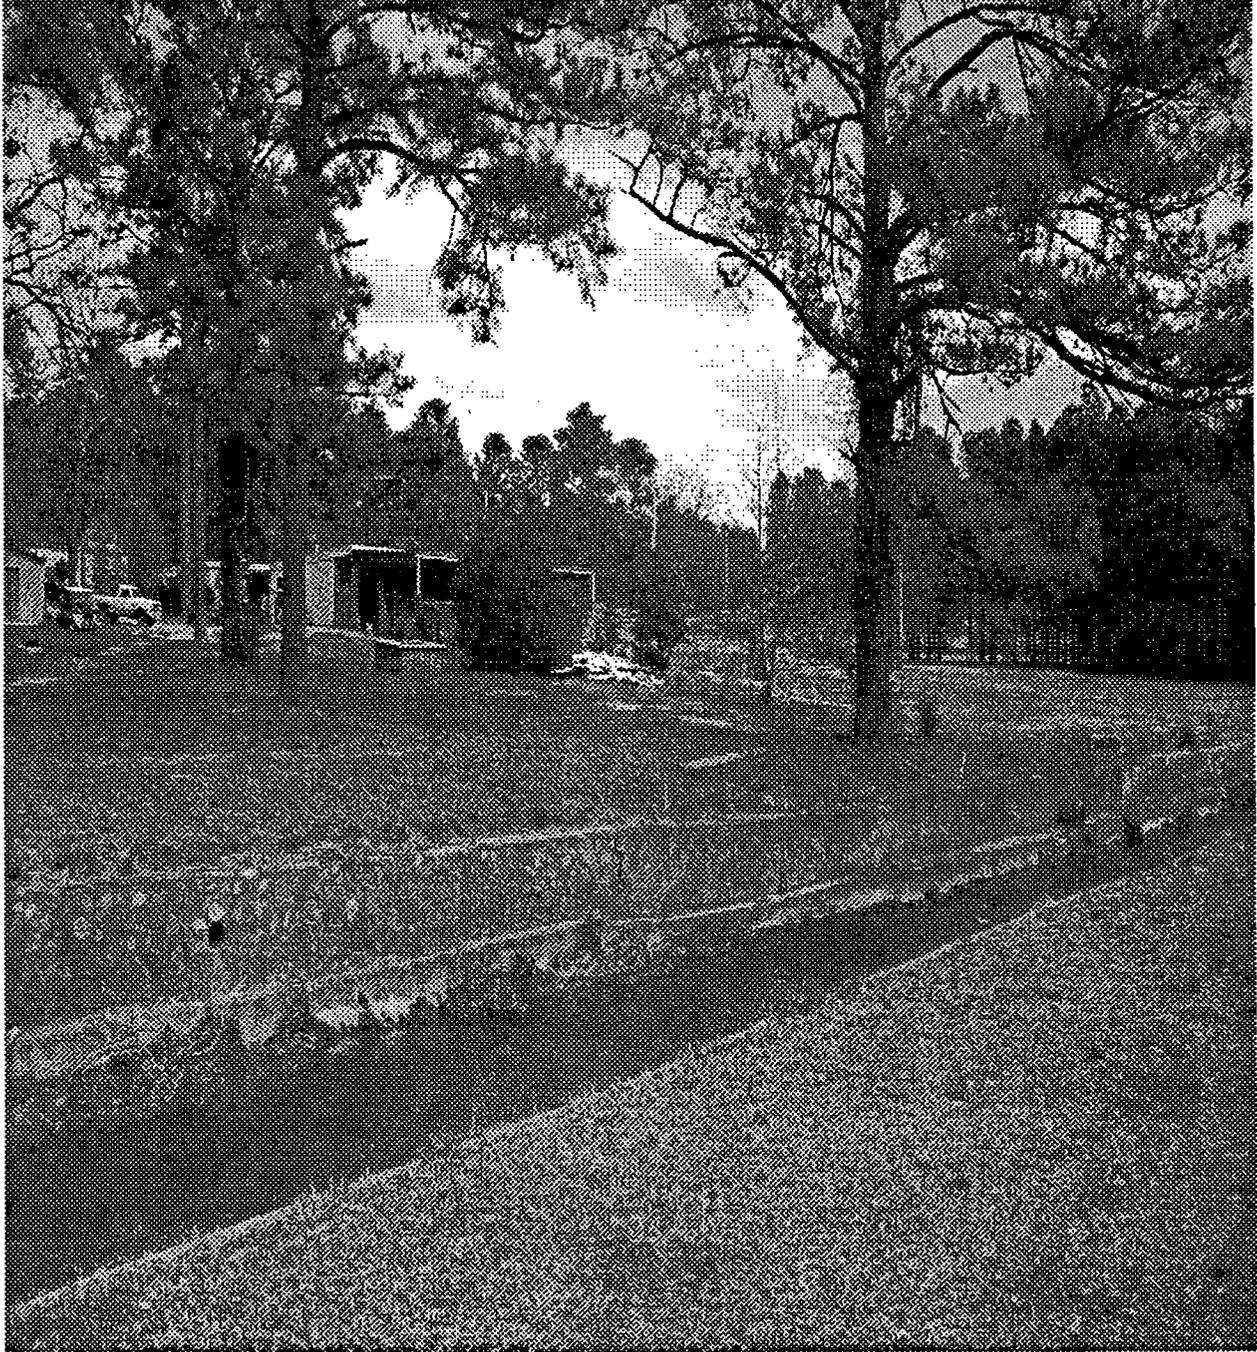
Photo C11 [3/4/98 - 12:24]

Site 83(7) is situated within the golf course boundaries just N of Cane Creek; photo faces E direction toward the Shed, and across the channelized Cane Creek.

Discharge pipes from the N bank of Cane Creek are visible in the photo as dark areas in the creek wall (one is about mid-way up the wall almost at the left edge of the photo; another is located at the base of the wall almost at the right edge of the photo). These drainage pipes may drain stormwater overflow captured by drainage pipes (see Photo C12) from the area immediately adjacent to the maintenance shed. In addition, the land between the shed and Cane Creek is graded to slope toward the creek.

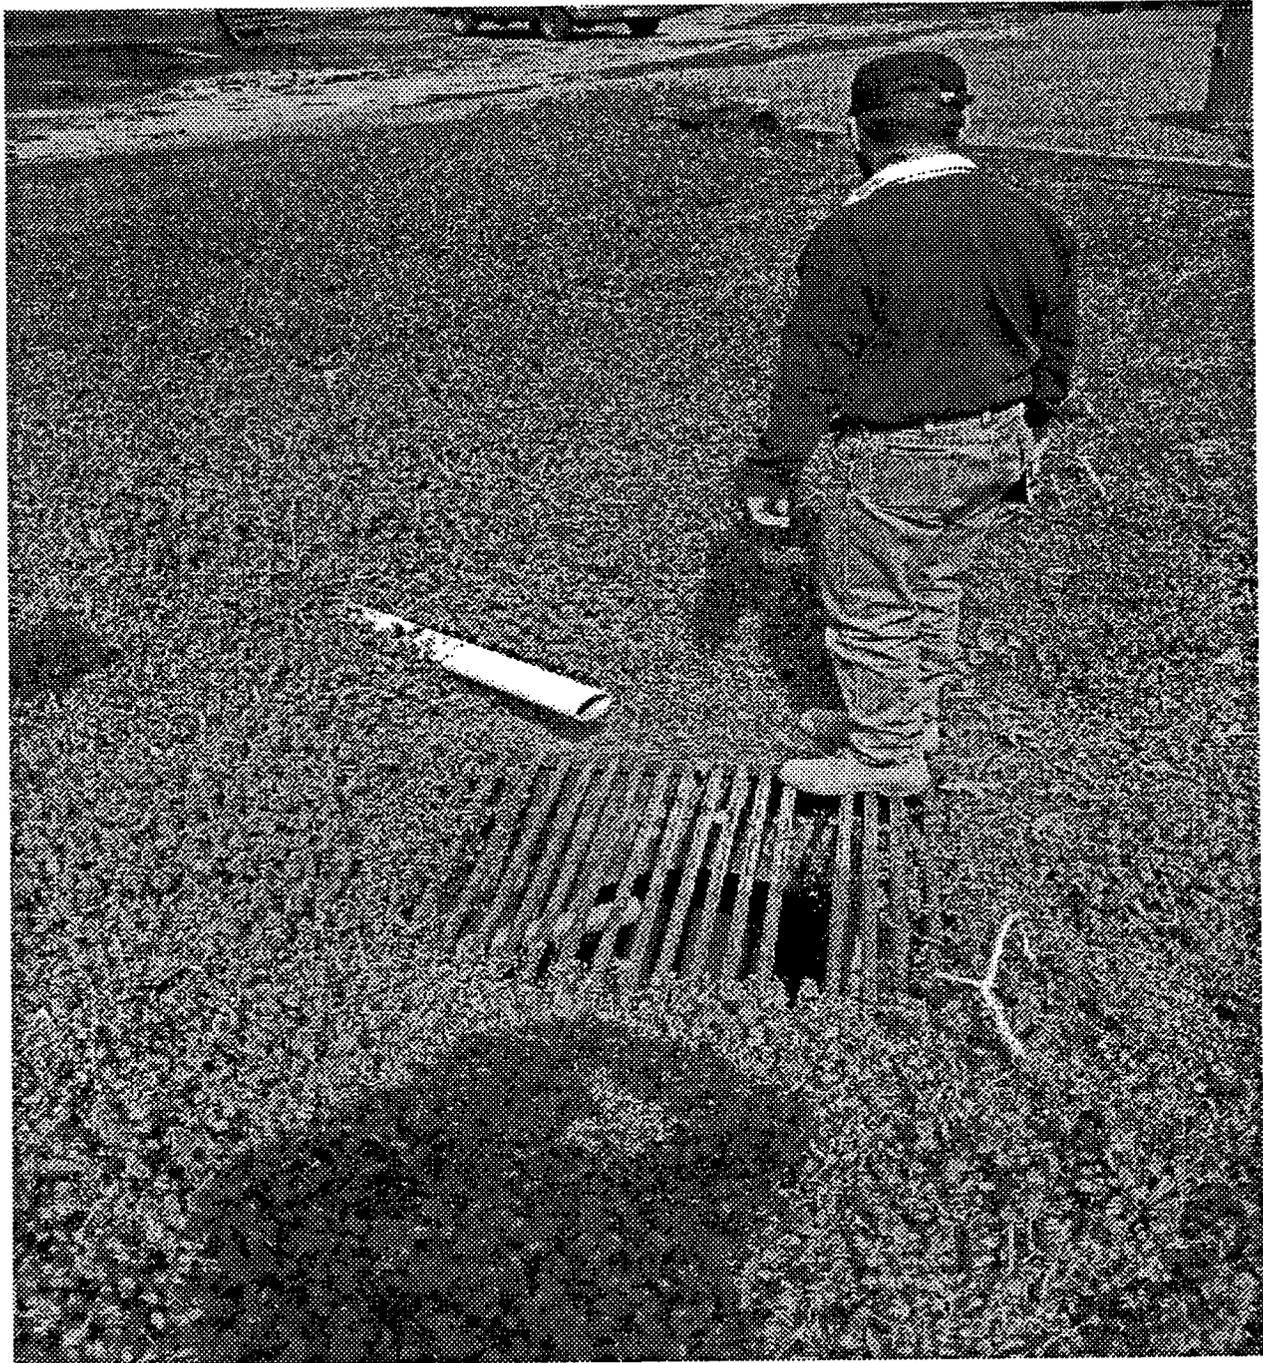
Photo C12 [3/4/98 - 12:34]

Site 83(7) is situated within the golf course boundaries just N of Cane Creek; photo faces NE direction directly down on a drainage pipe right next to the Shed.

Discharge pipes from the N bank of Cane Creek are visible in the photo as dark areas in the creek wall (one is about mid-way up the wall almost at the left edge of the photo; another is located at the base of the wall almost at the right edge of the photo). These drainage pipes may drain stormwater overflow captured by drainage pipes (see Photo C12) from the area immediately adjacent to the maintenance shed. In addition, the land between the shed and Cane Creek is graded to slope toward the creek.

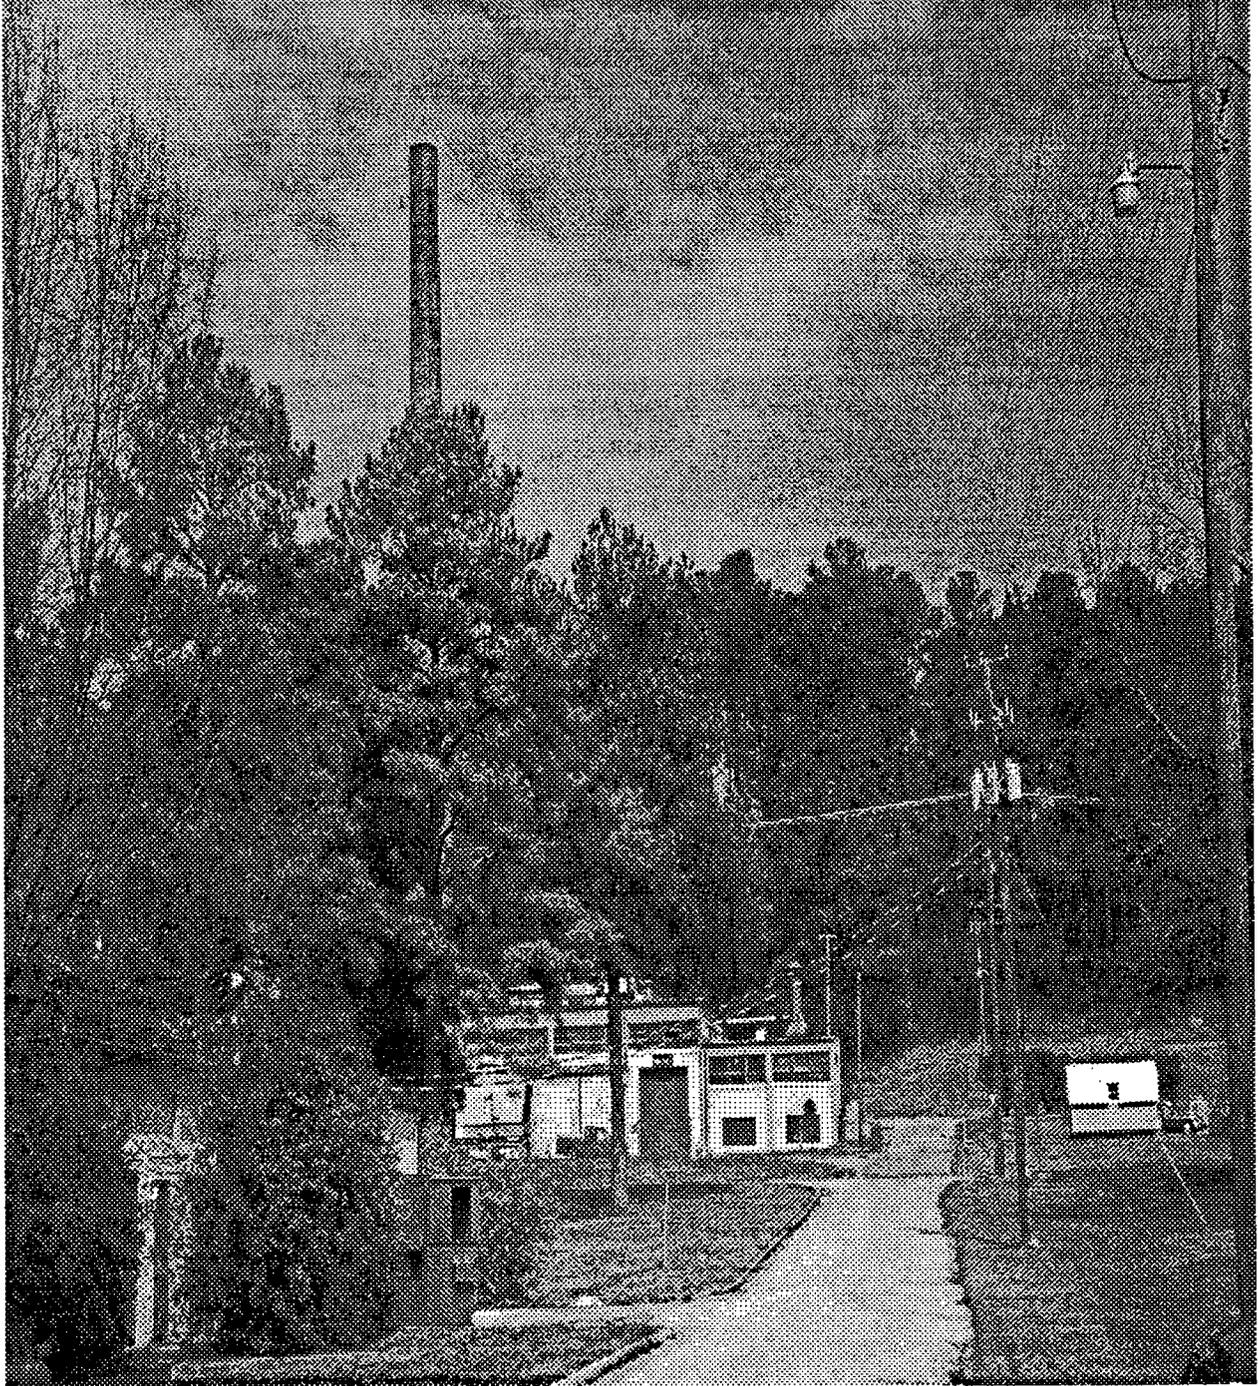
Photo C13 [3/4/98 - 12:35]

Site 23(7) consists of a boiler plant building (pictured as the white building just to the right of the smoke stack); photo faces N direction. Also associated with this area is Site 226(7) (not pictured), located immediately behind the white building.

Two large heating oil USTs are located at this site. Area immediately adjacent to the Site is moderately developed, however, the area behind (to the NE) is a large, densely forested area. Maintained lawns and stands of deciduous trees speckle the area.

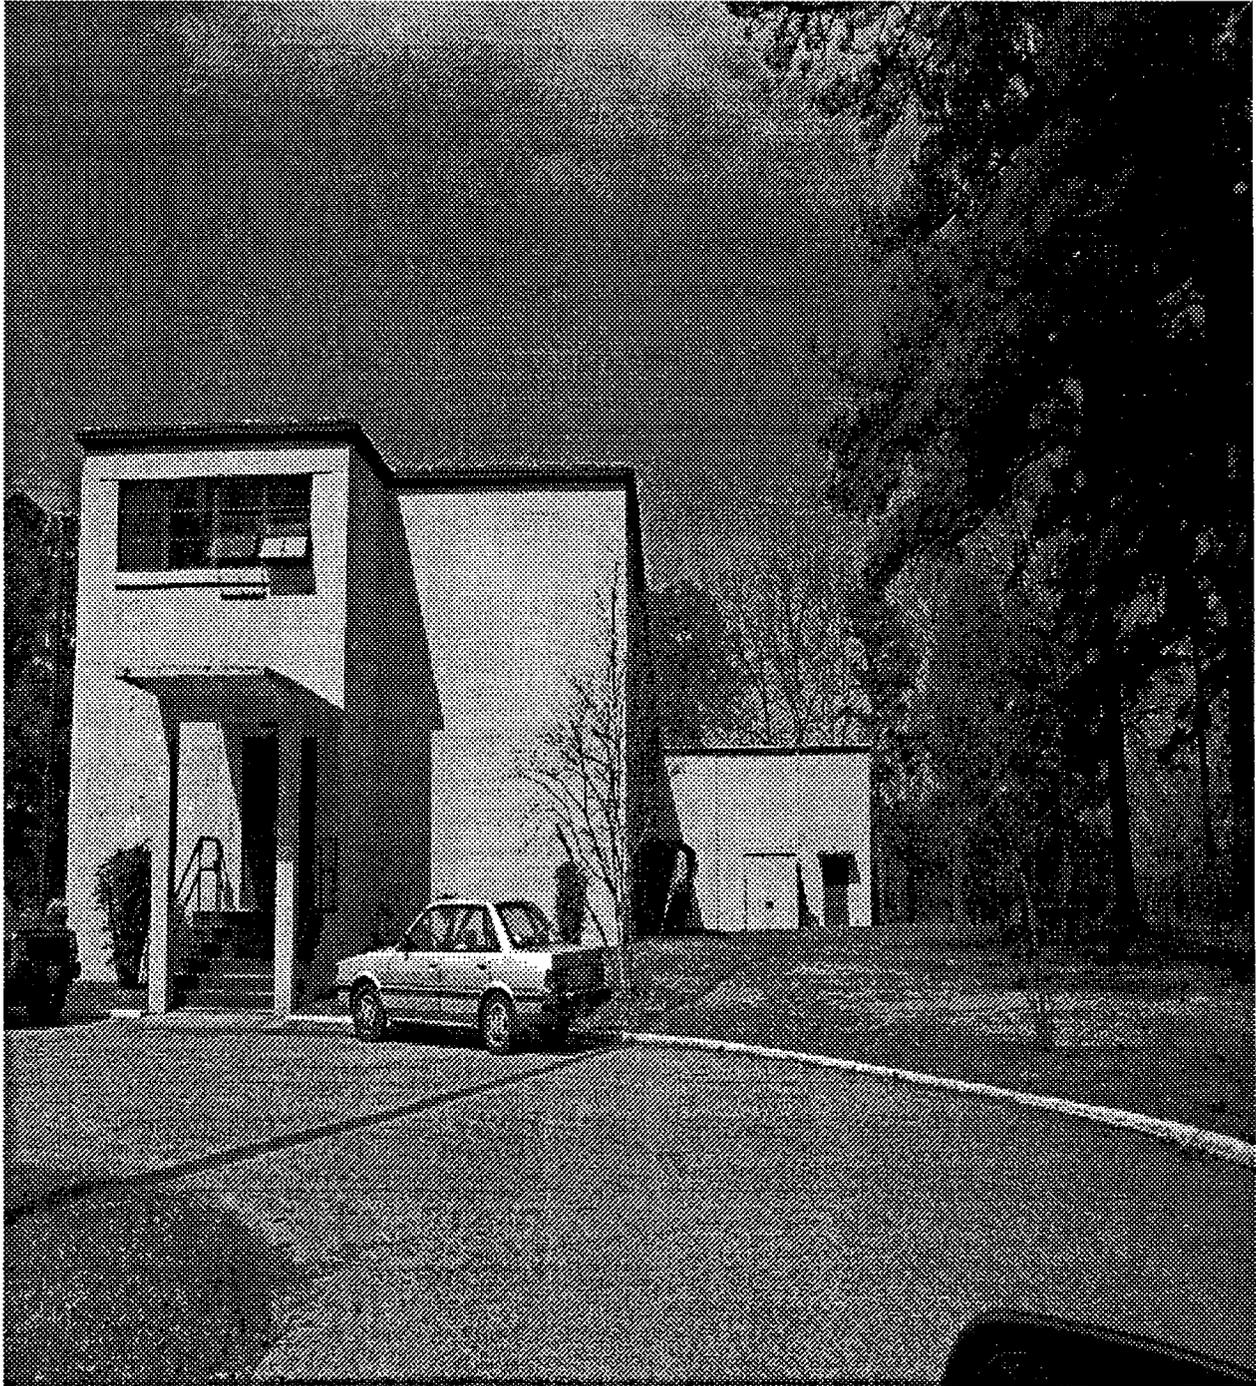
Photo C14 [3/4/98 - 12:40]

Site 172(7) (now Building 1060) sits atop a hill overlooking the northern-most extent of the Main Post golf course; photo faces NW direction looking at the current building.

There appear to be no obvious visible clues as the former use of this building or of any potential contamination. The building is surrounded by pavement and cleared forest for about 50 yards in all directions. The density of the tree line surrounding this cleared area is sparse. The pavement and driveway and the cleared land (pictured) is typical of the entire immediate surroundings of this building.

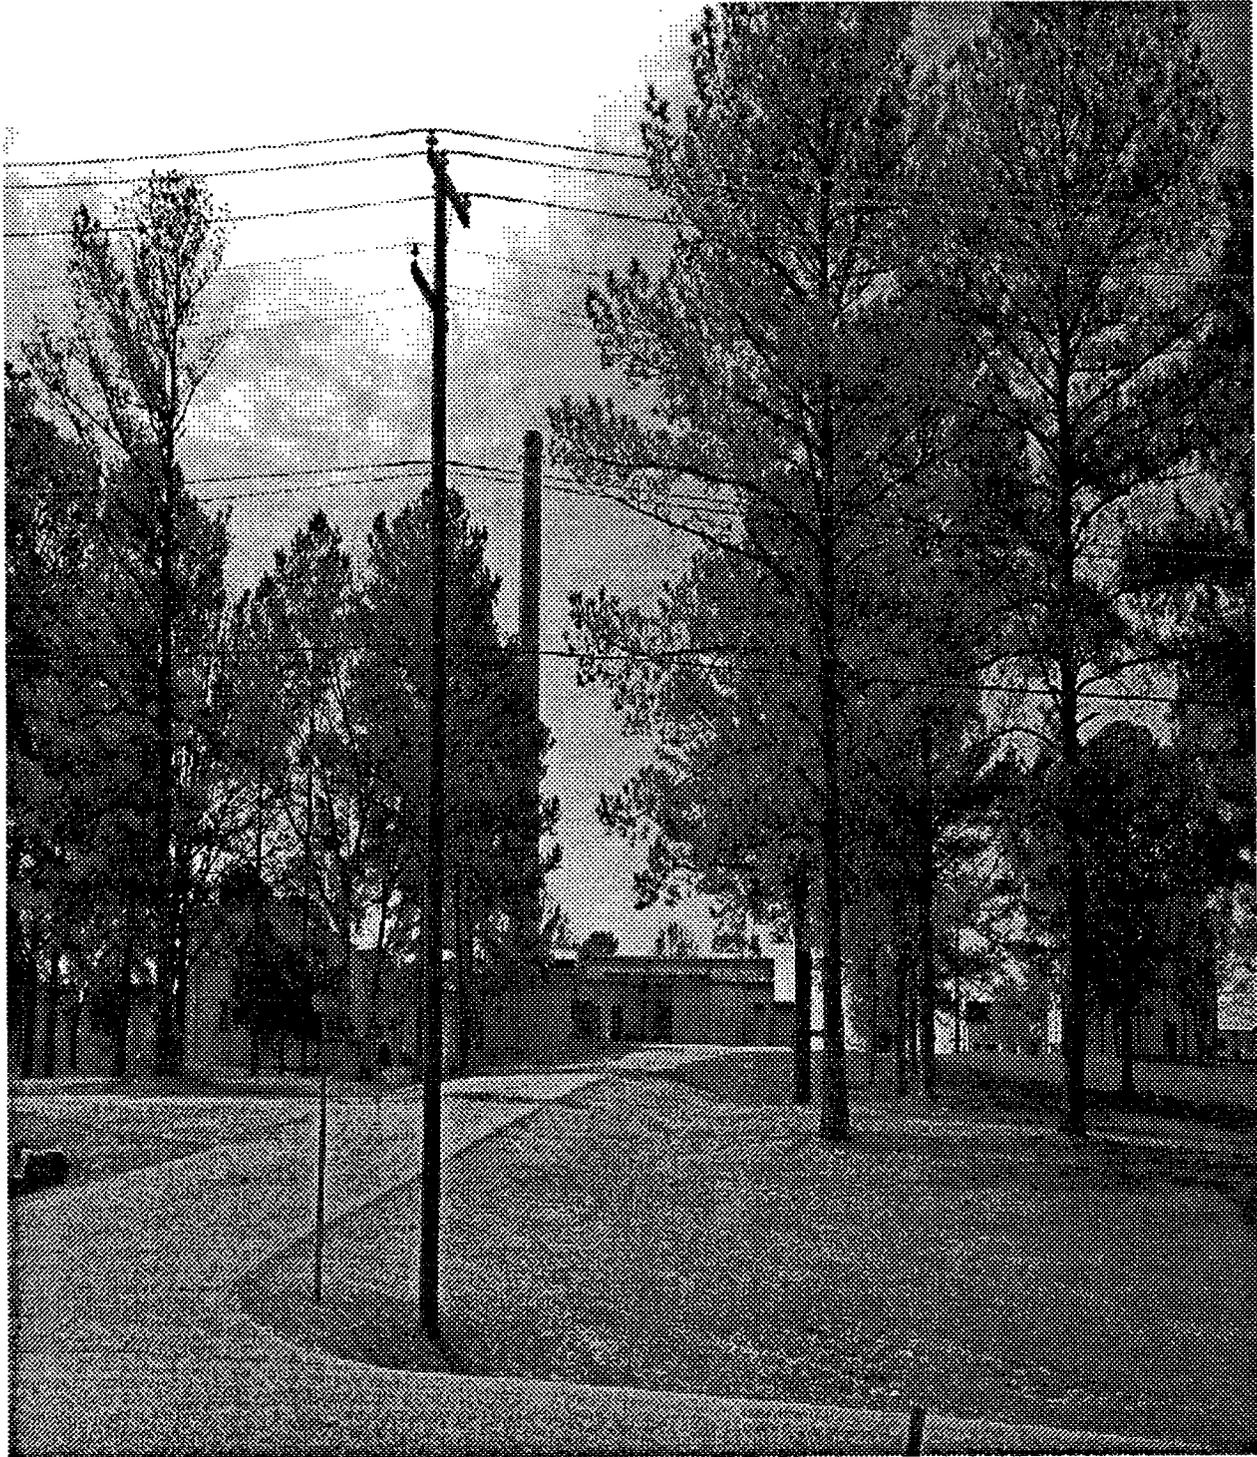
Photo C15 [3/4/98 - 12:43]

Site 14(7) (now Building 1076) sits within a moderately developed area; photo faces W direction, and was taken from a large paved lot across the street (see Photo C16).

The area surrounding this building consisting of cleared forest, maintained lawn, pavement and sparsely dense tree stands. The site is associated with two large USTs which have been removed. To the rear of viewer stands a large, empty paved lot associated with a former motor pool and gas station (see Photo C16).

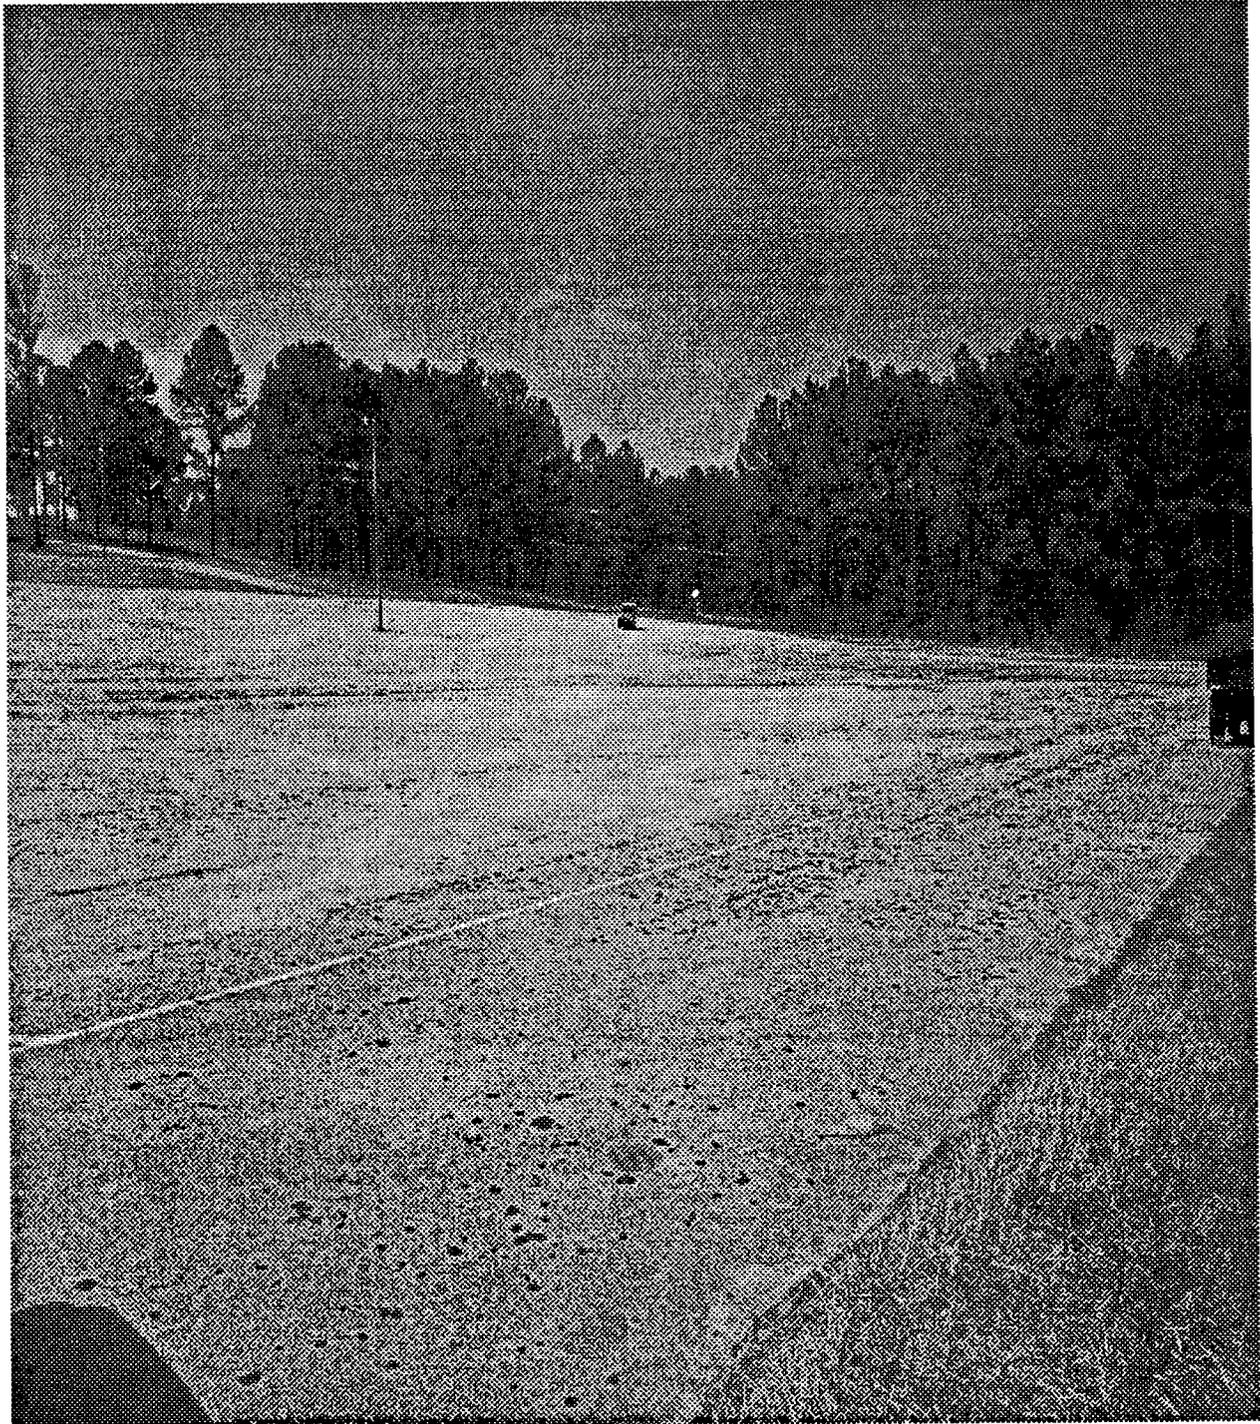
Photo C16 [3/4/98 - 12: 46]

Site 148(7) and 16(7) currently consists of a large paved lot; photo faces NW direction across the majority of the site.

Site is a large empty lot historically associated with a vehicle maintenance station, wash rack, and an oil/water separator. This site currently devoid of any structures. The eastern edge of the lot runs parallel to Cave Creek which flows due N within this reach. Thus, there is a very high potential for surface runoff discharge to the creek. The location of specific Site 16(7), a former gas station, is thought to be in the central-western edge of the lot. Two large USTs associated with the site have been removed.

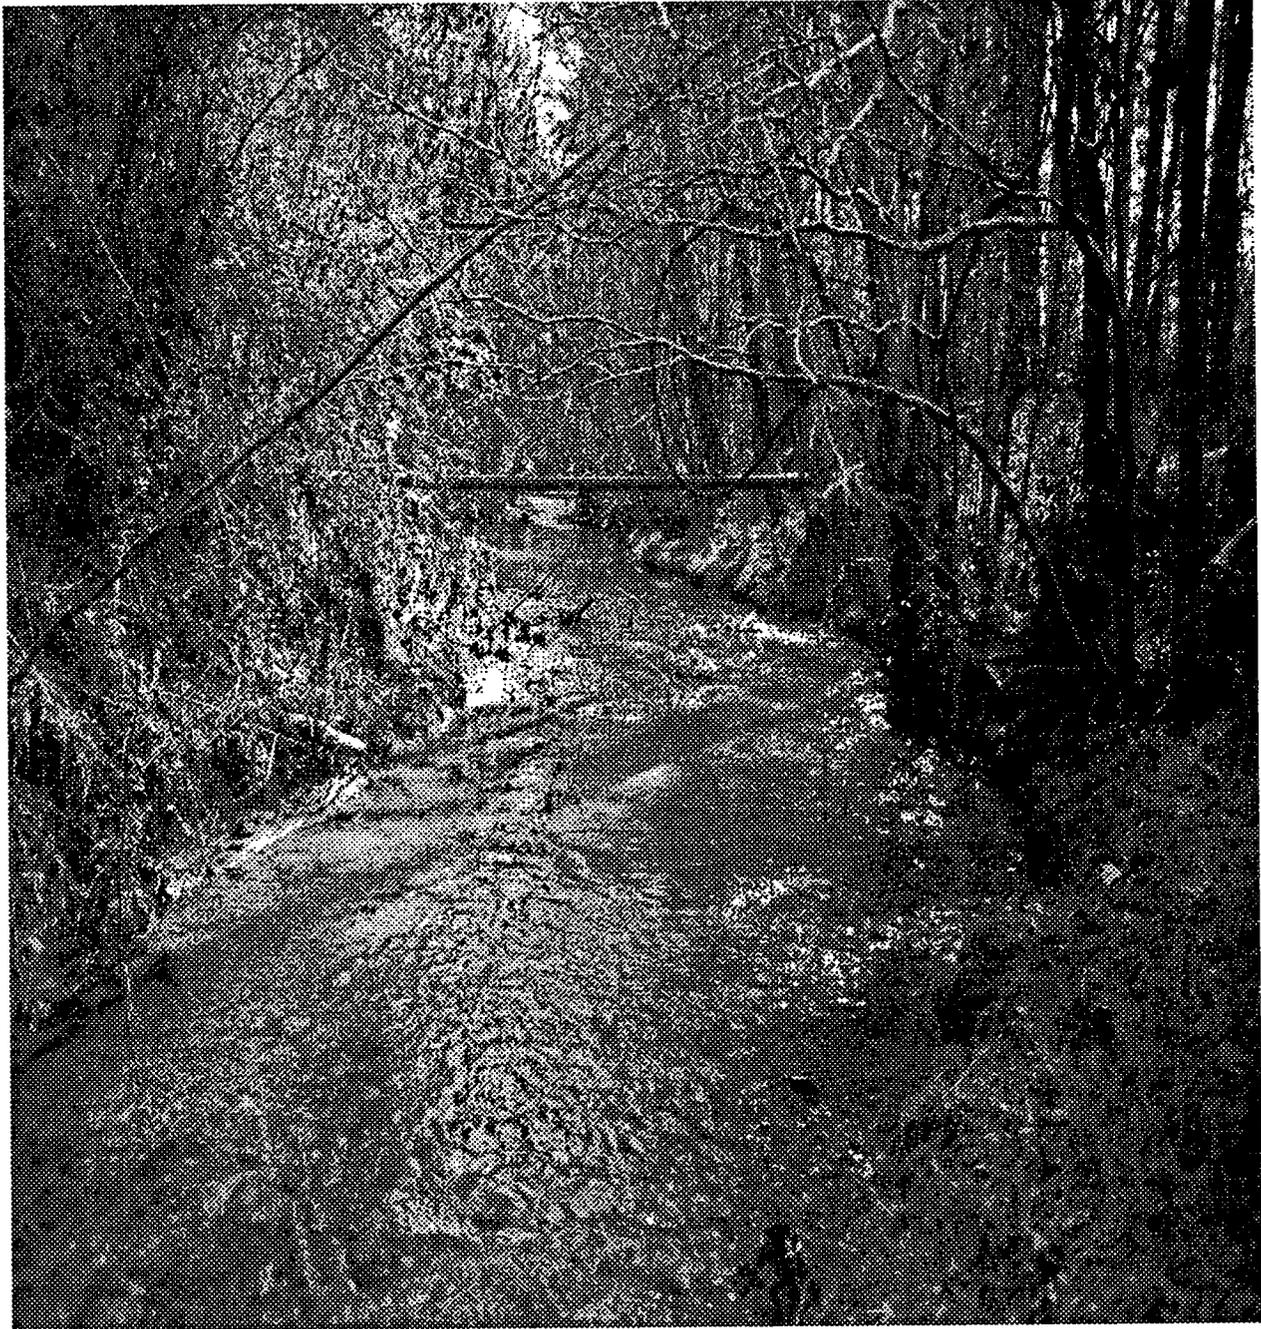
Photo C17 [3/4/98 - 12:48]

Site 16(7) currently consists of a large paved lot adjacent to a reach of Cave Creek; photo faces S direction upstream into Cave Creek.

Site is a large empty lot historically associated with a vehicle maintenance station, wash rack, and an oil/water separator. The eastern edge of the lot runs parallel to Cave Creek which flows due N within this reach. Thus, there is a very high potential for surface runoff discharge to the creek. The area immediately adjacent to the creek is densely vegetated with trees and underbrush. The substrate in this reach of Cave Creek is moderately gravel/sand with some islands of fine grained sediment.

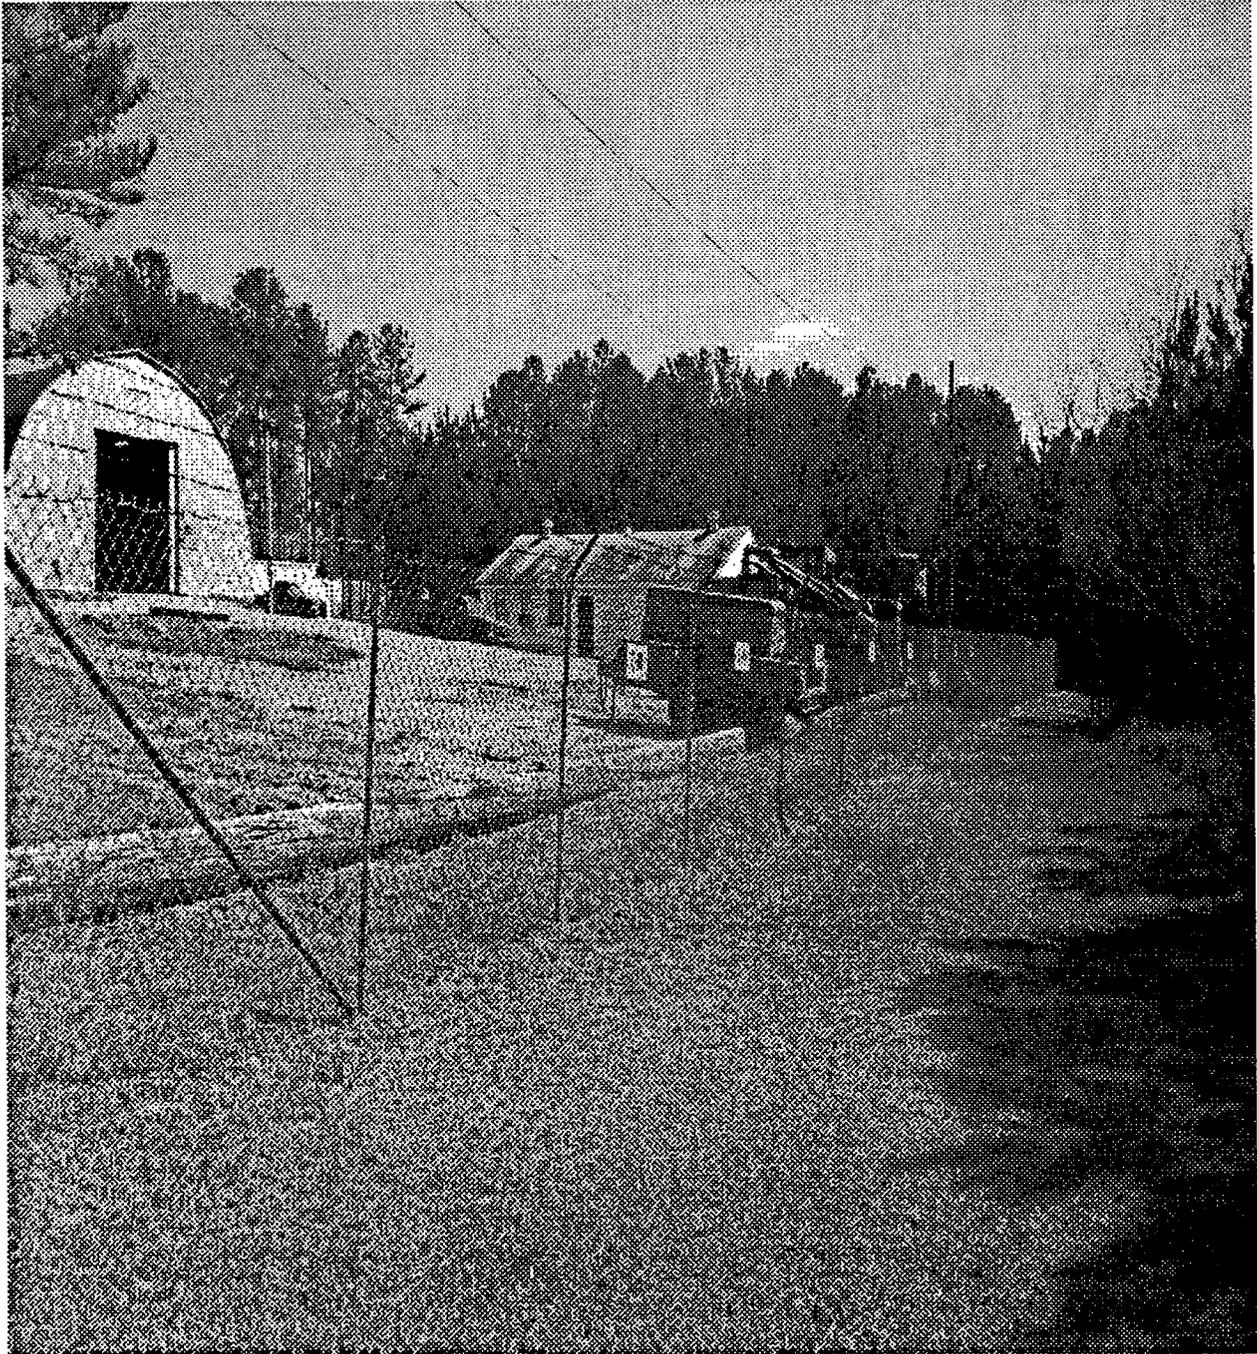
Photo C18 [3/4/98 - 1:15]

Site 143(7) currently consists of a fenced area containing paved lot, military buildings, parked military vehicles, and minimal maintained lawn (on the periphery of the area); photo faces SE direction across the majority of the site.

This area, however, is described exactly the same as Photo C16 and C17, although they are not in spatial proximity. This site is currently in use, and is associated with a vehicle maintenance station, wash rack, and an oil/water separator. This site is surrounded by a dense, wooded area approximately 50 yards away from the paved lot; there is a strip of maintained lawn separating the fenceline and the woods. Pictured is the side fenceline. At the end of the fence in view is a drainage area leading into the woods (see Photo C19).

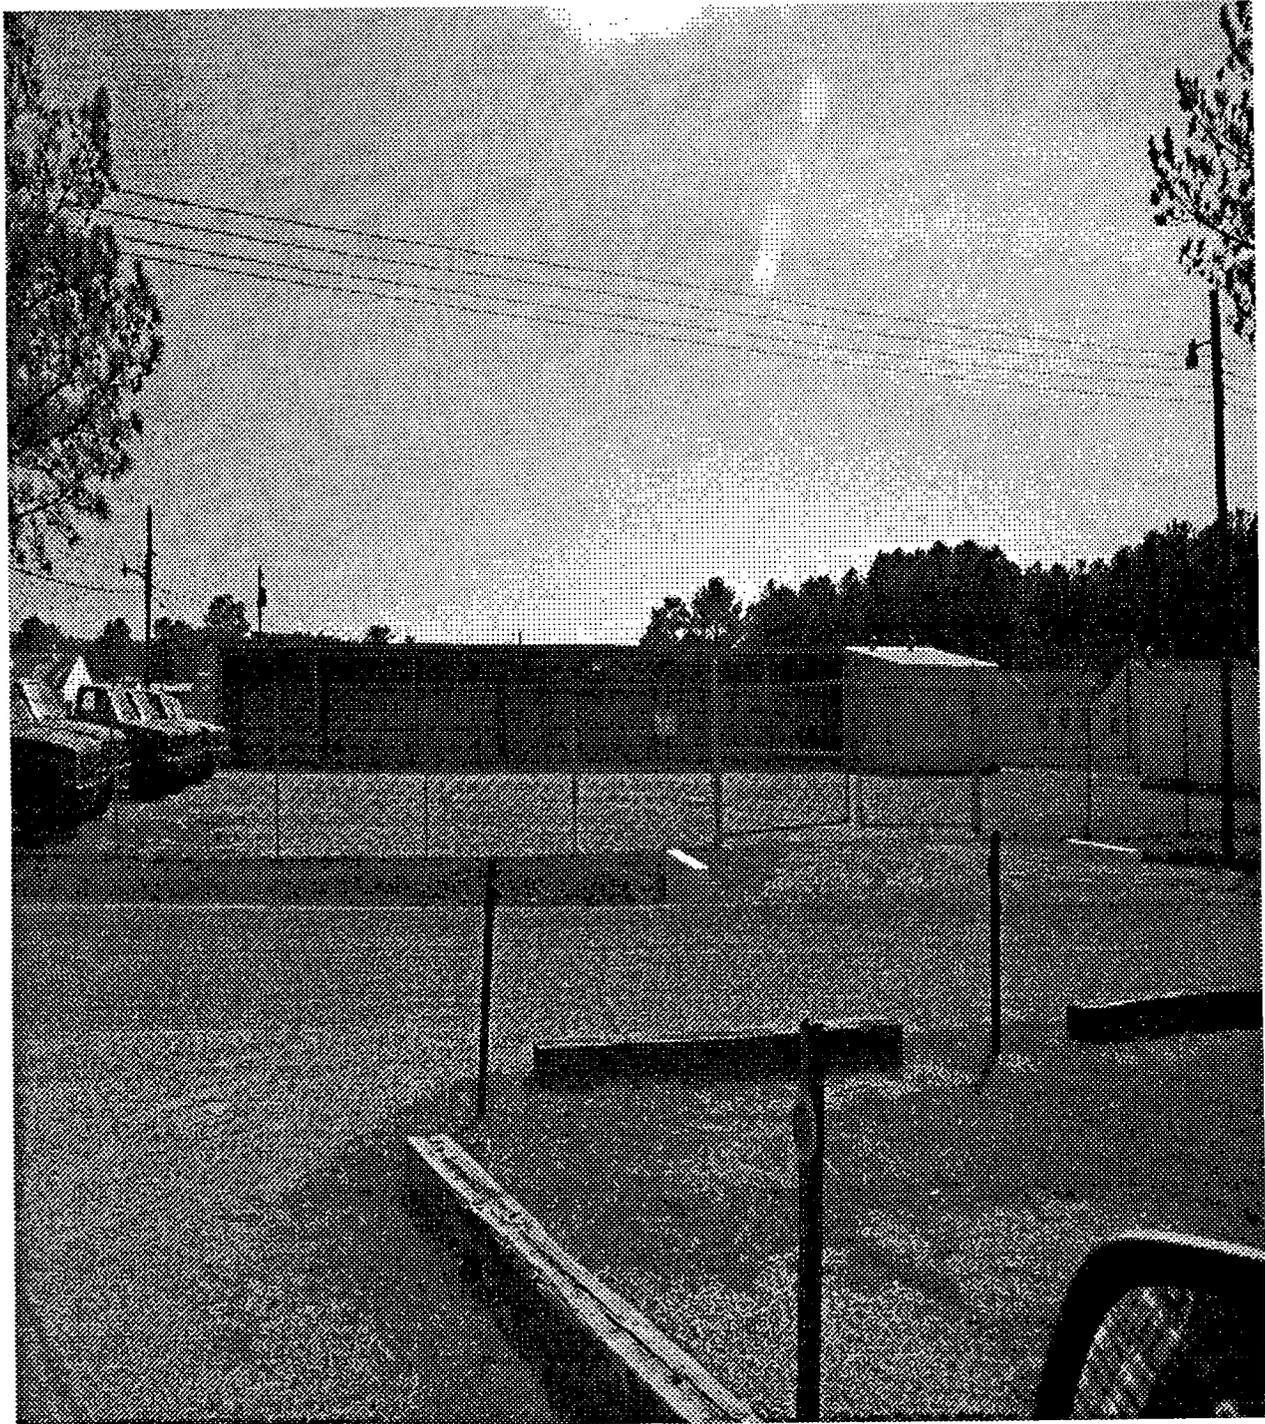
Photo C20 [3/4/98 - 1:30]

Site 174(7) currently consists of a large paved area with several buildings and storage sheds; photo faces S direction into the main storage shed and parking area behind the main gated entrance to the site.

The site is a large paved lot associated with storage of military vehicles and consumables. The site is surrounded by highly developed structures: a road to the N and additional storage buildings and pavement to the W, S, and E. The habitat quality is poor to non-existent.

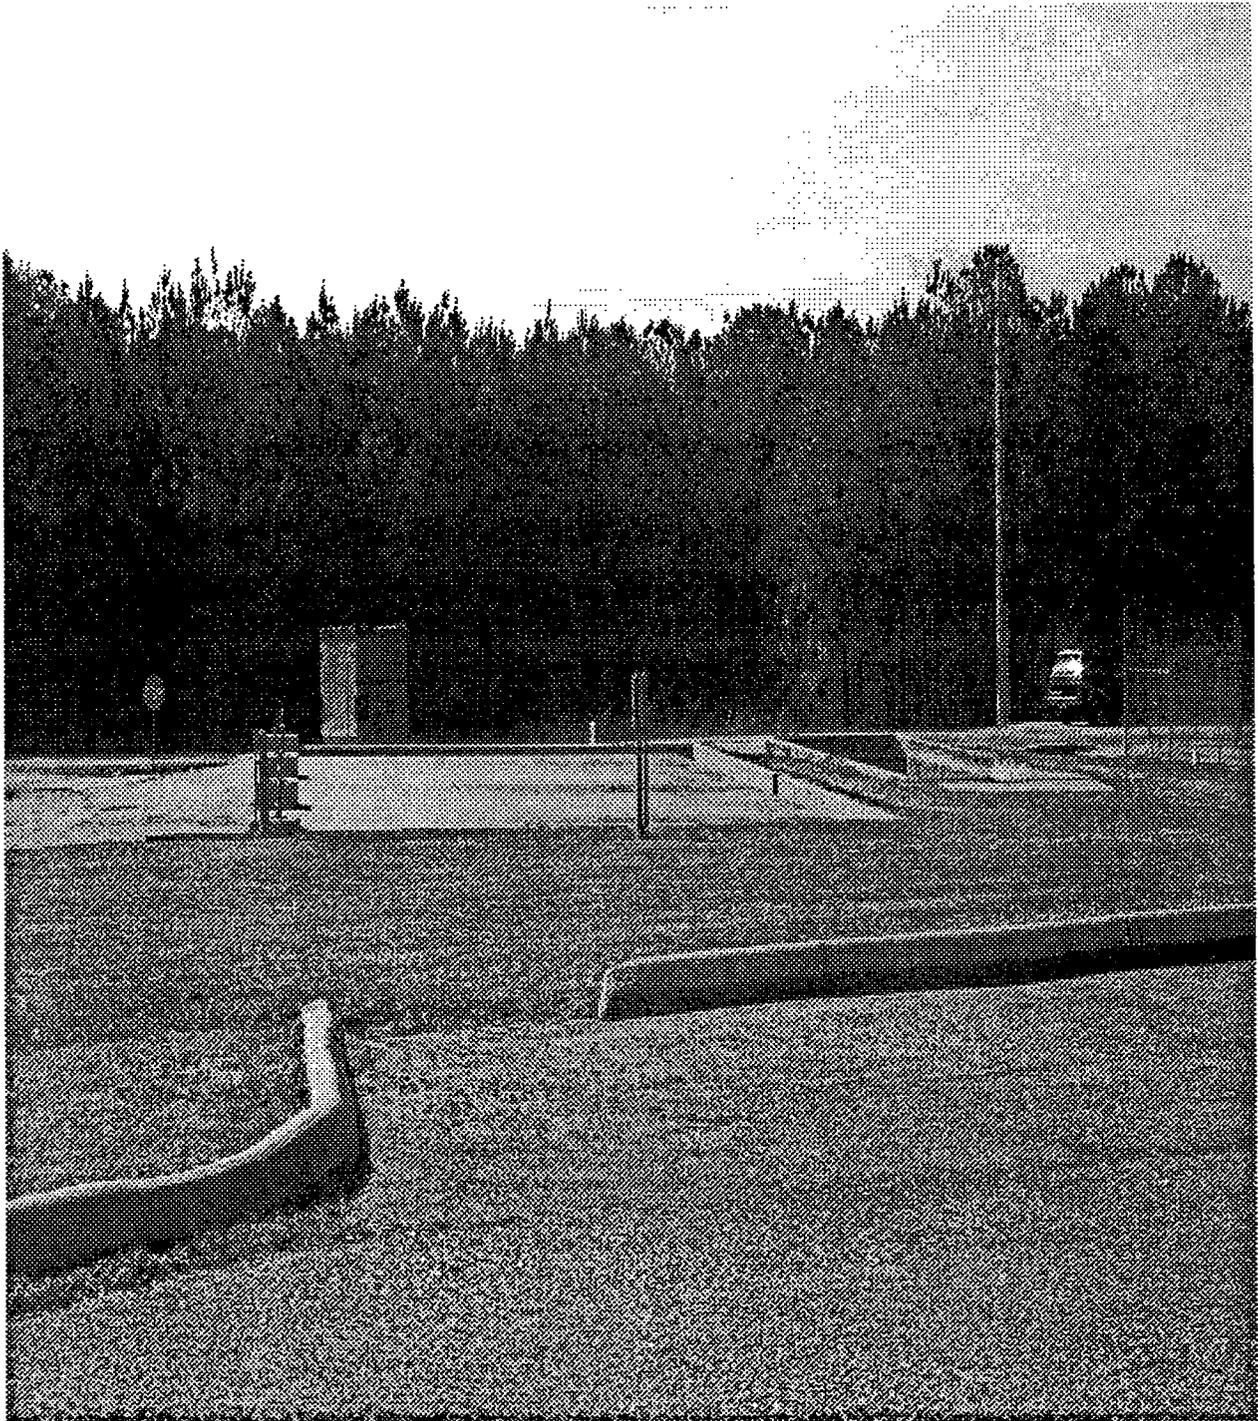
Photo C21 [3/4/98 - 1:40]

National Guard, Building 1234 Wash Rack with former oil/water separator [CERFA Parcel Map: 18,43]
Site 168(7) is located adjacent to an existing building; photo faces W direction with wash rack/oil-water separator in view.

The site is surrounded by road to the W and S. However, as pictured, significant forested habitat is situated to the W beyond the road on the western boundary of the site. The area to the E and N is highly developed pavement lots and buildings. With the exception of the forested area to the far W, the general habitat quality surrounding this site is poor.
