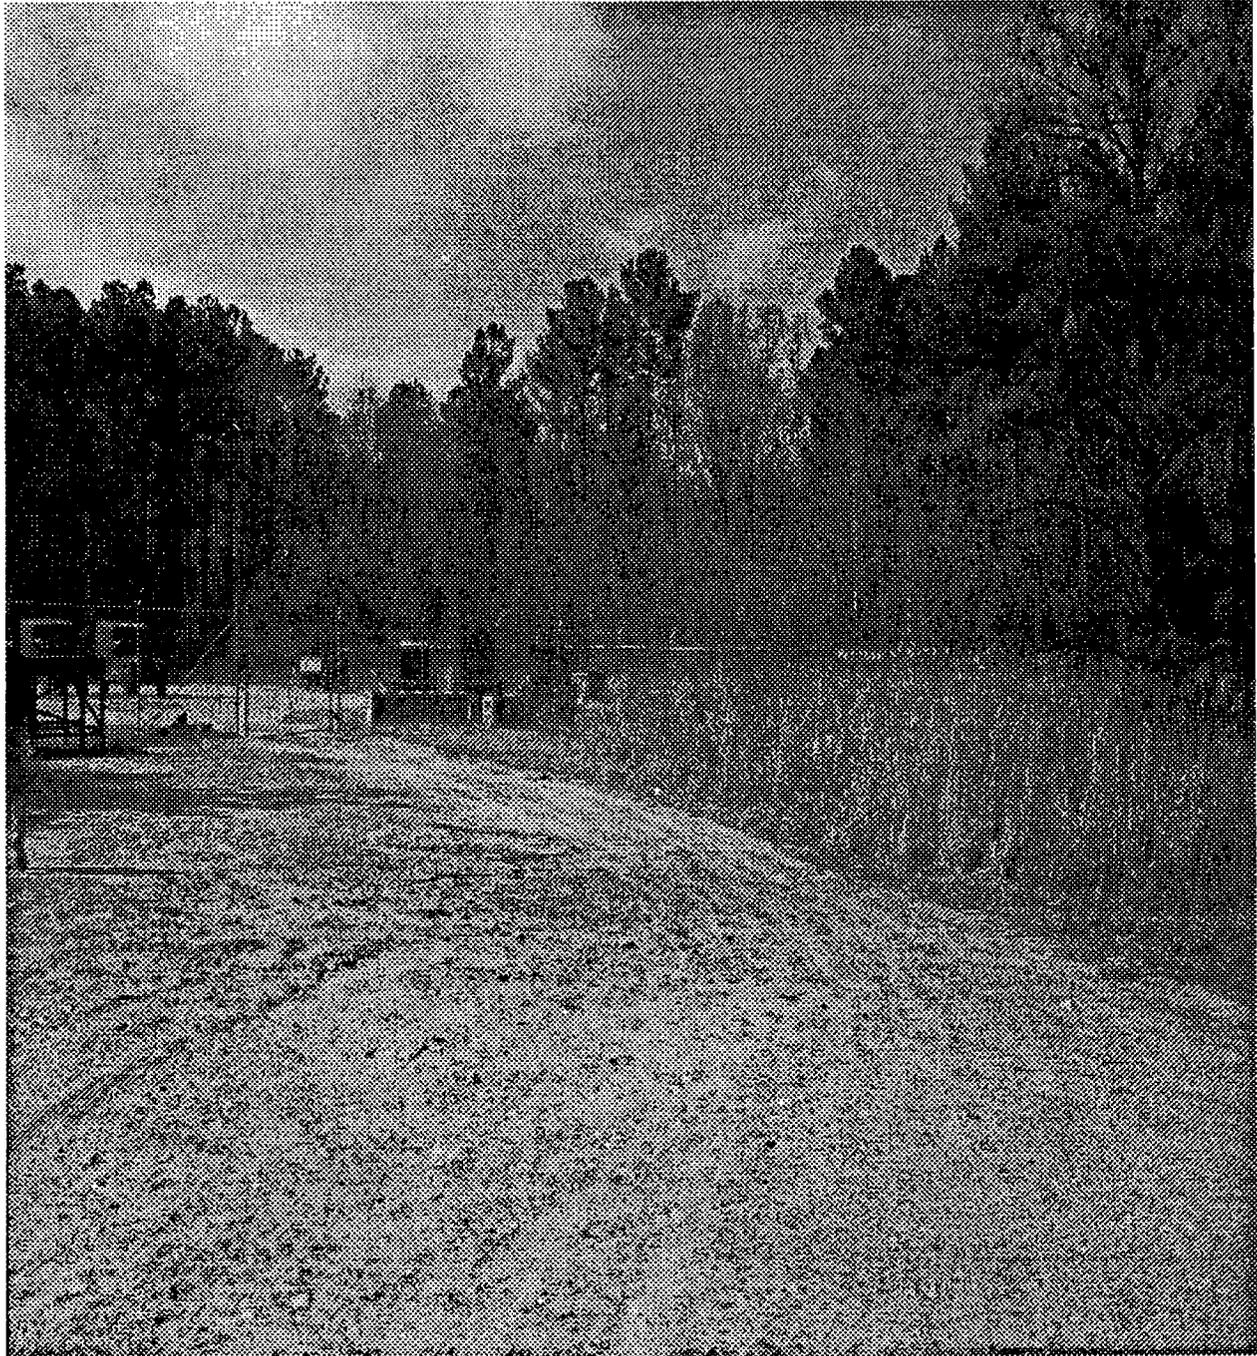
Photo C22 [3/4/98 - 1:45]

Site 140(7) structures no longer exist, with the exception of the concrete foundation (see Photo C23). The former gas station site is adjacent to an existing gravel-paved parking and storage lot (fenced area pictured) and a well-established wetland area; photo faces NW direction.

The site is unique in that it consists of a submerged building foundation around which a thriving wetland habitat has formed. The depth of the foundation is approximately 6-10 inches and it is completely submerged with water. A quick test of the substrate under the water indicated a few inches of sediment existed. The submerged foundation is surrounded by hydric soil and mature forest to the N and E, dirt road to the S, and the fenced lot to the W.

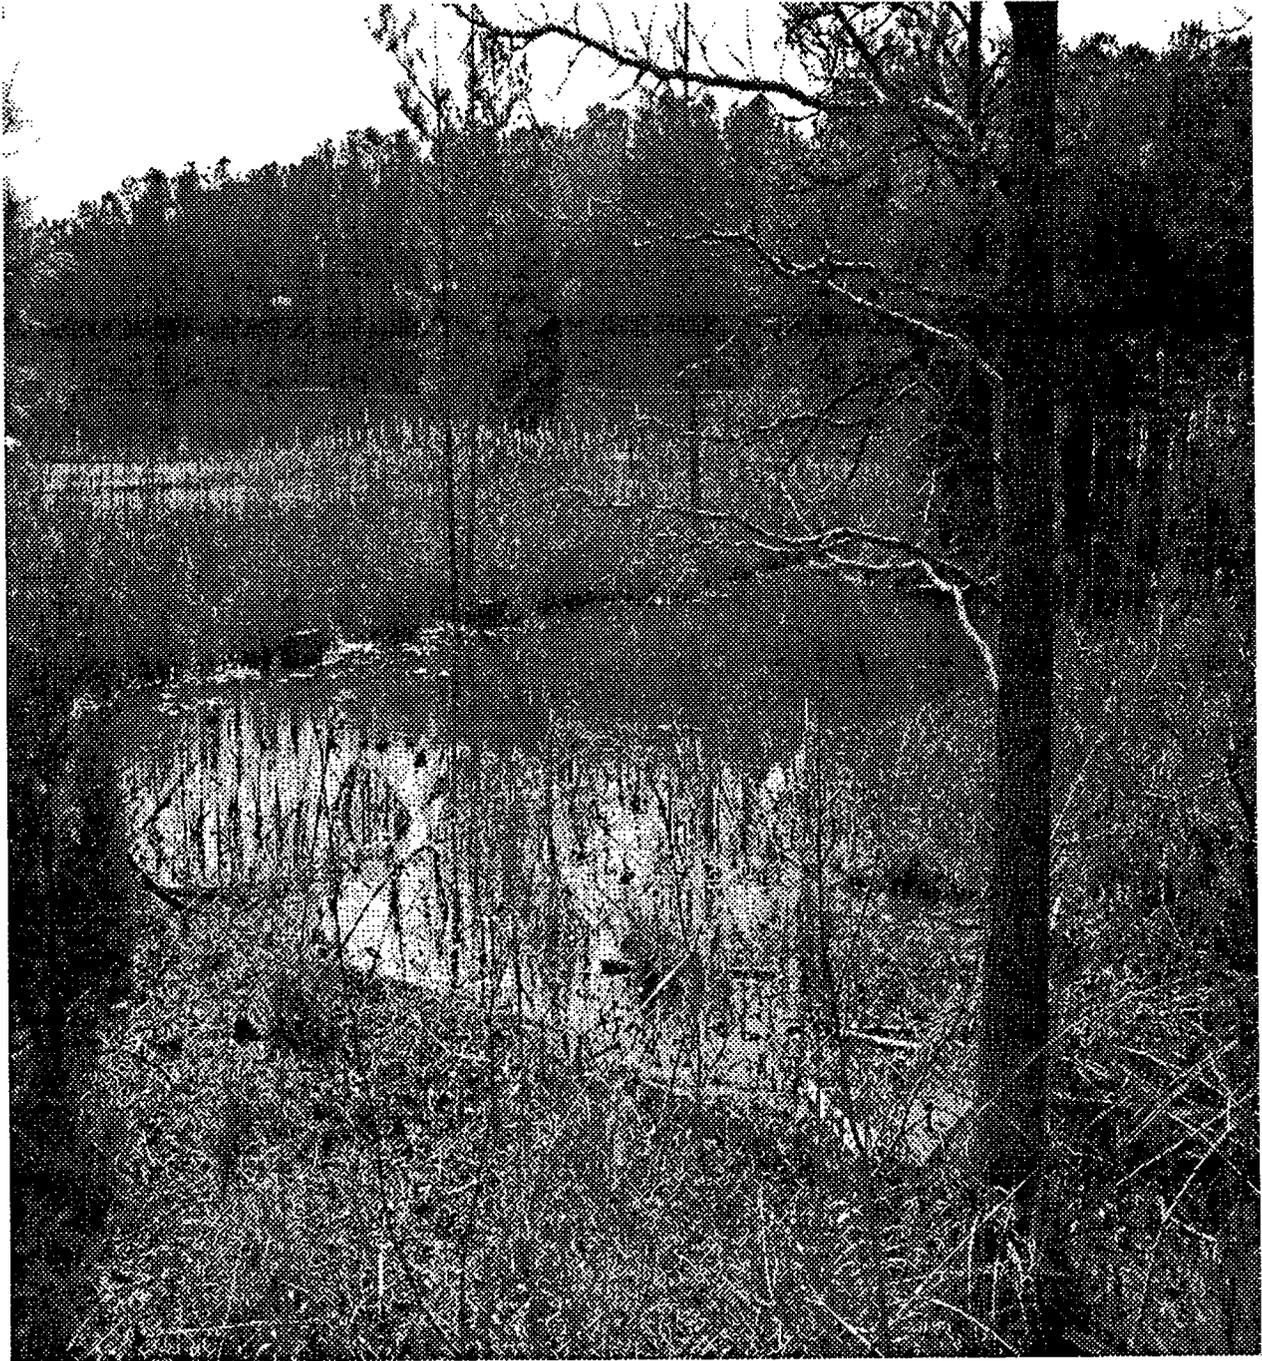
Photo C23 [3/4/98 - 1:48]

Site 140(7) structures no longer exist, with the exception of the concrete foundation (see Photo C23). The former gas station site is adjacent to an existing gravel-paved parking and storage lot and a well-established wetland area (pictured); photo faces SW direction across the submerged concrete foundation.

The site is unique in that it consists of a submerged building foundation around which a thriving wetland habitat has formed. The depth of the foundation is approximately 6-10 inches and it is completely submerged with water. A quick test of the substrate under the water indicated a few inches of sediment existed. The submerged foundation is surrounded by hydric soil and mature forest to the N and E, dirt road to the S, and the fenced lot to the W.

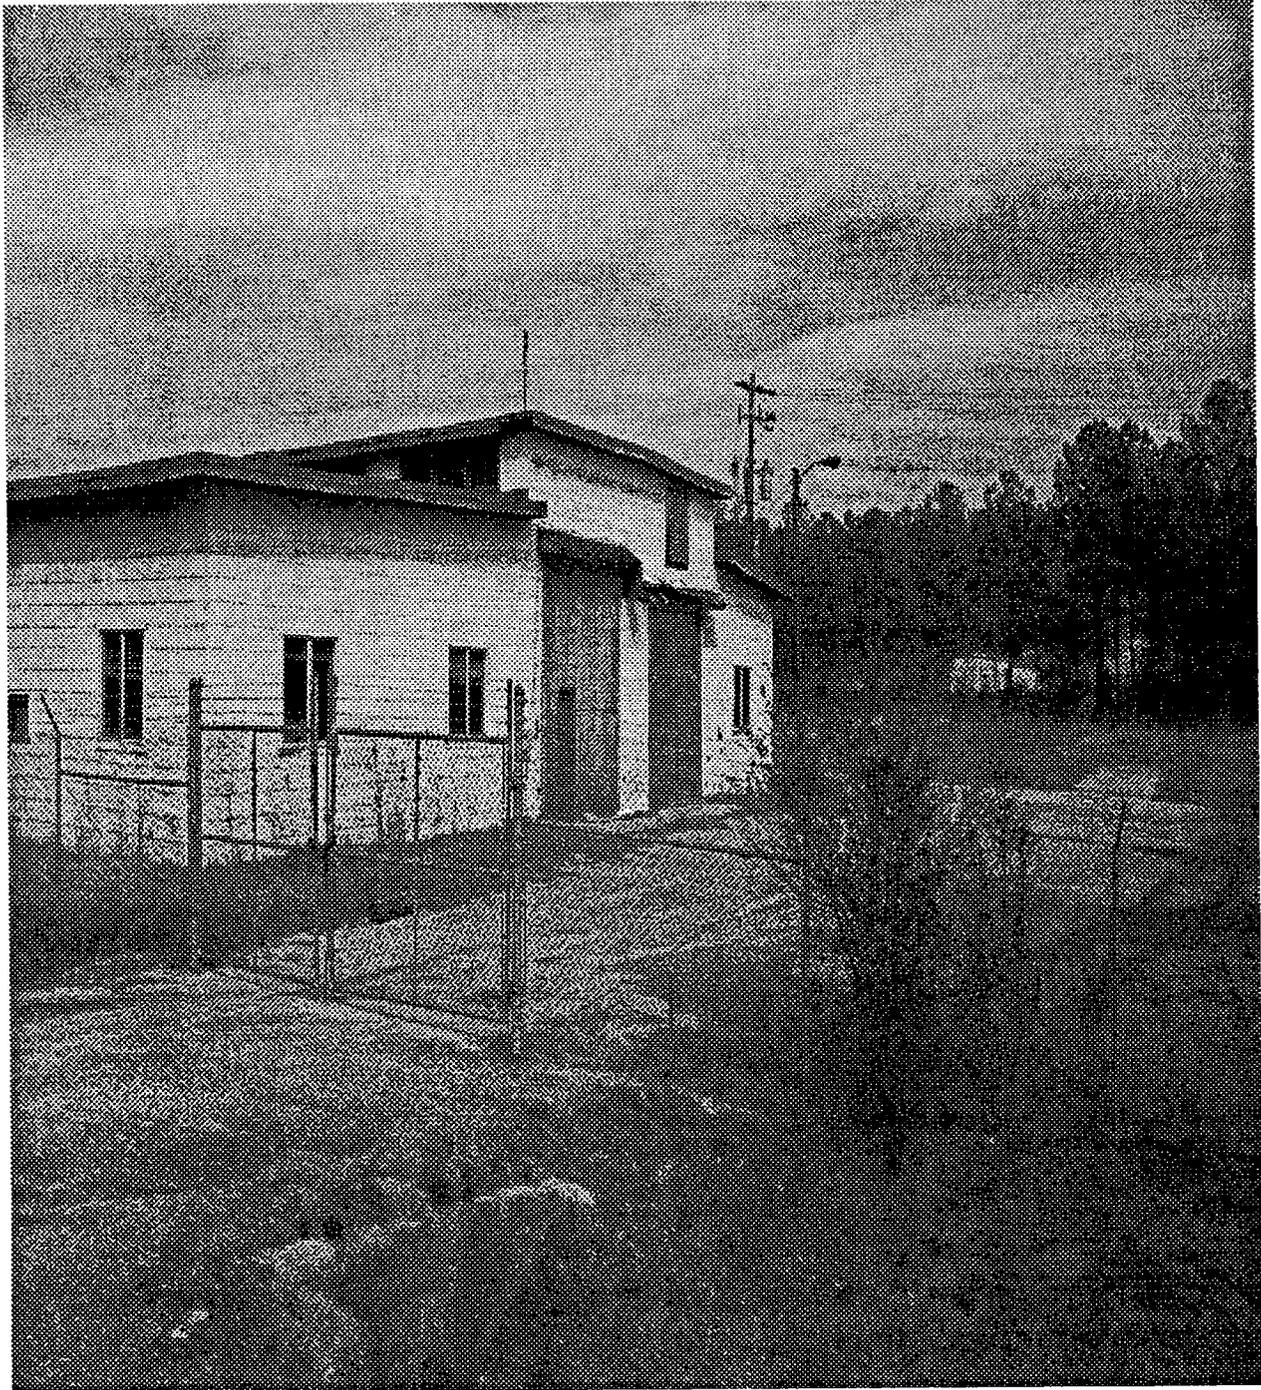
Photo C24 [3/4/98 - 1:56]

Site 46(7) is an abandoned building within a large paved/fenced area; photo faces NE direction. Cave Creek flows adjacent to the SW corner of the site, and a small tributary to Cave Creek runs along the SE to S boundary of the fenced area. The tributary discharges to the creek near the southern boundary of the fenced area.

This site consists of paved lot and building. However, it is surrounded by significant aquatic features to the S, and by forested habitat to the N, E, and W. The site clearly drains S to the tributary and to Cave Creek (see Photo D2), as determined by the presence of several drainage ditches leading from the fenceline to the S into the tributary.

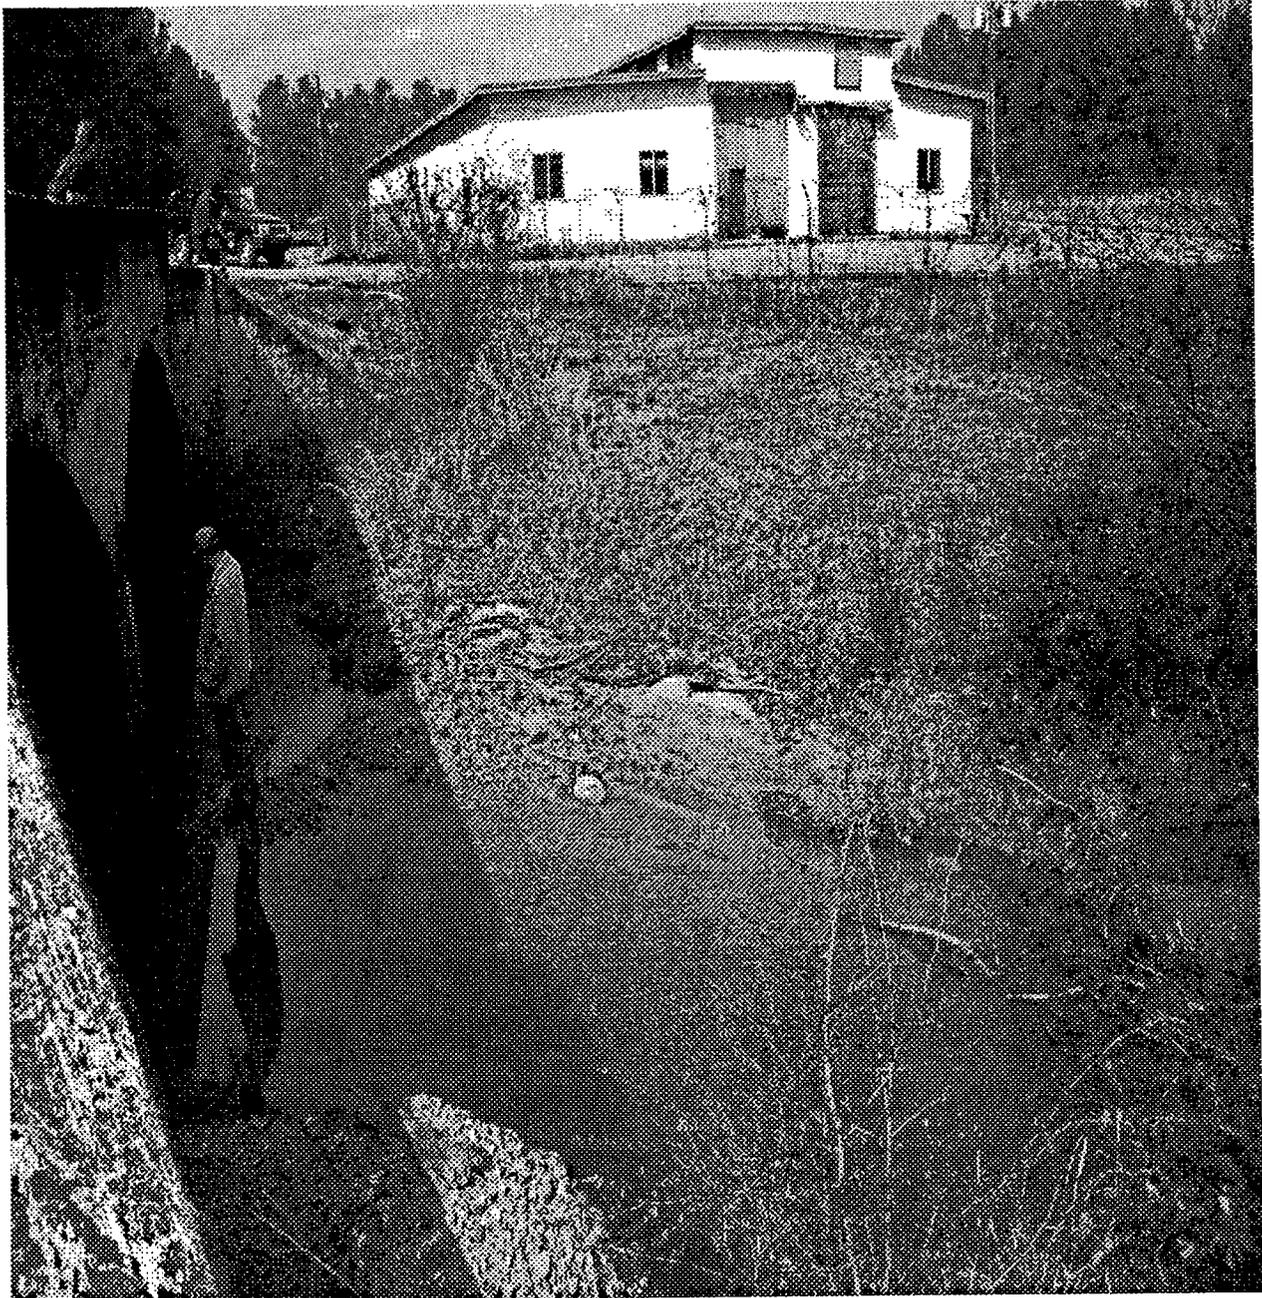
Photo C25 [3/4/98 - 2:00]

Site 46(7) is an abandoned building within a large paved/fenced area; photo faces N direction looking across Cave Creek. The road/overpass over the creek is to the far left of view. A discharge pipe for stormwater flow is evident in the background (upper left quadrant of view). Cave Creek flows adjacent to the SW corner of the site, and a small tributary to Cave Creek runs along the SE to S boundary of the fenced area. The tributary discharges to the creek near the southern boundary of the fenced area.

This site consists of paved lot and building. However, it is surrounded by significant aquatic features to the S, and by forested habitat to the N, E, and W. The site clearly drains S to the tributary and to Cave Creek (see Photo D2), as determined by the presence of several drainage ditches leading from the fenceline to the S into the tributary.

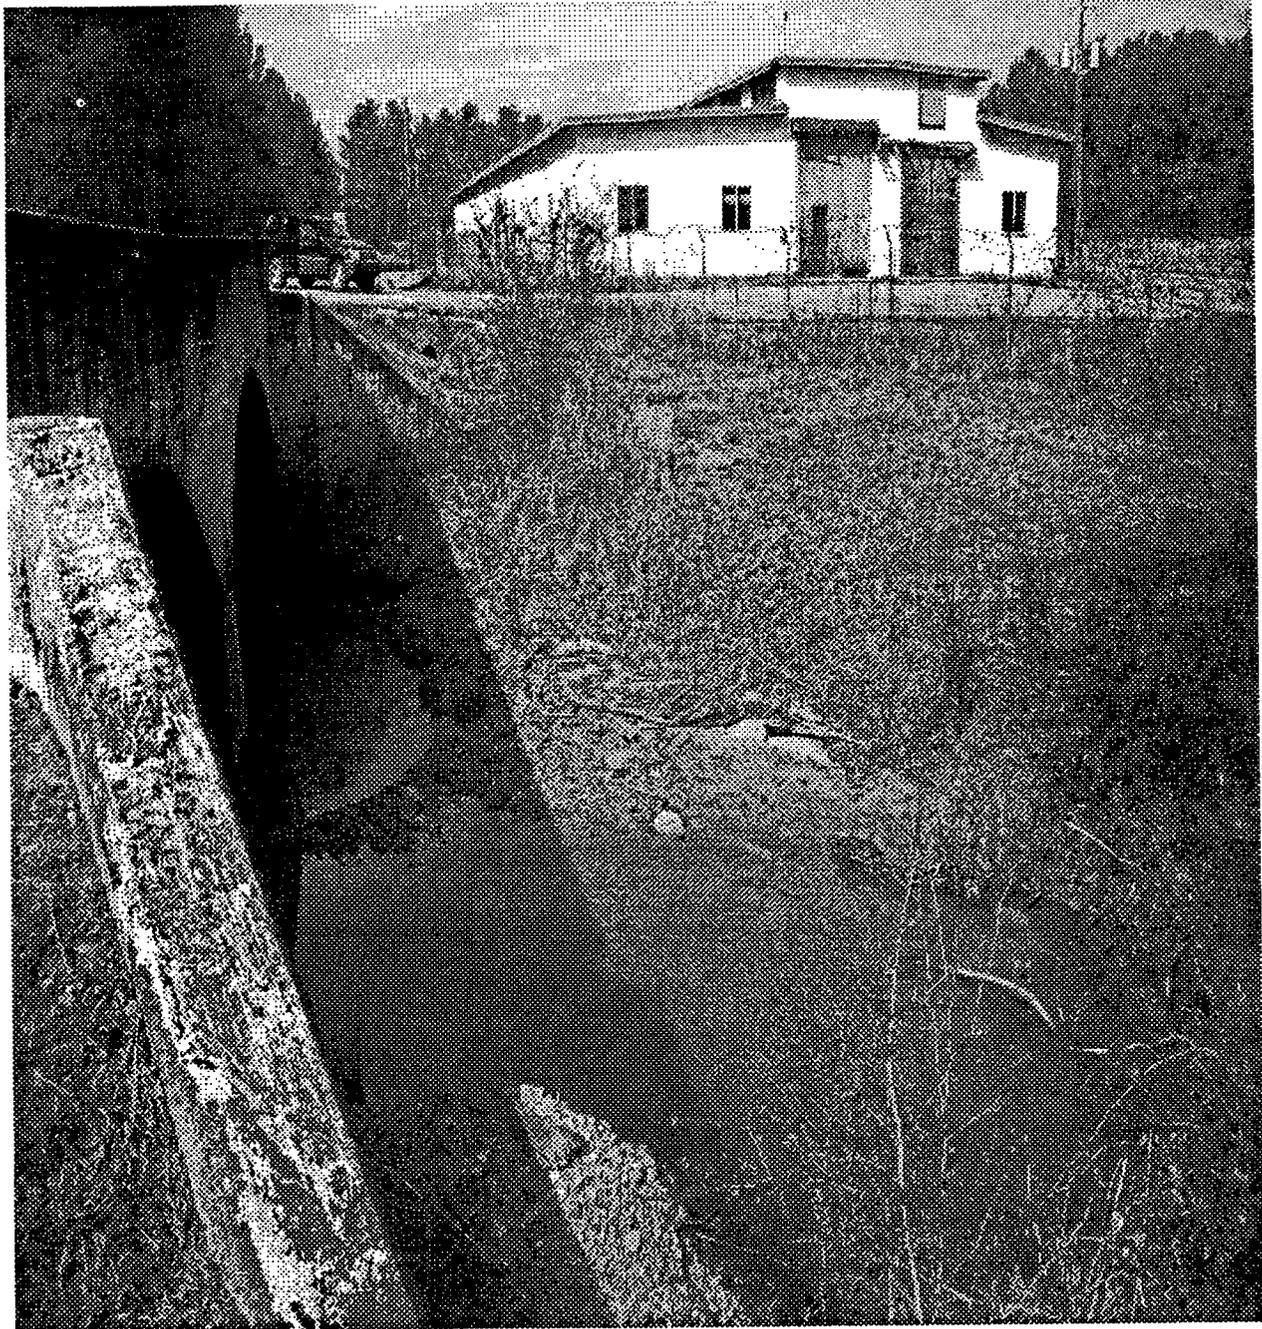
Photo D1 [3/4/98-2:05]

Site 46(7) is an abandoned building within a large paved/fenced area; photo faces N direction looking across Cave Creek. The road/overpass over the creek is to the far left of view. A discharge pipe for storm water flow is evident in the background (upper left quadrant of view). Cave Creek flows adjacent to the SW corner of the site, and a small tributary to Cave Creek runs along the SE to S boundary of the fenced area. The tributary discharges to the creek near the southern boundary of the fenced area.

This site consists of a paved lot and building. However, it is surrounded by significant aquatic features to the S, and by forested habitat to the N, E, and W. The site clearly drains S to the tributary and to Cave Creek (see Photo D2), as determined by the presence of several drainage ditches leading from the fence line to the S into the tributary.

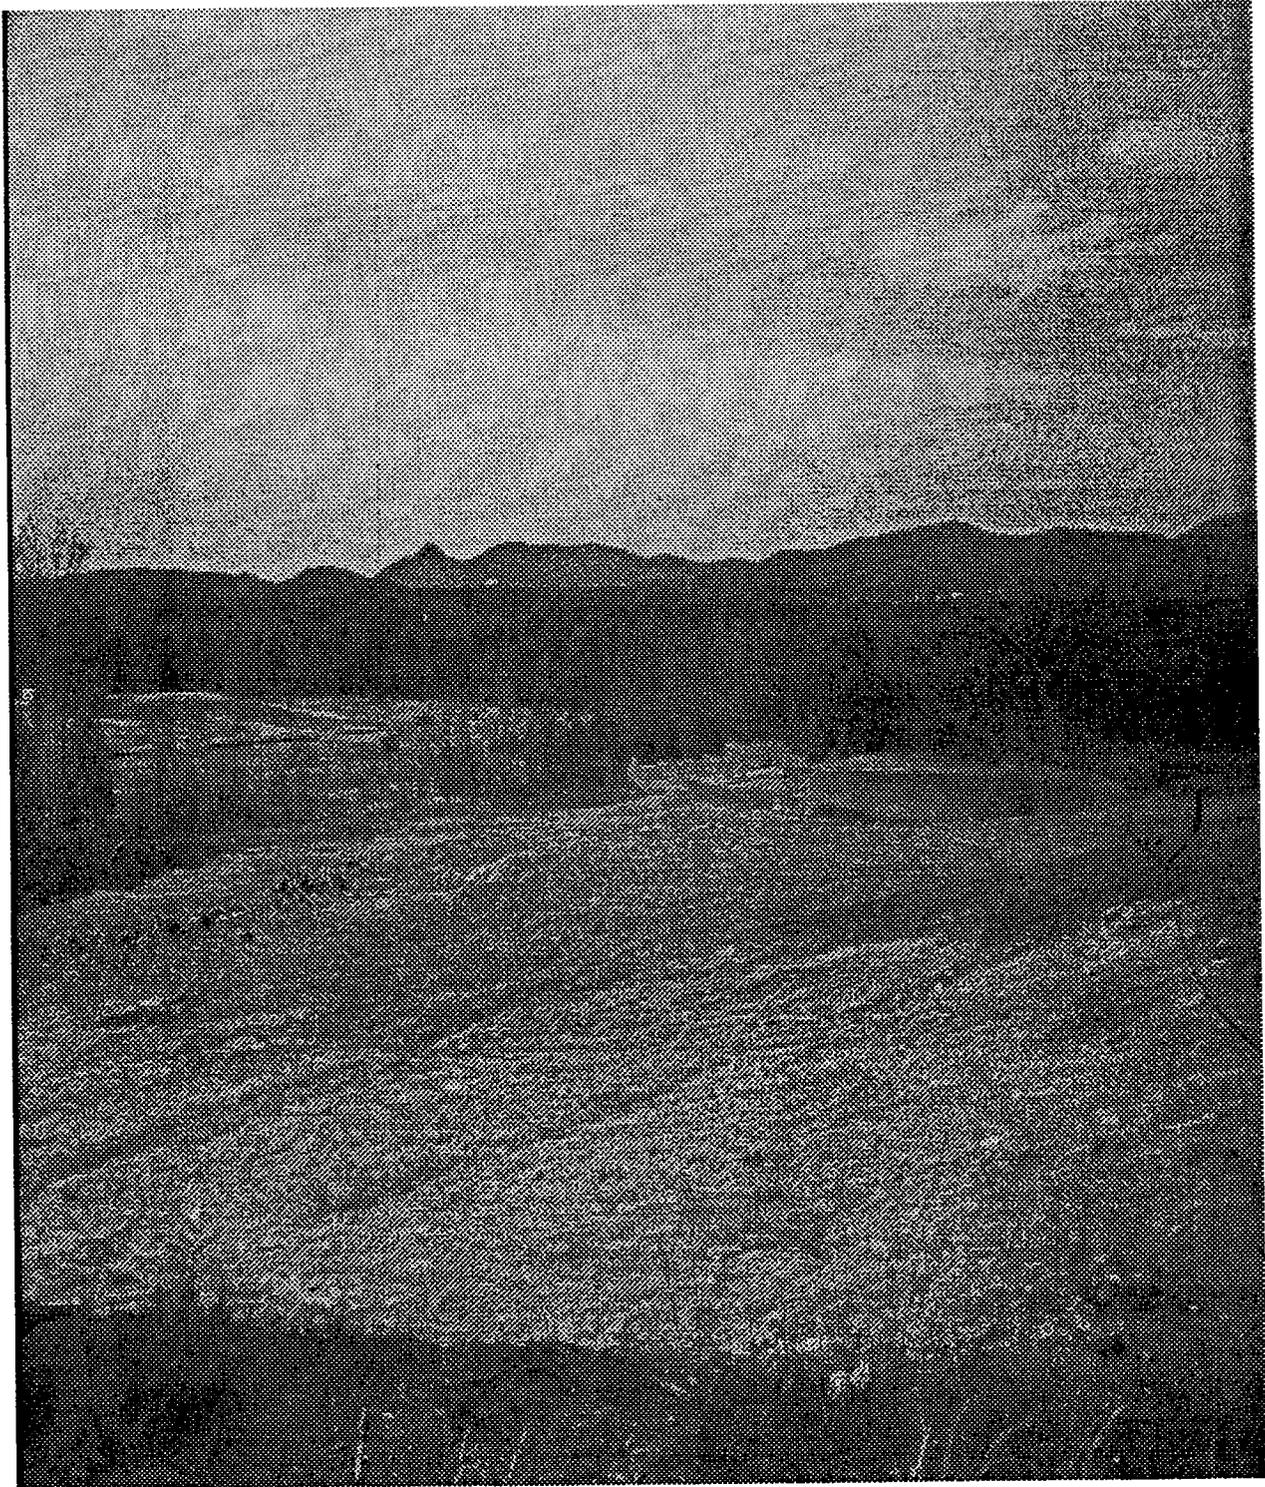
Photo D4 [3/4/98-2:30]

Current Industrial Landfill 175(5) [CERFA Parcel Map 20,48] and former landfill #4 81(5) [CERFA 19,46] This photo is an overview shot of sites 175(5) and 81(5) taken in the NE direction from an overlook area. Site 175(5) is a 12.9 acre area which is currently only accepting yard wasted and construction debris. A special area also accepts asbestos. Site 81(5) is a closed unlined sanitary landfill. The approximate area of site 81(5) is 42 acres. The site is surrounded by heavy vegetation and forest. Note retention pond in far right of photograph.

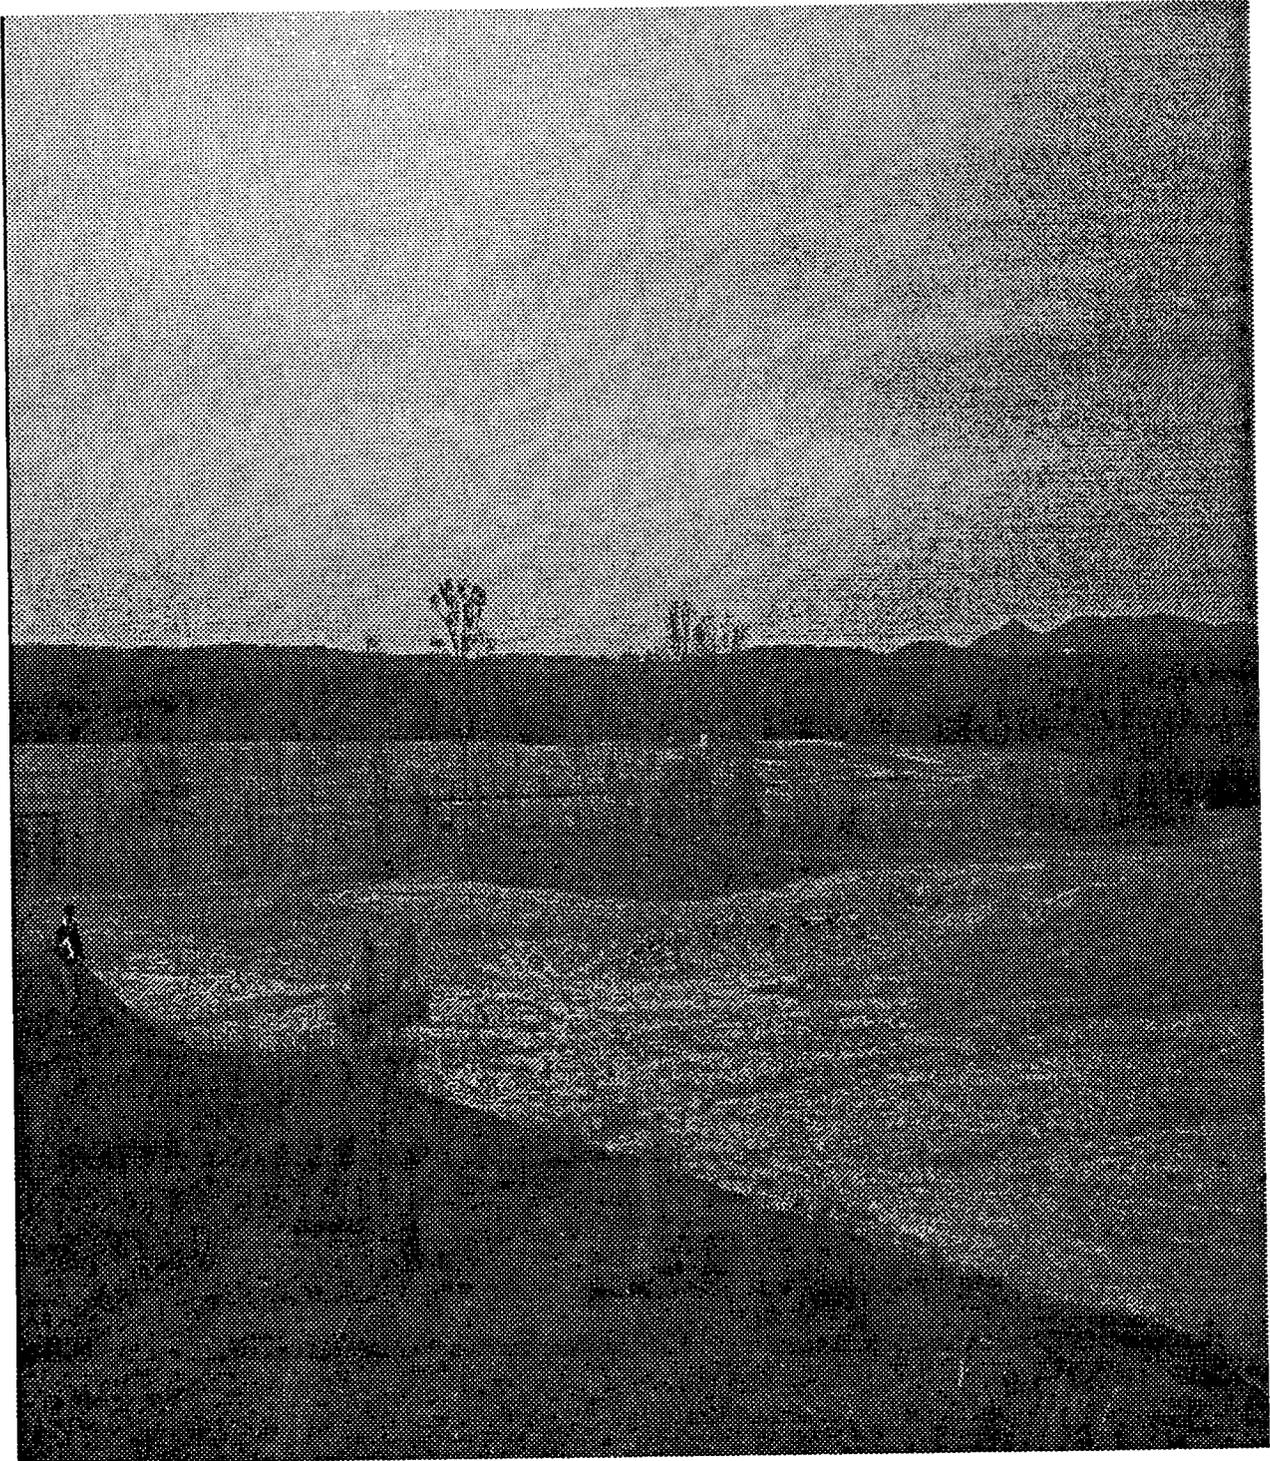
Photo D5 [3/4/98-2:30]

Current Industrial Landfill 175(5) [CERFA Parcel Map 20,48] and former landfill #4 81(5) [CERFA 19,46] Same as D4, but more north direction- N direction

This photo is an overview shot of sites 175(5) and 81(5) taken from an overlook area. Site 175(5) is a 12.9 acre area which is currently only accepting yard wasted and construction debris. A special area also accepts asbestos. Site 81(5) is a closed unlined sanitary landfill. The approximate area of site 81(5) is 42 acres. The site is surrounded by heavy vegetation and forest.

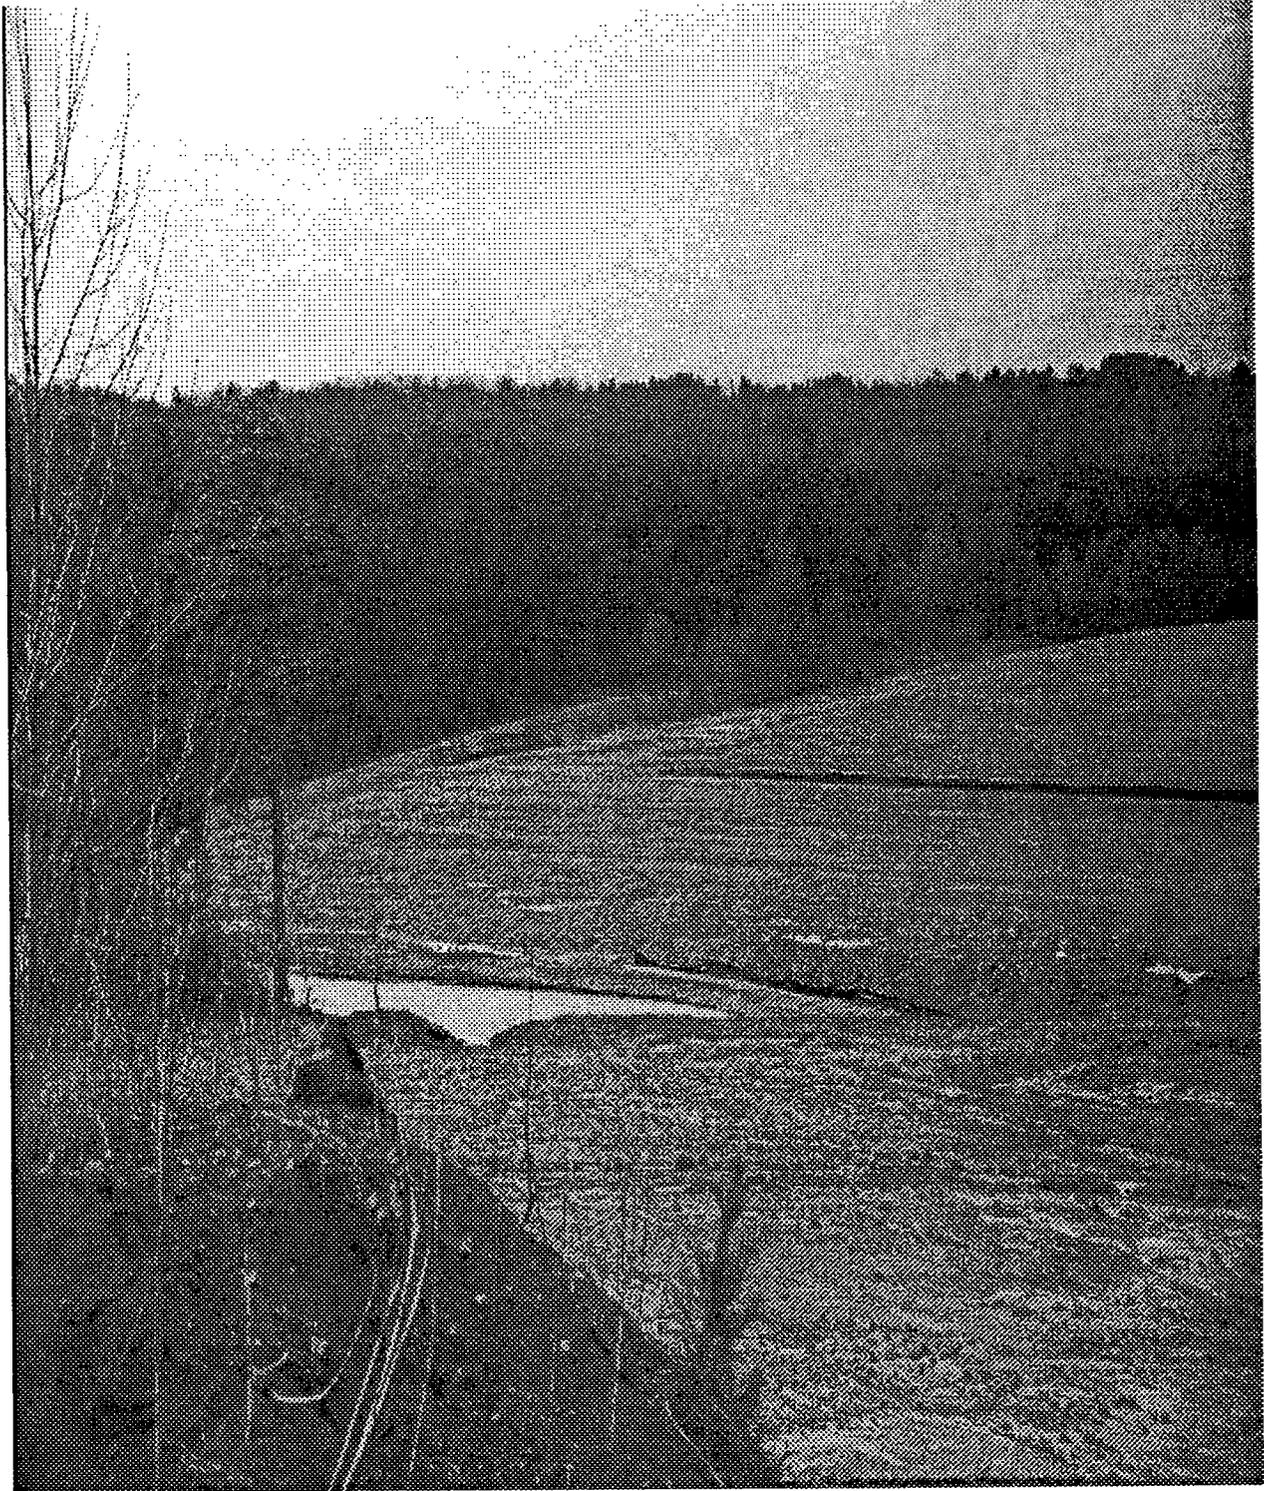
Photo D6 [3/4/98-2:30]

Current Industrial Landfill 175(5) [CERFA Parcel Map 20,48] and former landfill #4 81(5) [CERFA 19,46] Same as D5, but further NW- NW direction.

Site 175(5) is a 12.9 acre area which is currently only accepting yard wasted and construction debris. A special area also accepts asbestos. Site 81(5) is a closed unlined sanitary landfill. The approximate area of site 81(5) is 42 acres. The site is surrounded by heavy vegetation and forest. Note retention pond in far right of photograph. Note retention pond in far left of photo.

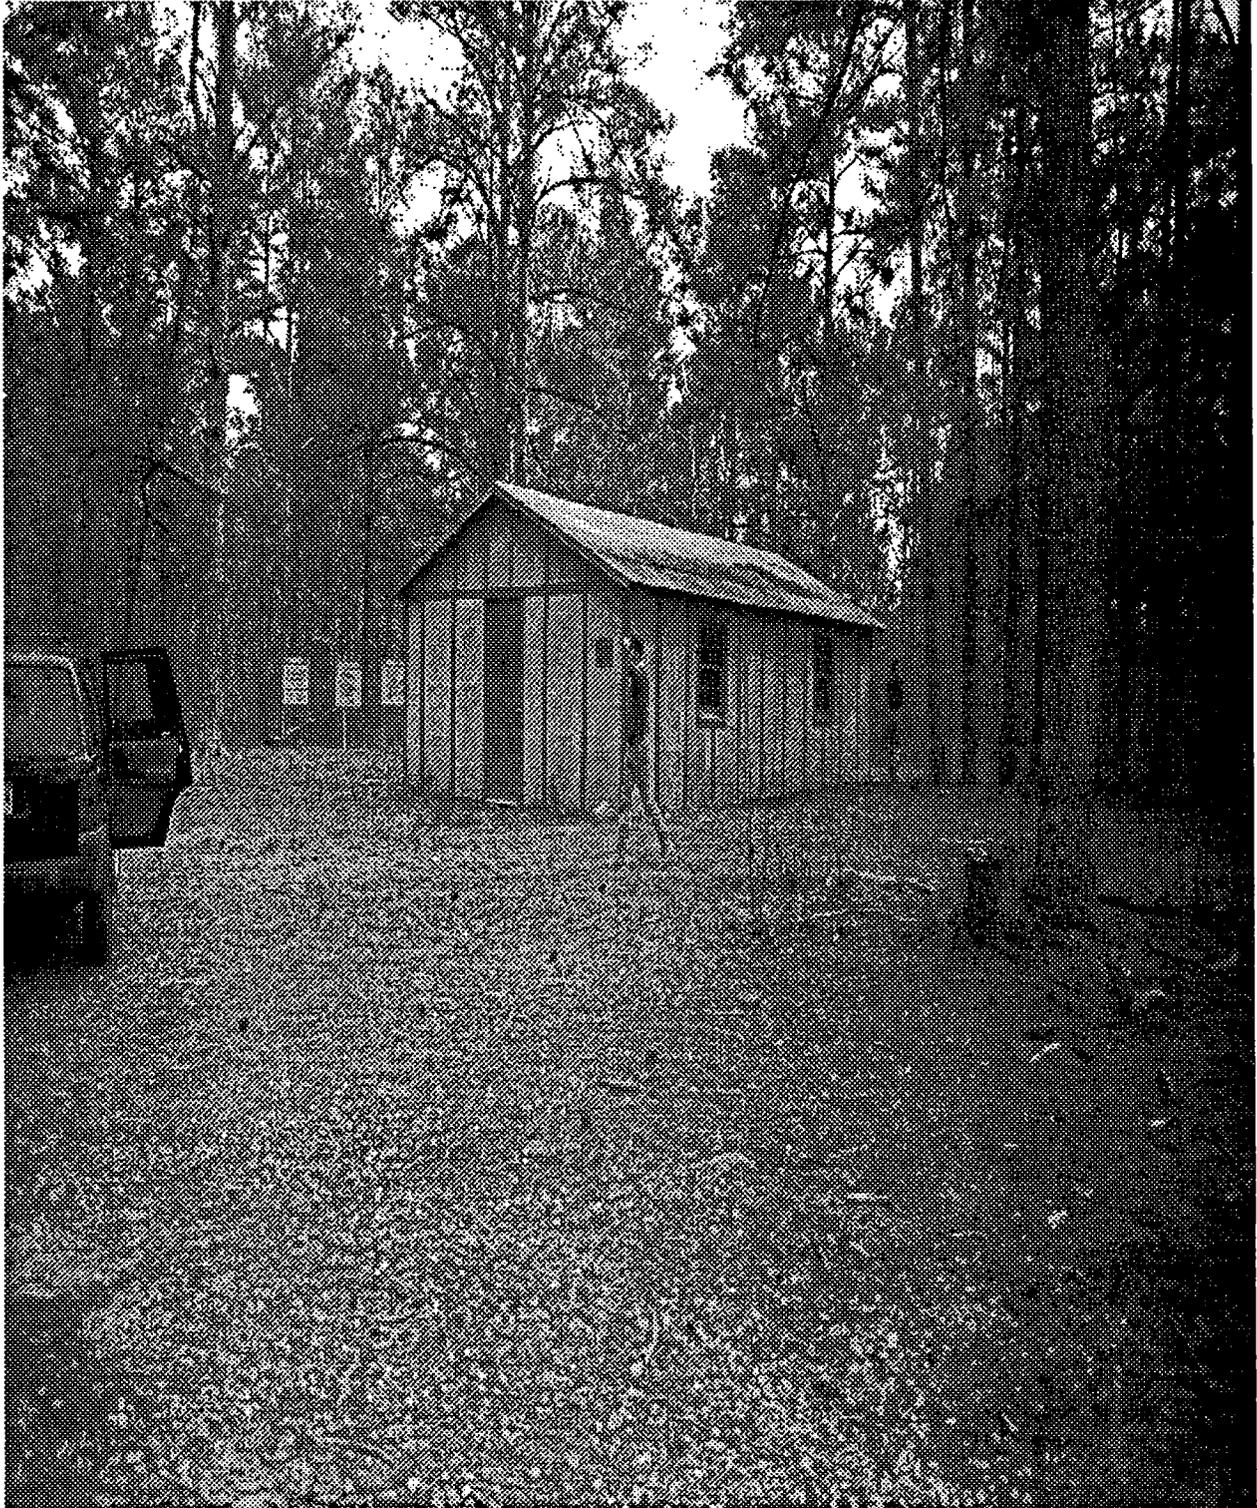
Photo D7 [3/4/98-2:37]

Site 195(7) consists of a building used to test gas masks. The site is a 0.36 acre area surrounded by woods. No seeps or creeks noted during site walk. Photo looks to the south at the actual building used for testing wooded area can be seen all around the area.

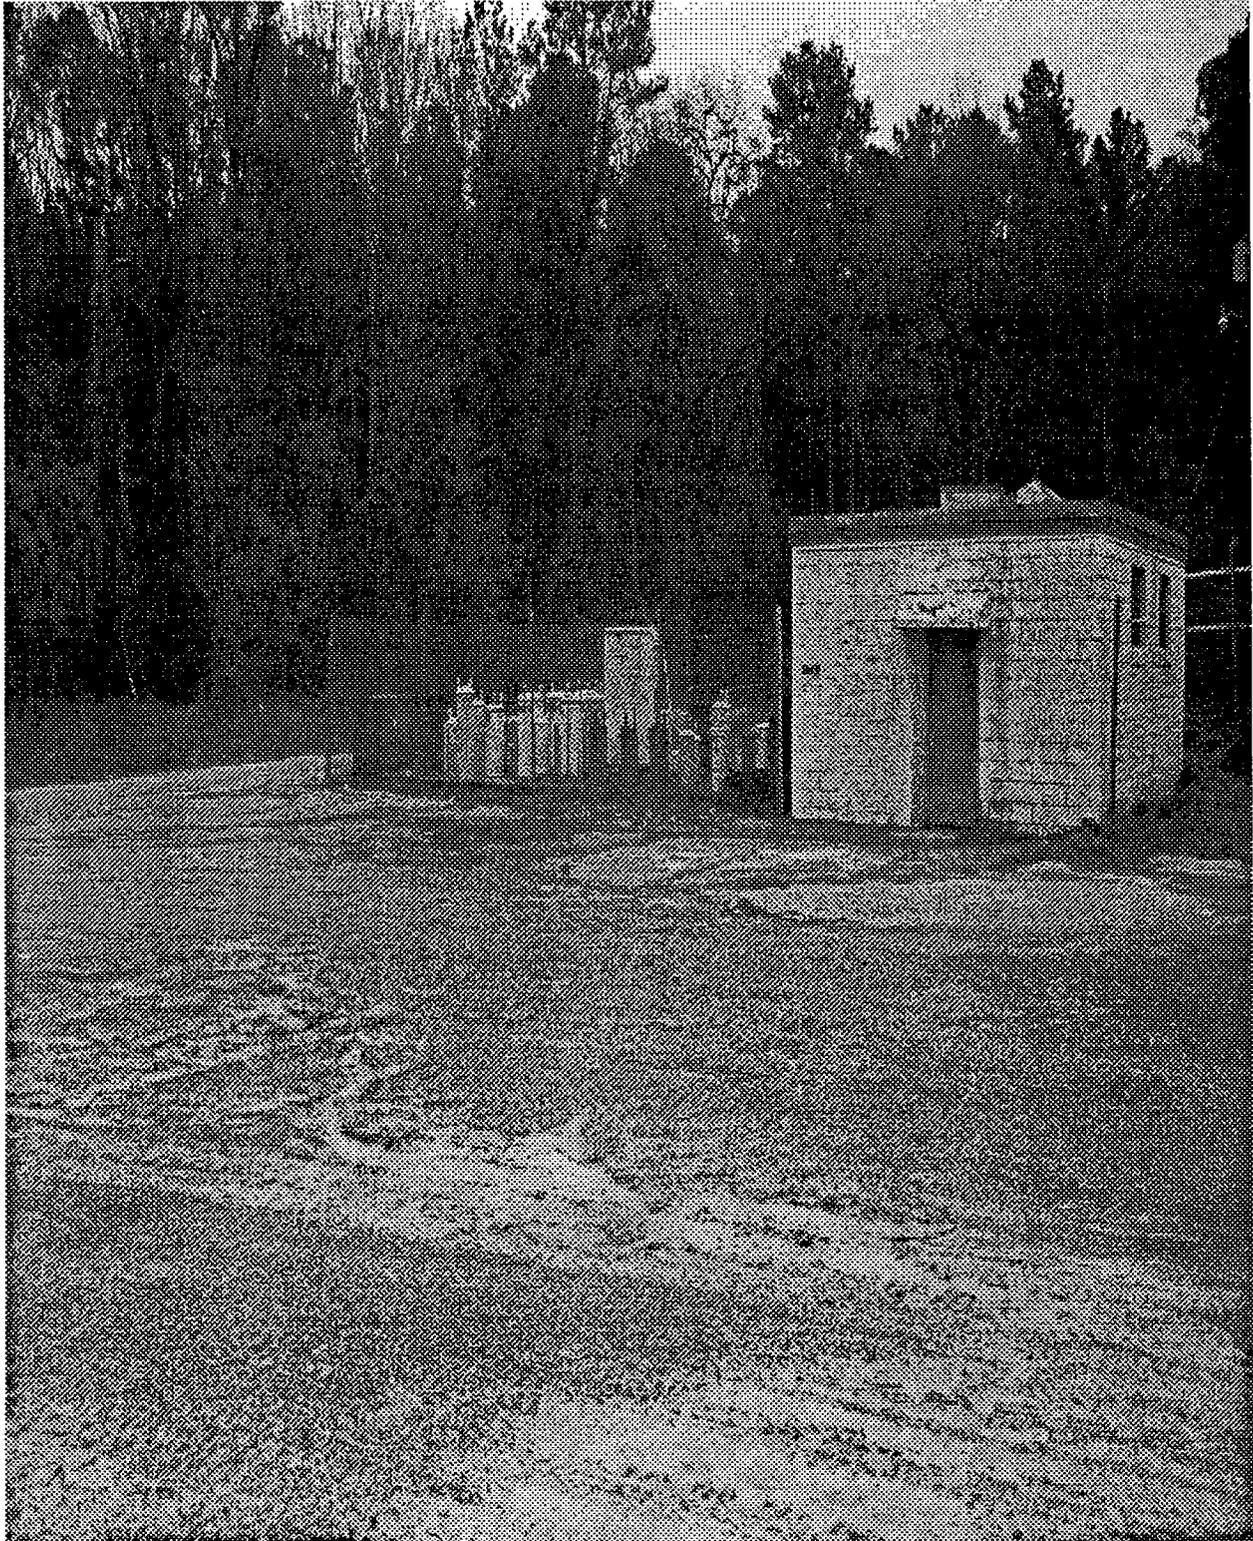
Photo D8 [3/4/98-3:00]

Former Tar Plant /Temporary Transformer Storage Bldg. (4437) Sites 32(7)/99(7) [CERFA Parcel Map 21,39] This photo taken in the N direction shows bldg. 4437 and the associated transformer storage yard. A densely wooded area exists directly behind the site and Cave Creek runs parallel to the NW fence line of the site.

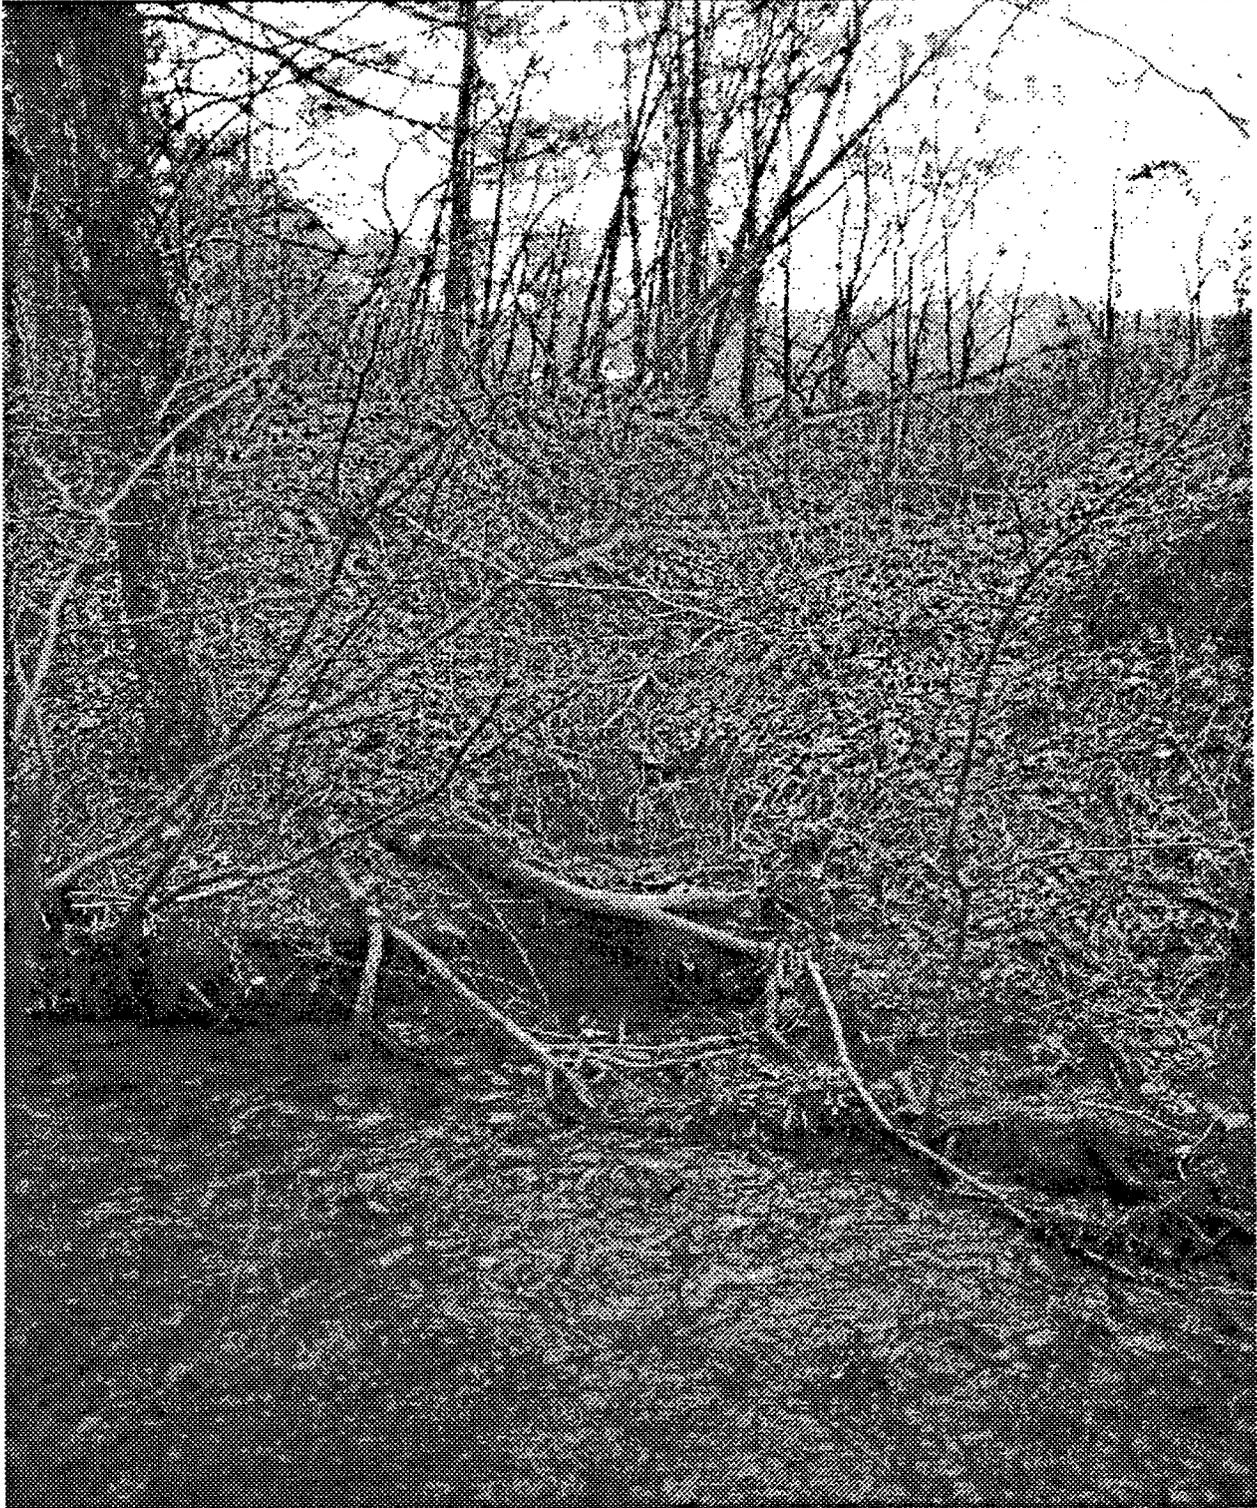
Photo D9 [3/4/98-3:10]

Drainage ditch into stream from transformer yard, Site 32(7)/99(7) [CERFA Parcel Map 21, 39]

This photo taken in the E direction show a drainage ditch coming from the former Tar Plant /Temporary Transformer Storage Bldg. (4437) going into Cave Creek (approx. 30 yds. distance). The photo shows dense vegetation and small trees scattered about.
