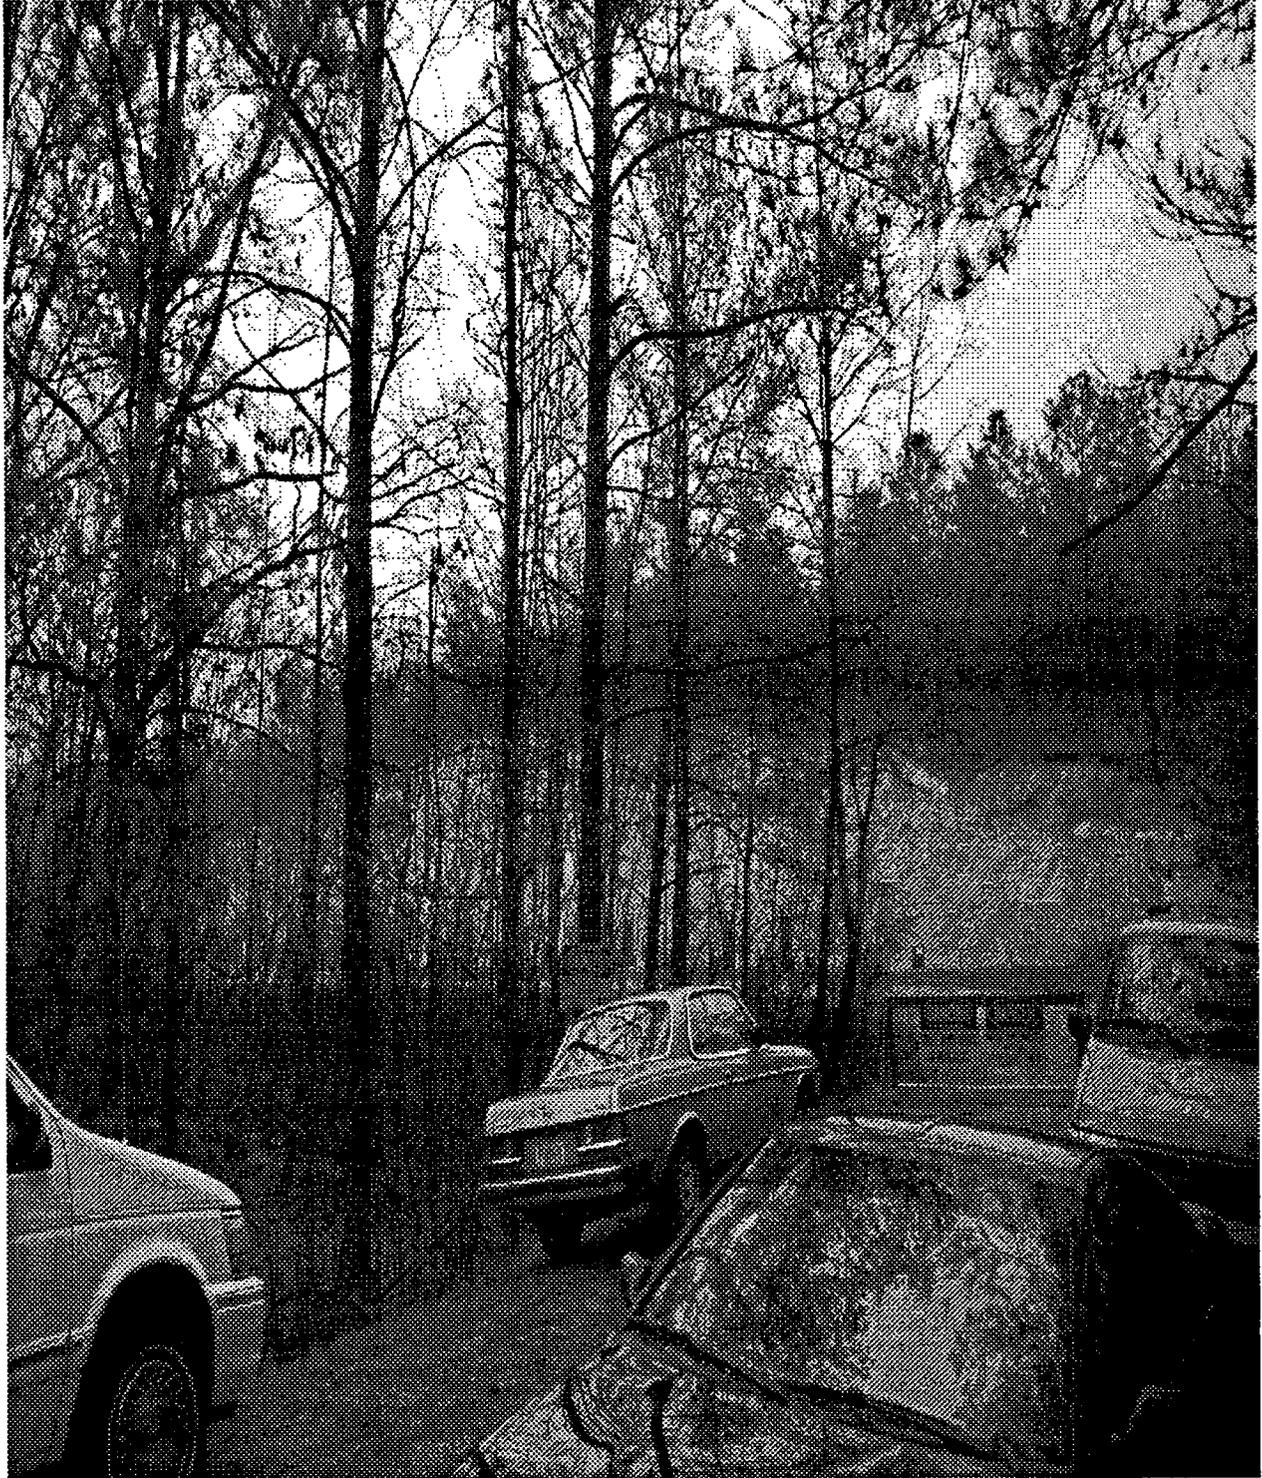
Photo E19 [3/5/98-1:23]

Range 19 is located on Southwest Main Post and has been in use from 1976 through the present. The photograph faces the NE. The site is an open area against a backstop hill. The Range is surrounded by pine forest. There is a drainage ditch between Iron Mountain Road and Range 19. It does not appear to drain behind the Range (i.e., hillside). A site walk was not performed due to restricted access (range was in use).

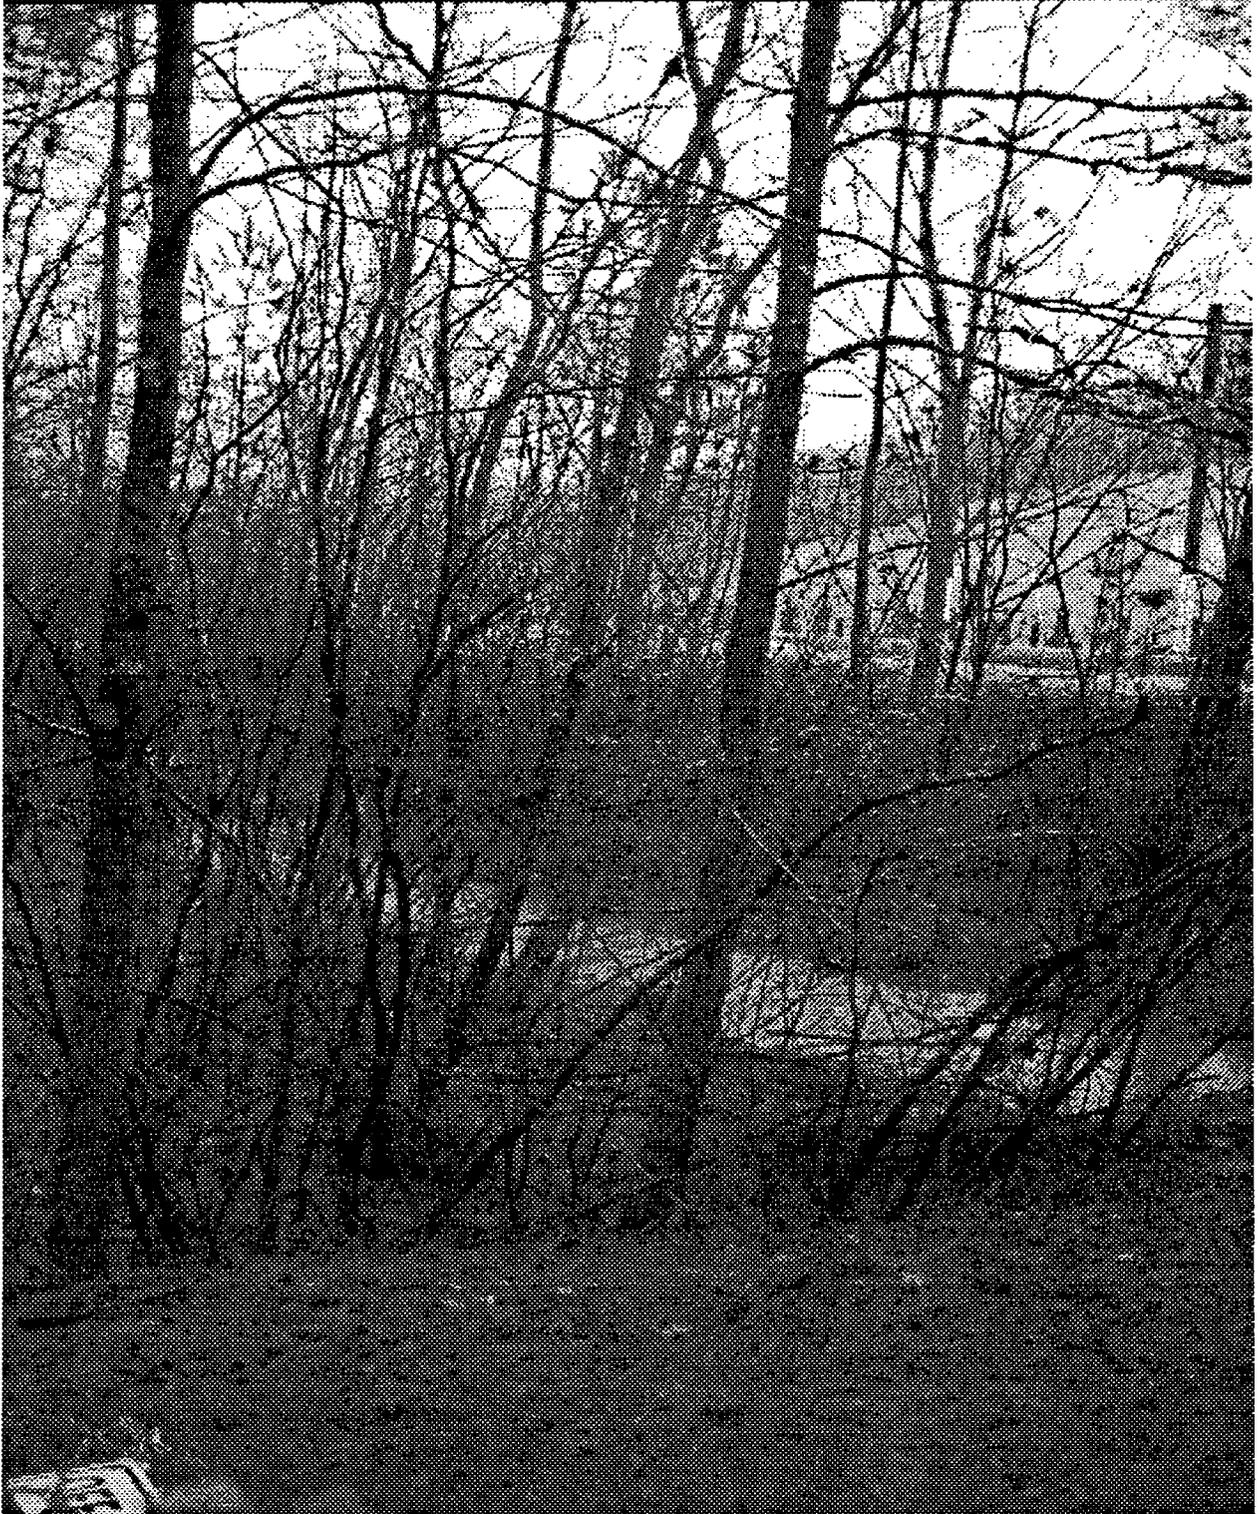
Photo E20 [3/5/98-1:24]

Range 19 is located on Southwest Main Post and has been in use from 1976 through the present. The photograph faces the NE. The site is an open area against a backstop hill. The Range is surrounded by pine forest. This photograph faces north and shows the drainage ditch mentioned in E19. The ditch is surrounded by small trees. A site walk was not performed due to restricted access (range was in use).

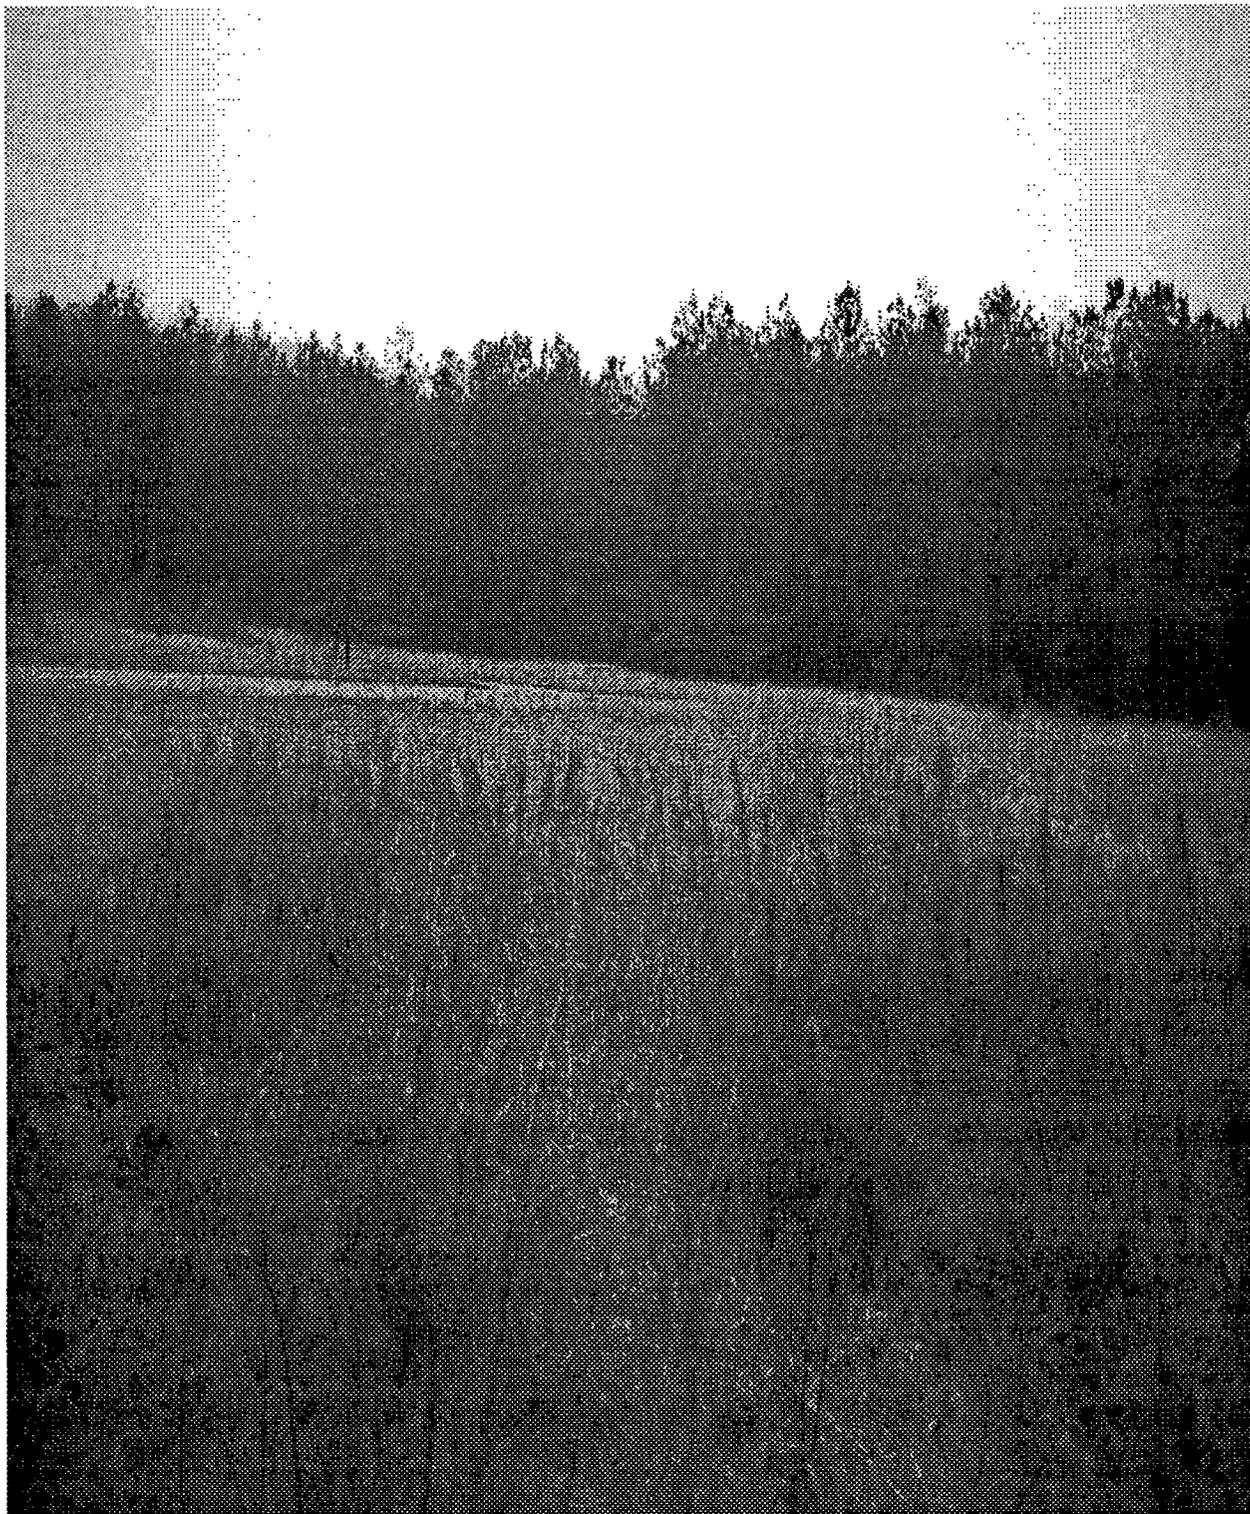
Photo E21 [3/5/98-1:30]

This photograph faces south and shows an open clearing in the middle of a highly wooded area. Large stands of pine trees surround the site. The area in the middle contains tall grasses and there is a paved road through the middle of the area as noted in the middle of the photograph. No aquatic areas were noted during the site visit.

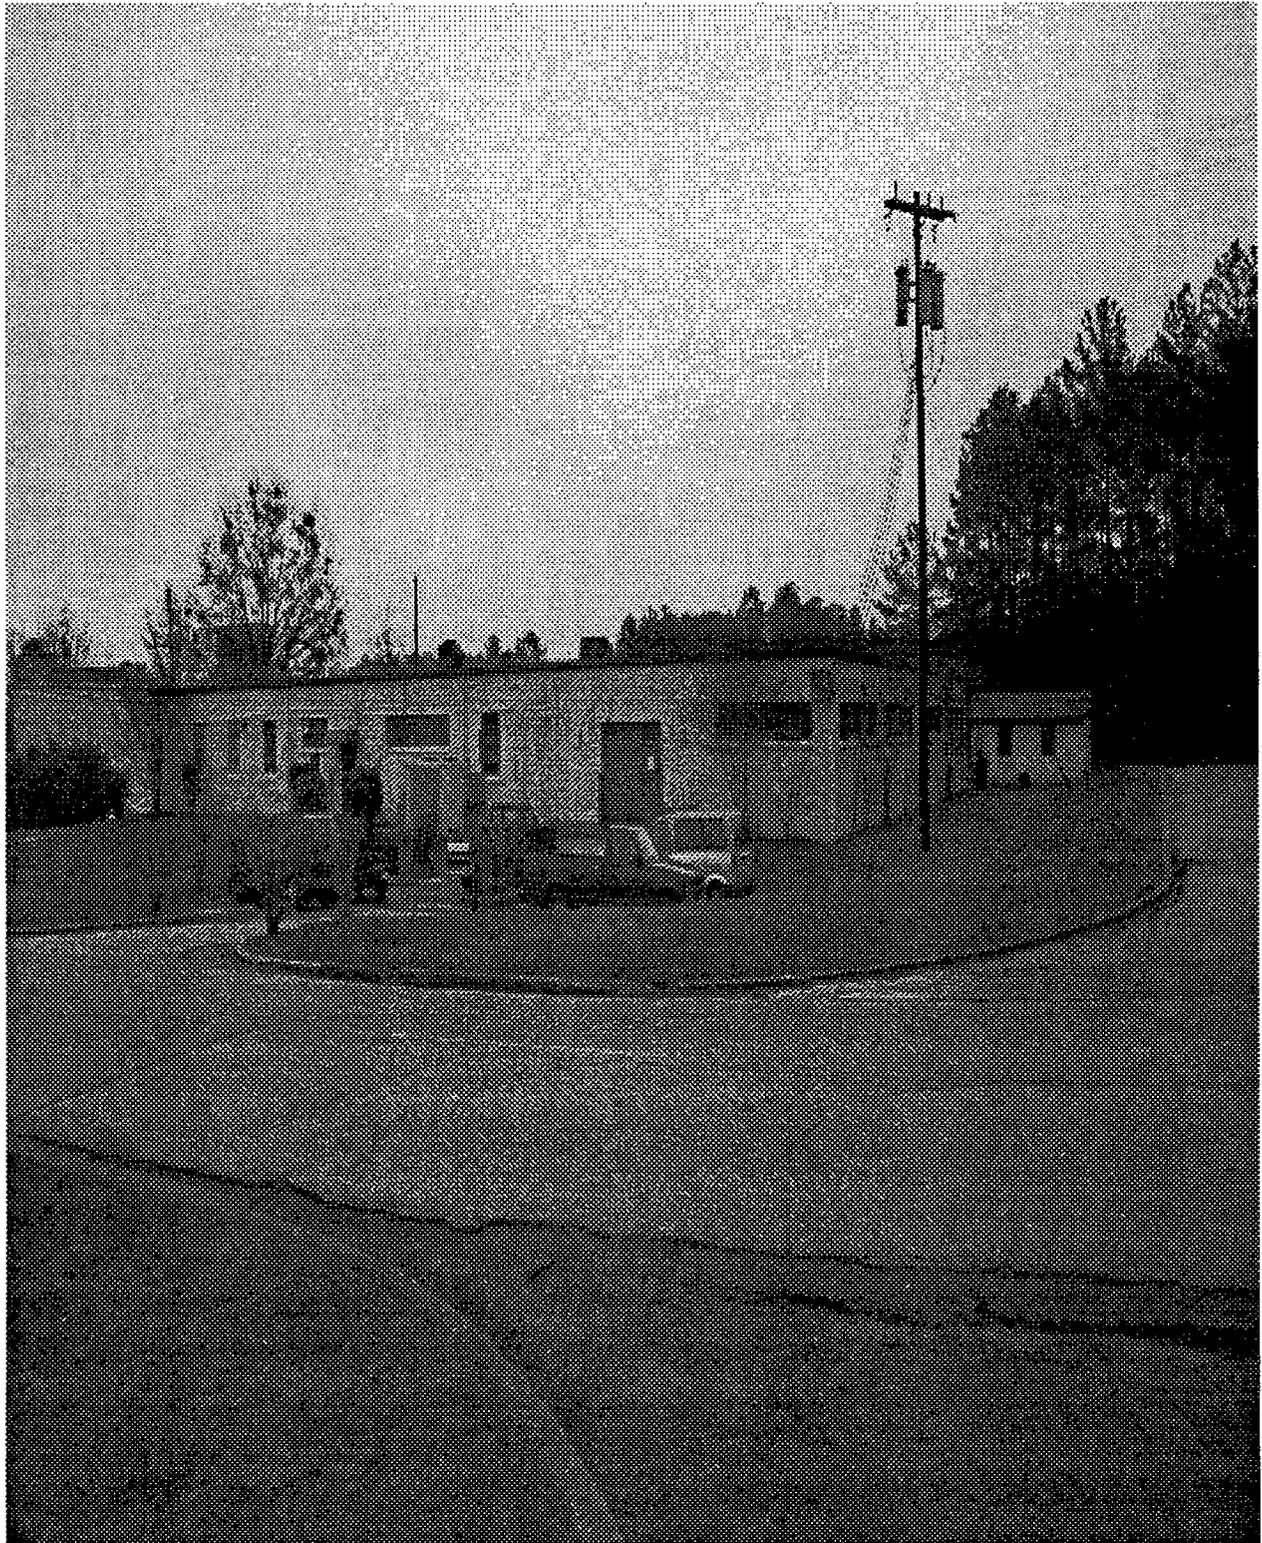
Photo E23 [3/5/98-1:39]

This 0.77 acre site once stored and used solvents. The photo faces the NE and shows bldg. 3138 located adjacent to stand of pine trees. This site is an open developed parking lot with buildings. No aquatic habitat was observed.

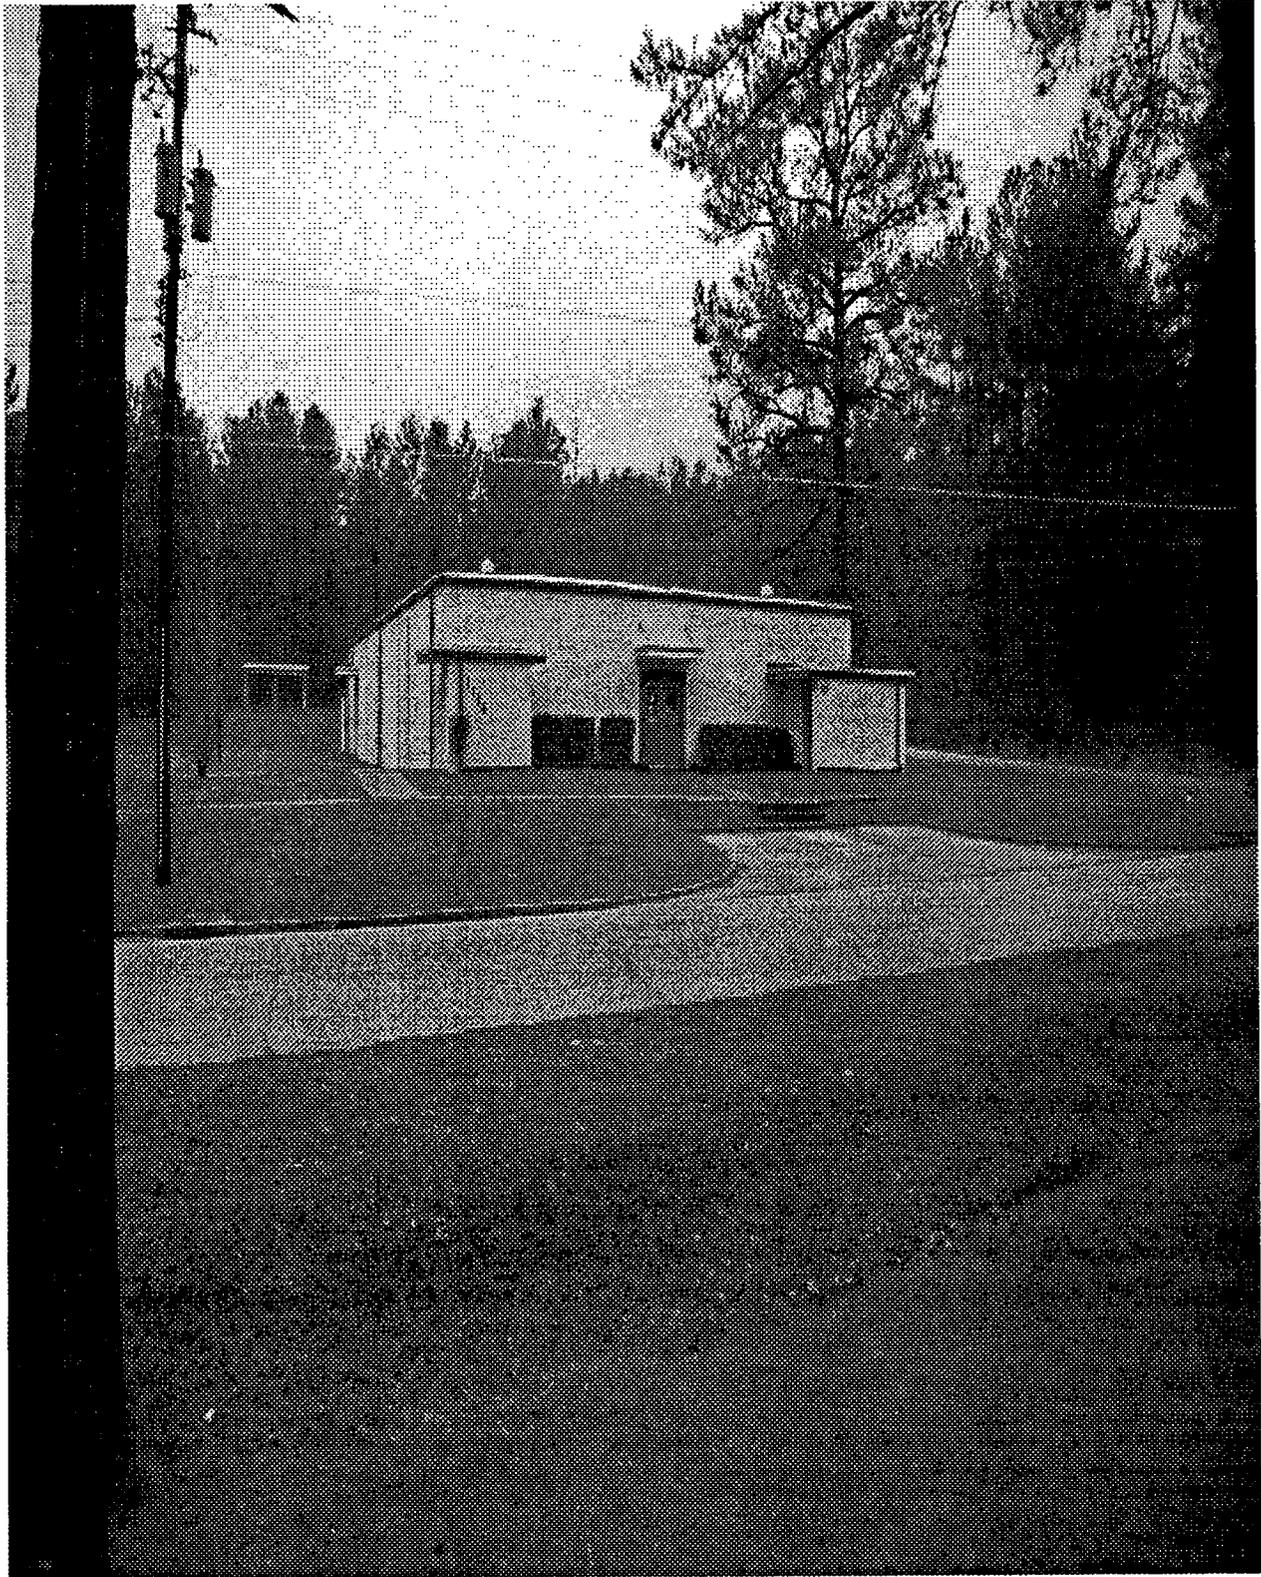
Photo E24 [3/5/98-1:45]

Former Personnel Decontamination Station (PDS) at Bldg. 3185, Site 179(7) [CERFA Parcel Map 19,32] This site is an open developed parking lot with associated building. Directly behind the building is a densely forested area.

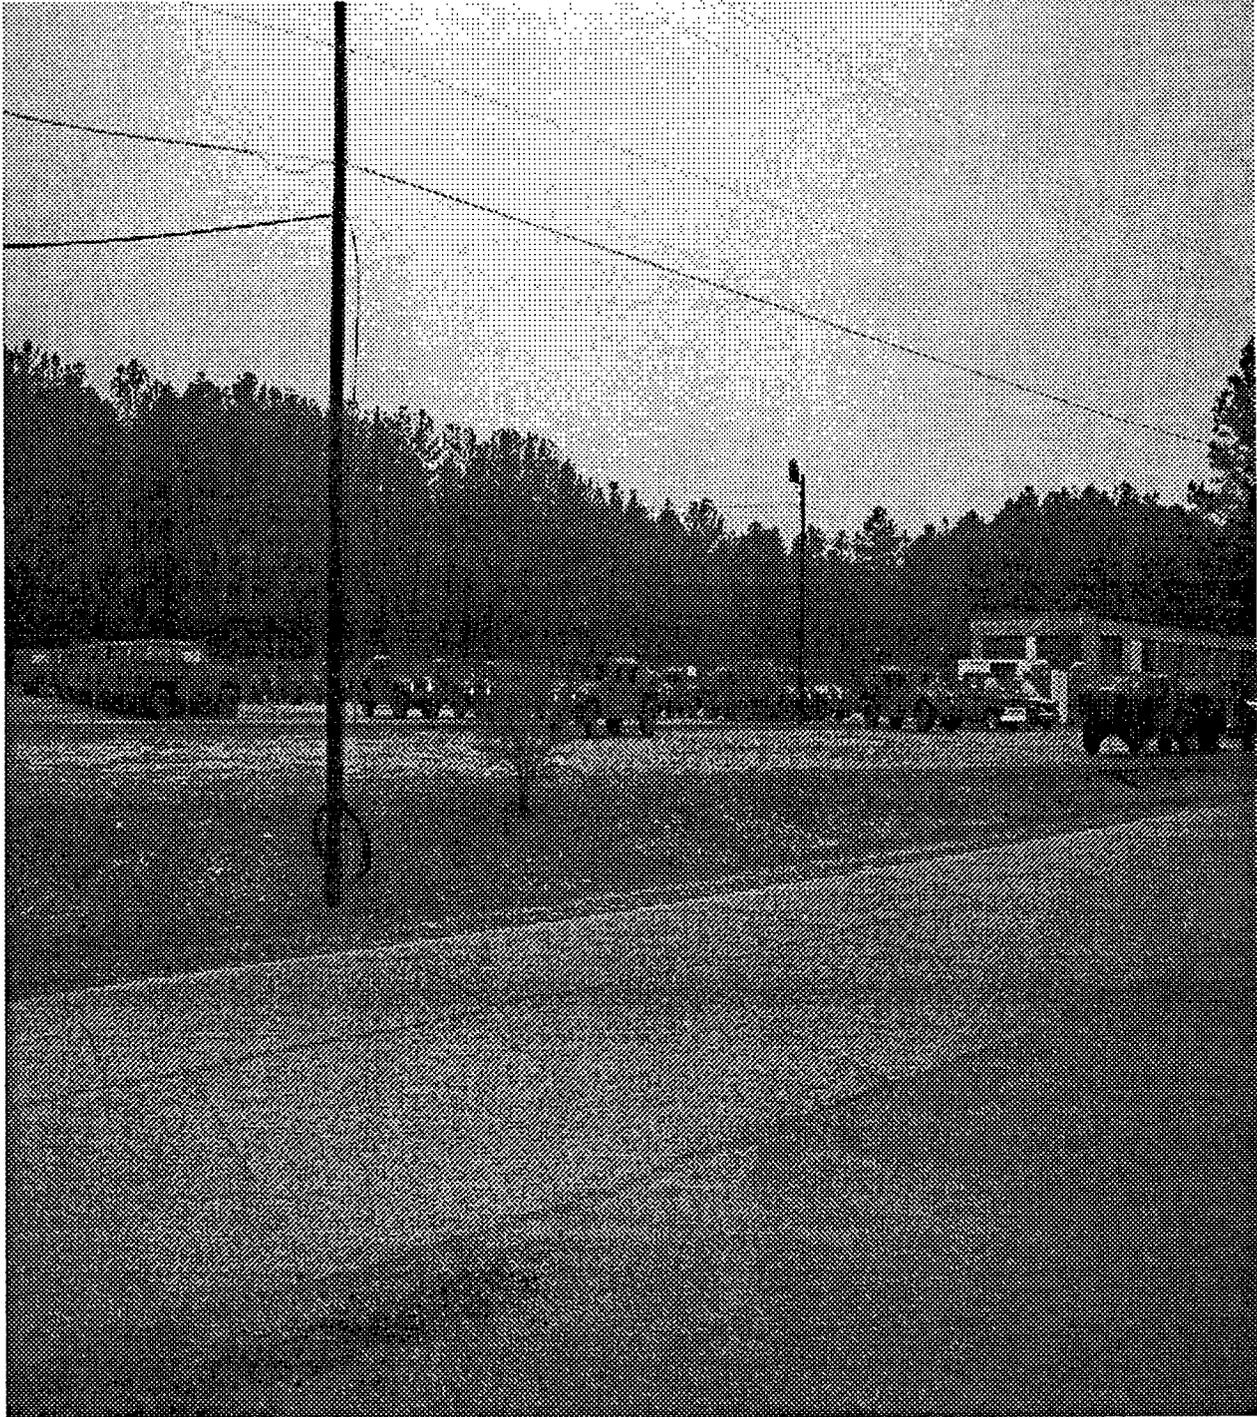
Photo F1 [3/5/98-1:55]

The Motor Pool at Area 3100, is across from the Polygraph Institute. Site 146(7) Complex also encompasses sites 73(7), 25(7), 212(7), and 24(7). The site consists of vehicle maintenance area, wash rack, USTs, and a oil water separator. Site 73(7) bldg. 3144 is a wash rack; Site 25(7) bldg. 3138 Motor Pool is a UST (10,000 gal.); Site 24(7) bldg. 3138 Motor Pool is an oil UST (3,000 gal.); and Site 212(7) bldg. 3138 Motor Pool is one 5,000 gal. UST for heating oil. The photo faces W and shows an open lot (asphalt and gravel) with parked military vehicles. The site is surrounded by tall pine stands.

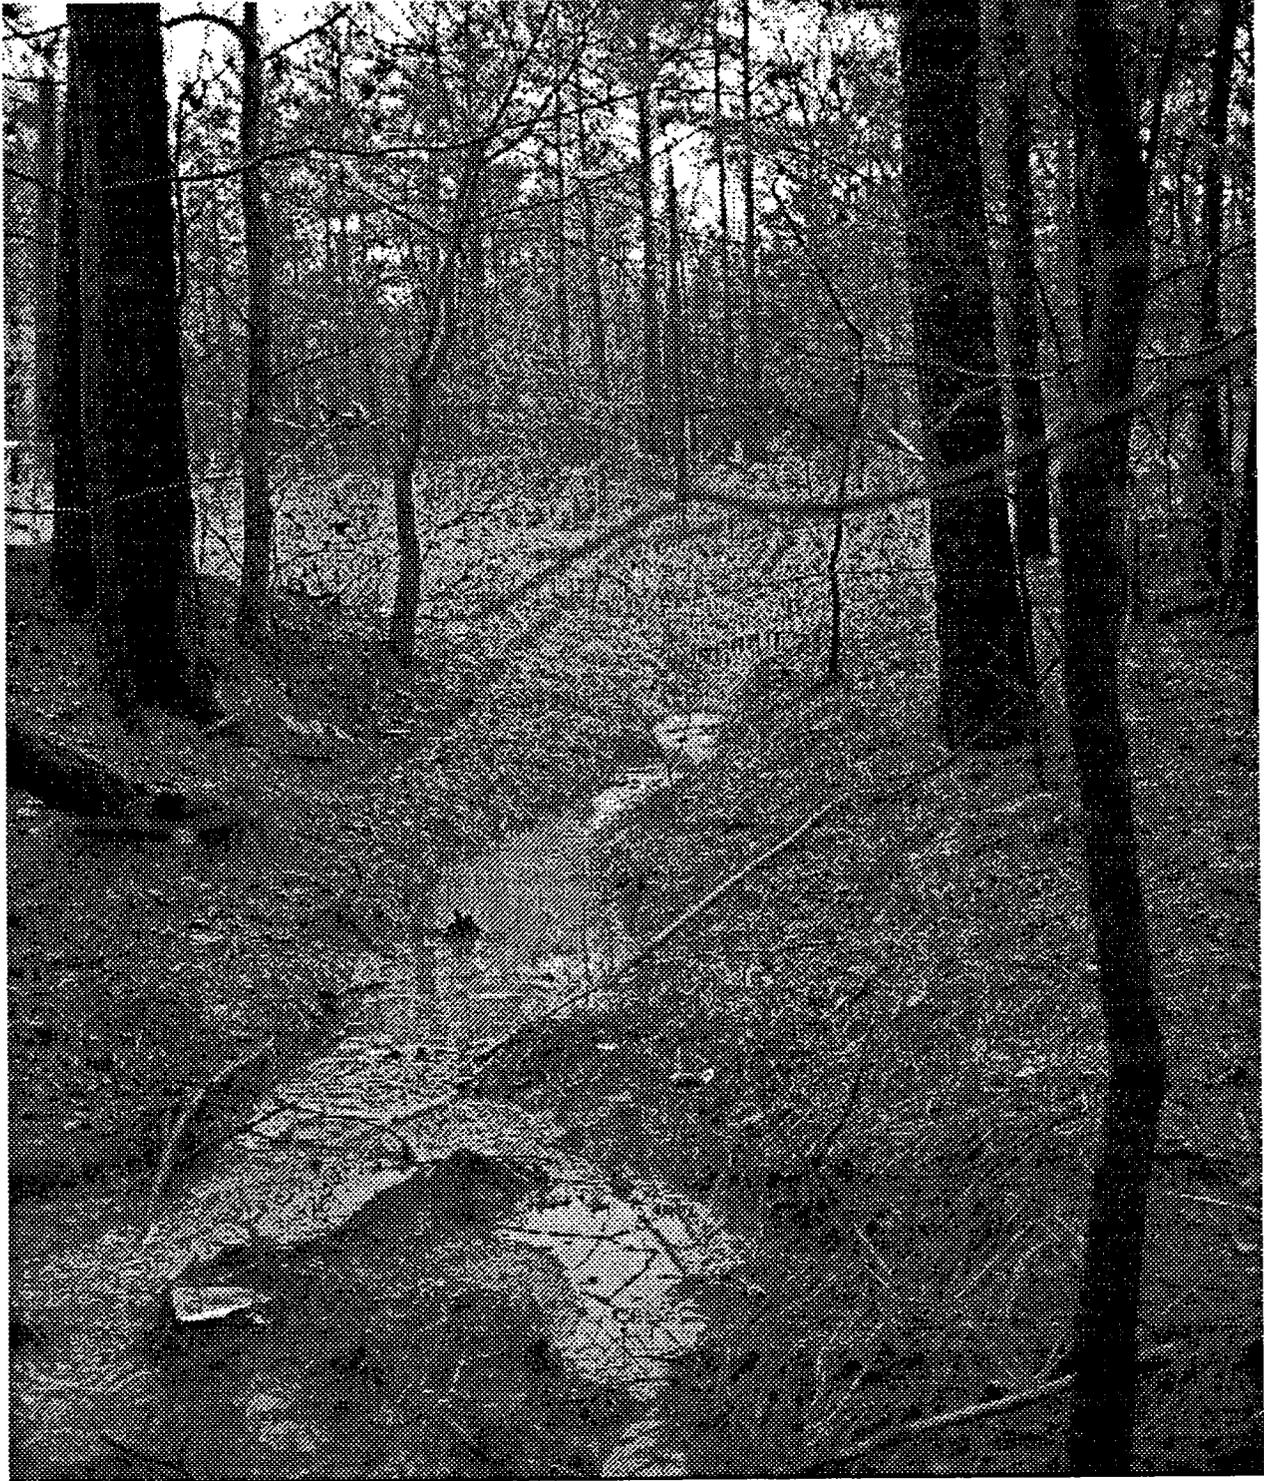
Photo F2 [3/5/98-2:10]

The Motor Pool at Area 3100, is across from the Polygraph Institute. Site 146(7) Complex also encompasses sites 73(7), 25(7), 212(7), and 24(7). The site consists of vehicle maintenance area, wash rack, USTs, and a oil water separator. The photo faces South and shows a stream running from the NW corner of the fenced parking area. Small stands of pine are scattered around the area.

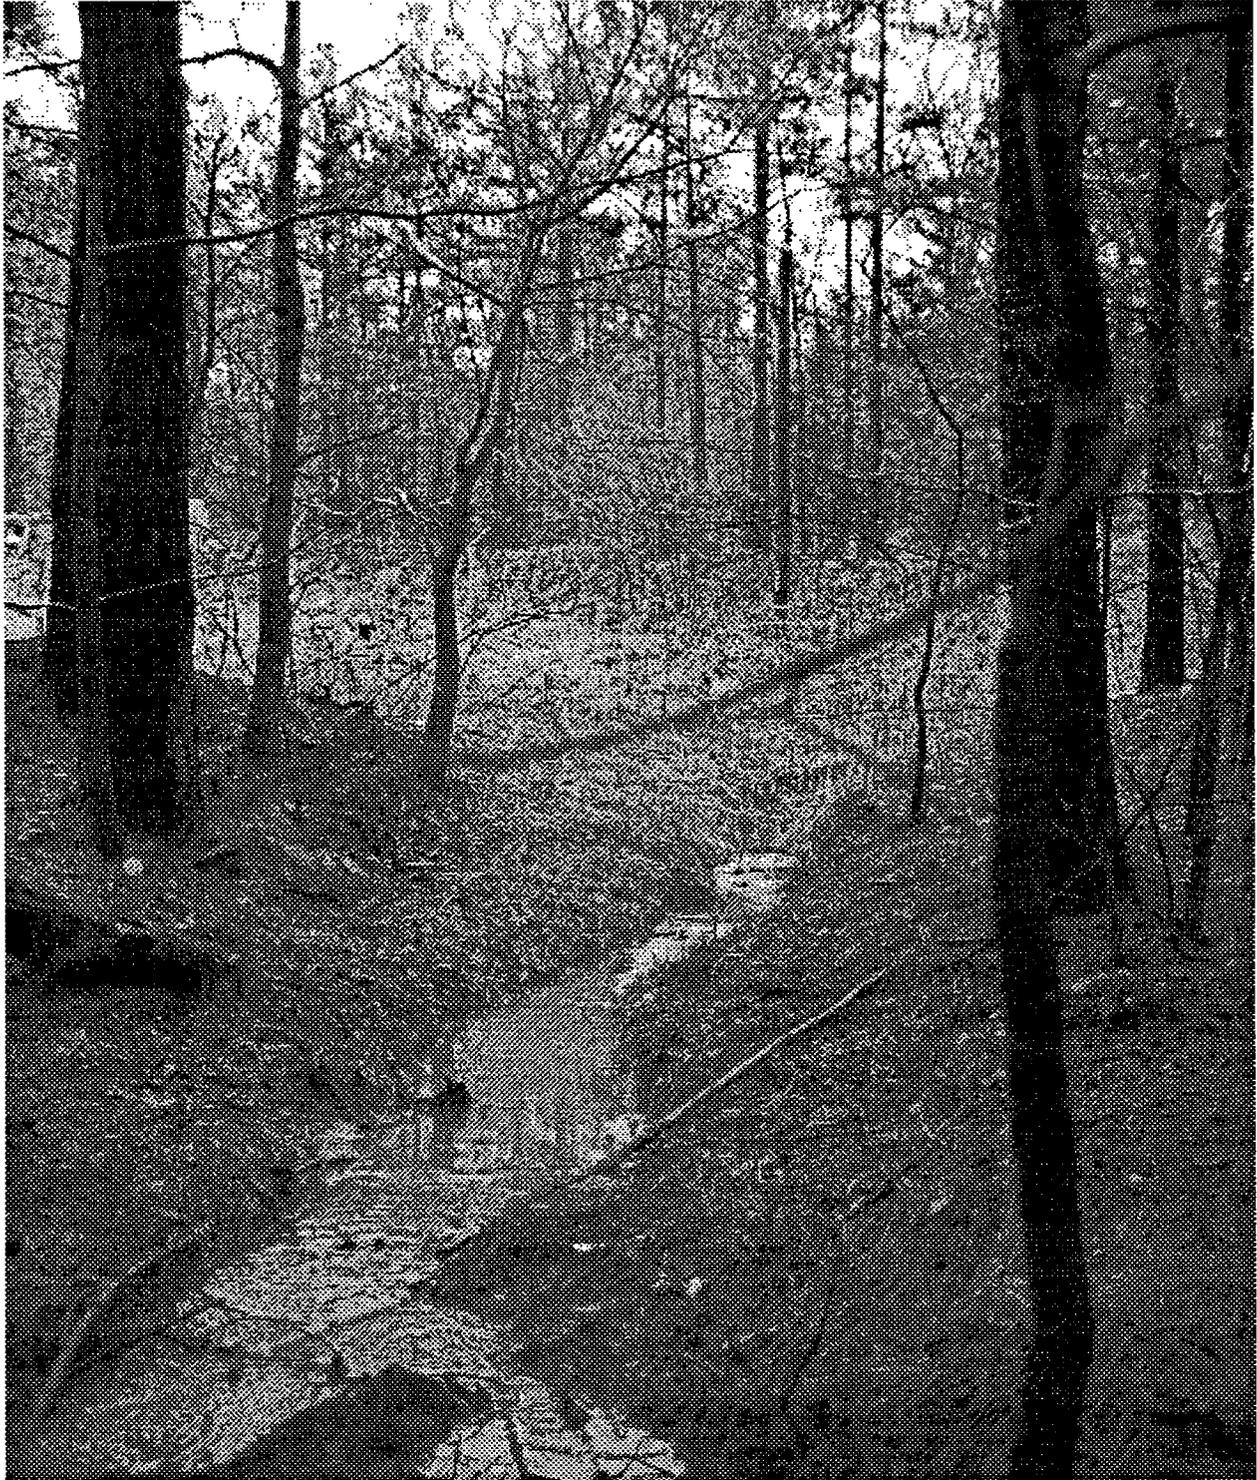
Photo F3 [3/5/98-2:15]

The Motor Pool at Area 3100, is across from the Polygraph Institute. Site 146(7) Complex also encompasses sites 73(7), 25(7), 212(7), and 24(7). The site consists of vehicle maintenance area, wash rack, USTs, and a oil water separator. This photo is the same as F2, and shows a stream running from the NW corner of the fenced parking area. Small stands of pine are scattered around the area.

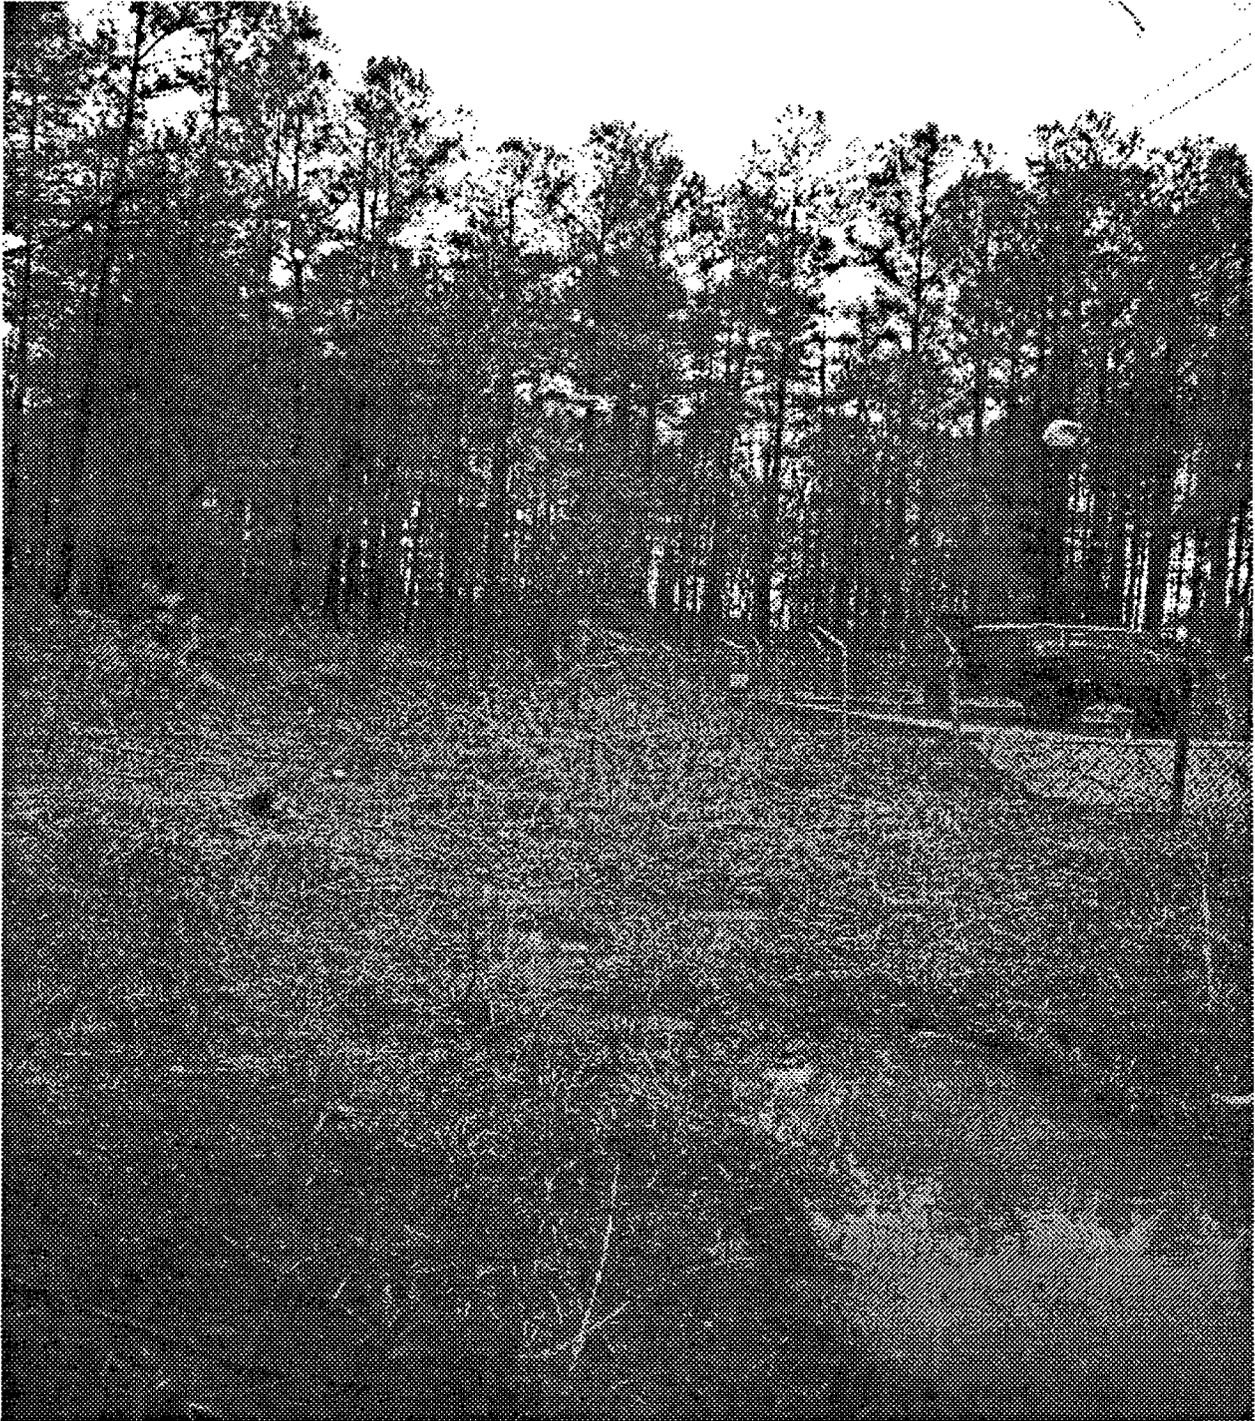
Photo F4 [3/5/98-2:20]

The Motor Pool at Area 3100, is across from the Polygraph Institute. Site 146(7) Complex also encompasses sites 73(7), 25(7), 212(7), and 24(7). The site consists of vehicle maintenance area, wash rack, USTs, and a oil water separator. This photo is of the same stream as in F2 and F3 but from the North. The stream is draining the parking area to the far right of the photo. A wash rack is present at the far right of the photo with a military vehicle on top of it and soldiers are seen washing the vehicle. Drainage from the concrete wash area is draining into the creek. A tall stand of pines is seen to the North.

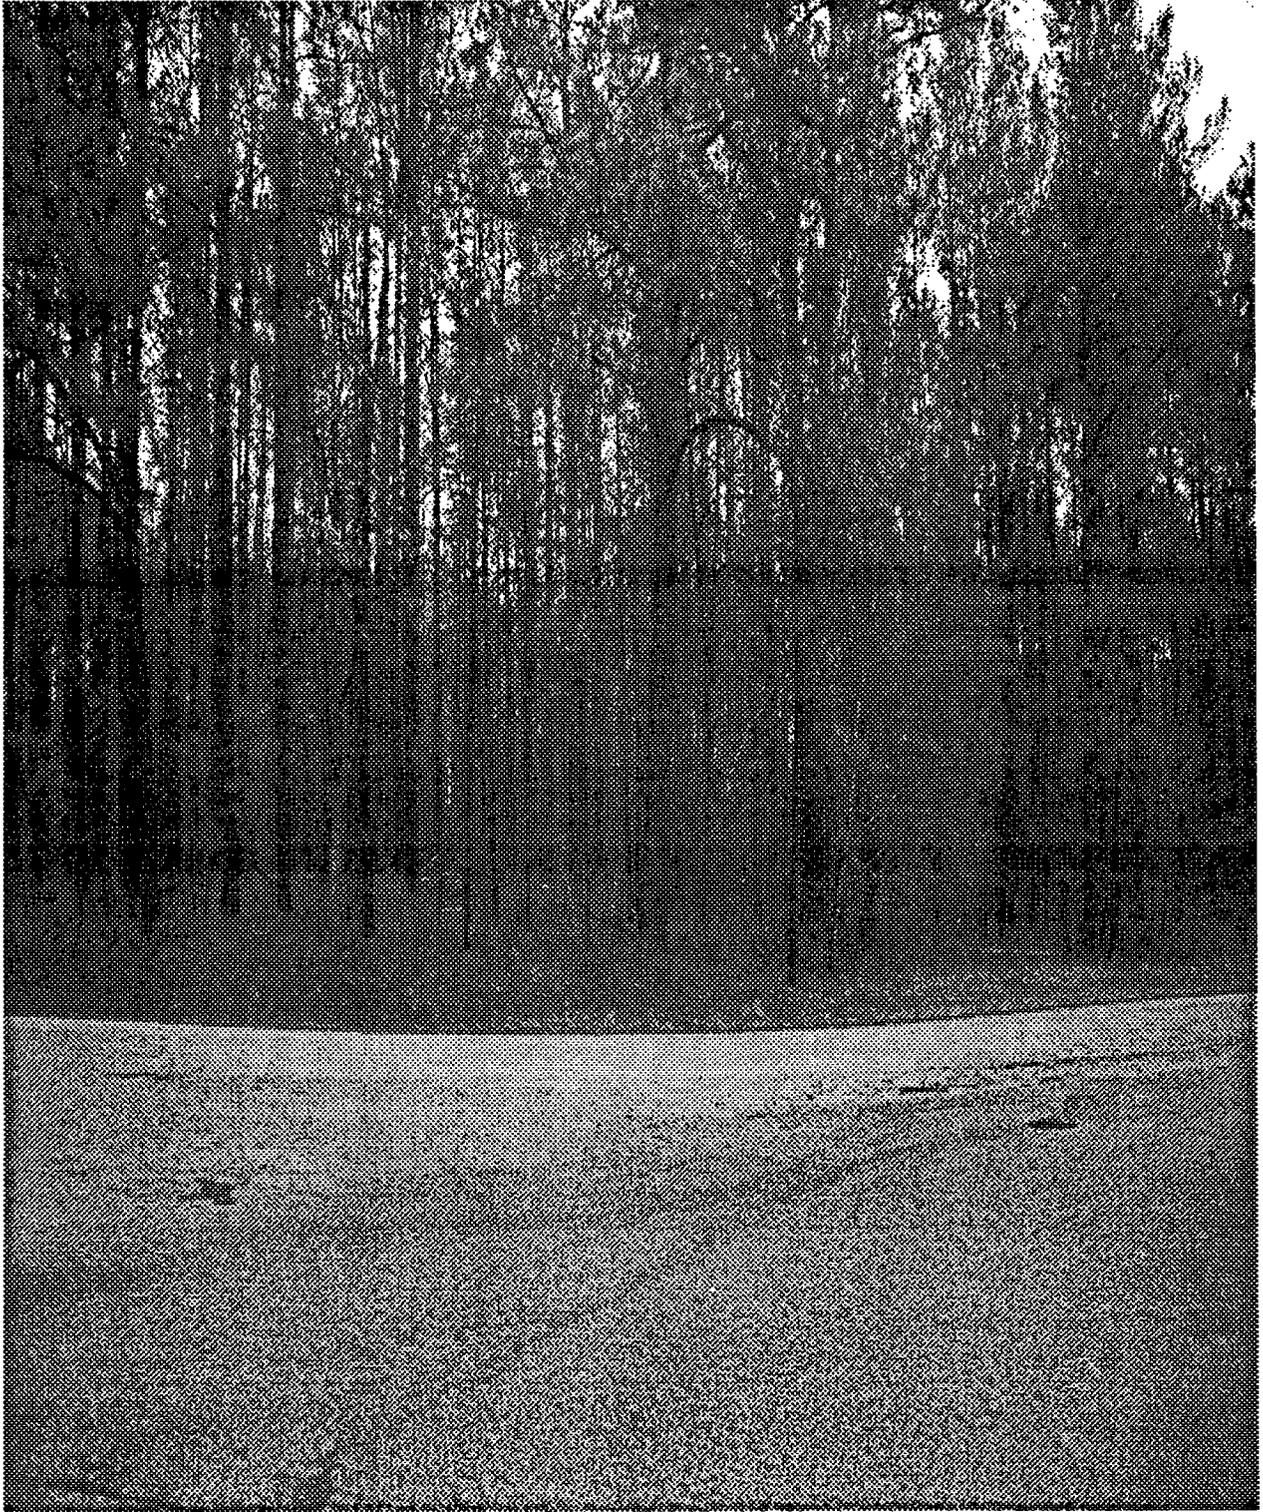
Photo F5 [3/5/98-2:30]

This groundscar is south of Bldg. 3134 and is contained within a heavily wooded area. The photo face North and show the densely wooded area. The actual groundscar was not located. No aquatic habitats were observed on this site.

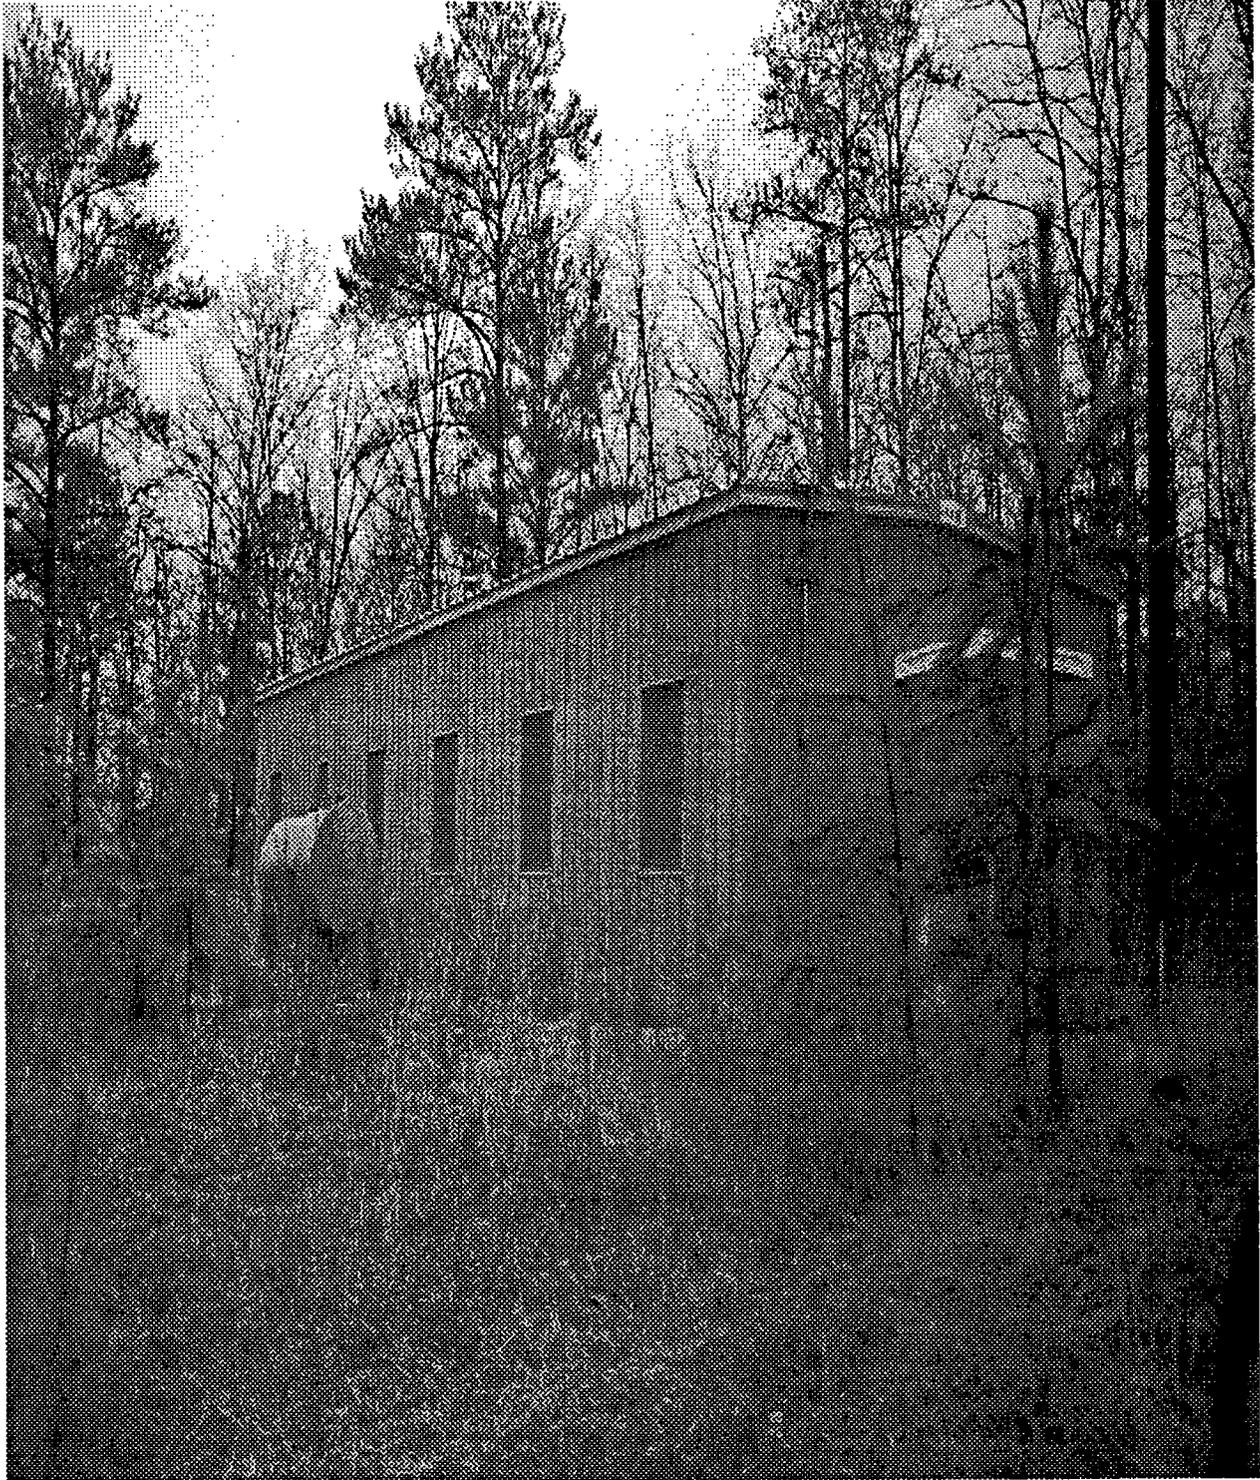
Photo F7 [3/5/98-2:43]

This site is located in a heavily wooded area. The photograph faces to the north and show the AST and bldg. PR6357-16. Tall stands of pine trees can be seen directly behind the building. Small pines and grassy areas surround the building and AST. Directly South of the site is Range 16 (see photo F6). No aquatic systems were observed in the general area.
