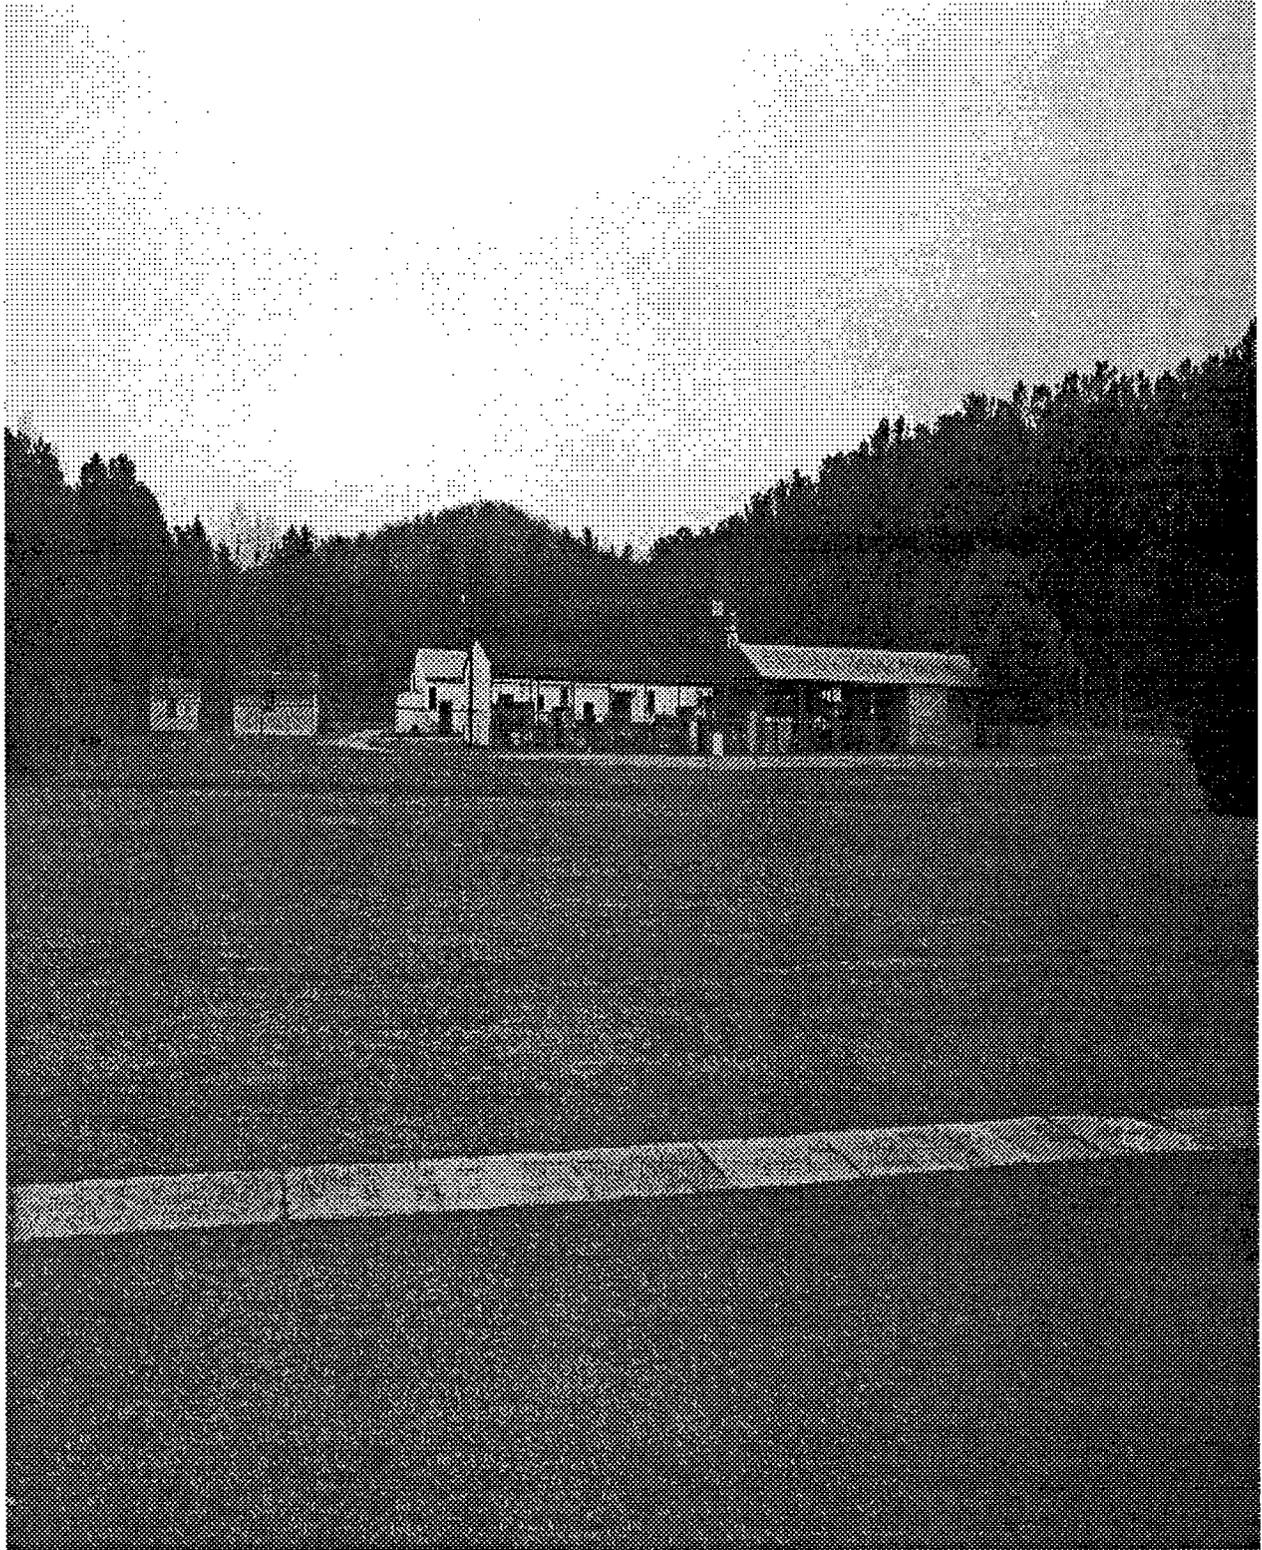
Photo F8 [3/5/98-2:53]

This photograph faces south and shows the site as an open grass field bounded by roads to the north and west, buildings to the south, and South Branch Cane Creek to the east. There is a ditch along the road to the north running parallel to the site, which drains into South Branch Cane Creek under Bridge 4314.

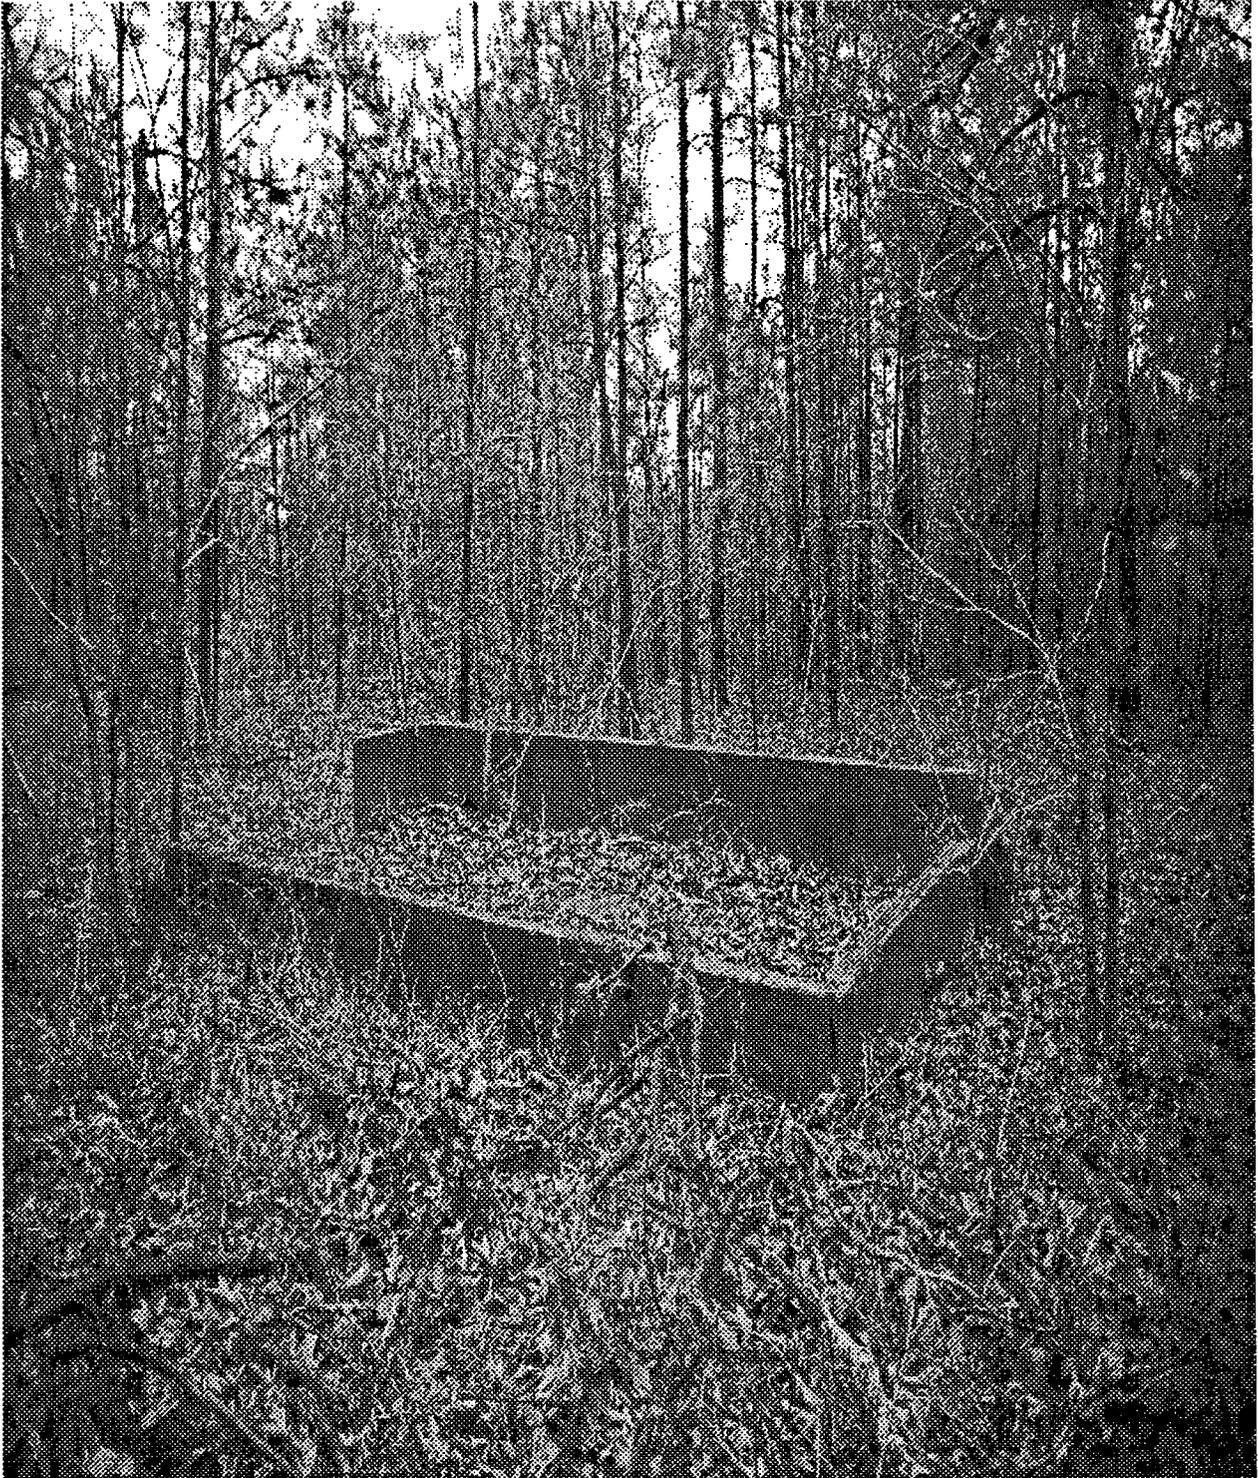
Photo F10 [3/5/98-3:15]

The groundscar is located in a wooded area at the south end of the confidence course. This photograph faces north and shows an old foundation in a wooded area. The entire area is covered with small pines (0-6 inches in diameter). No water or drainage ditches were present at the site. Wild Turkeys were spotted foraging in a wooded area directly across the road (west) from this site (see photo F9).

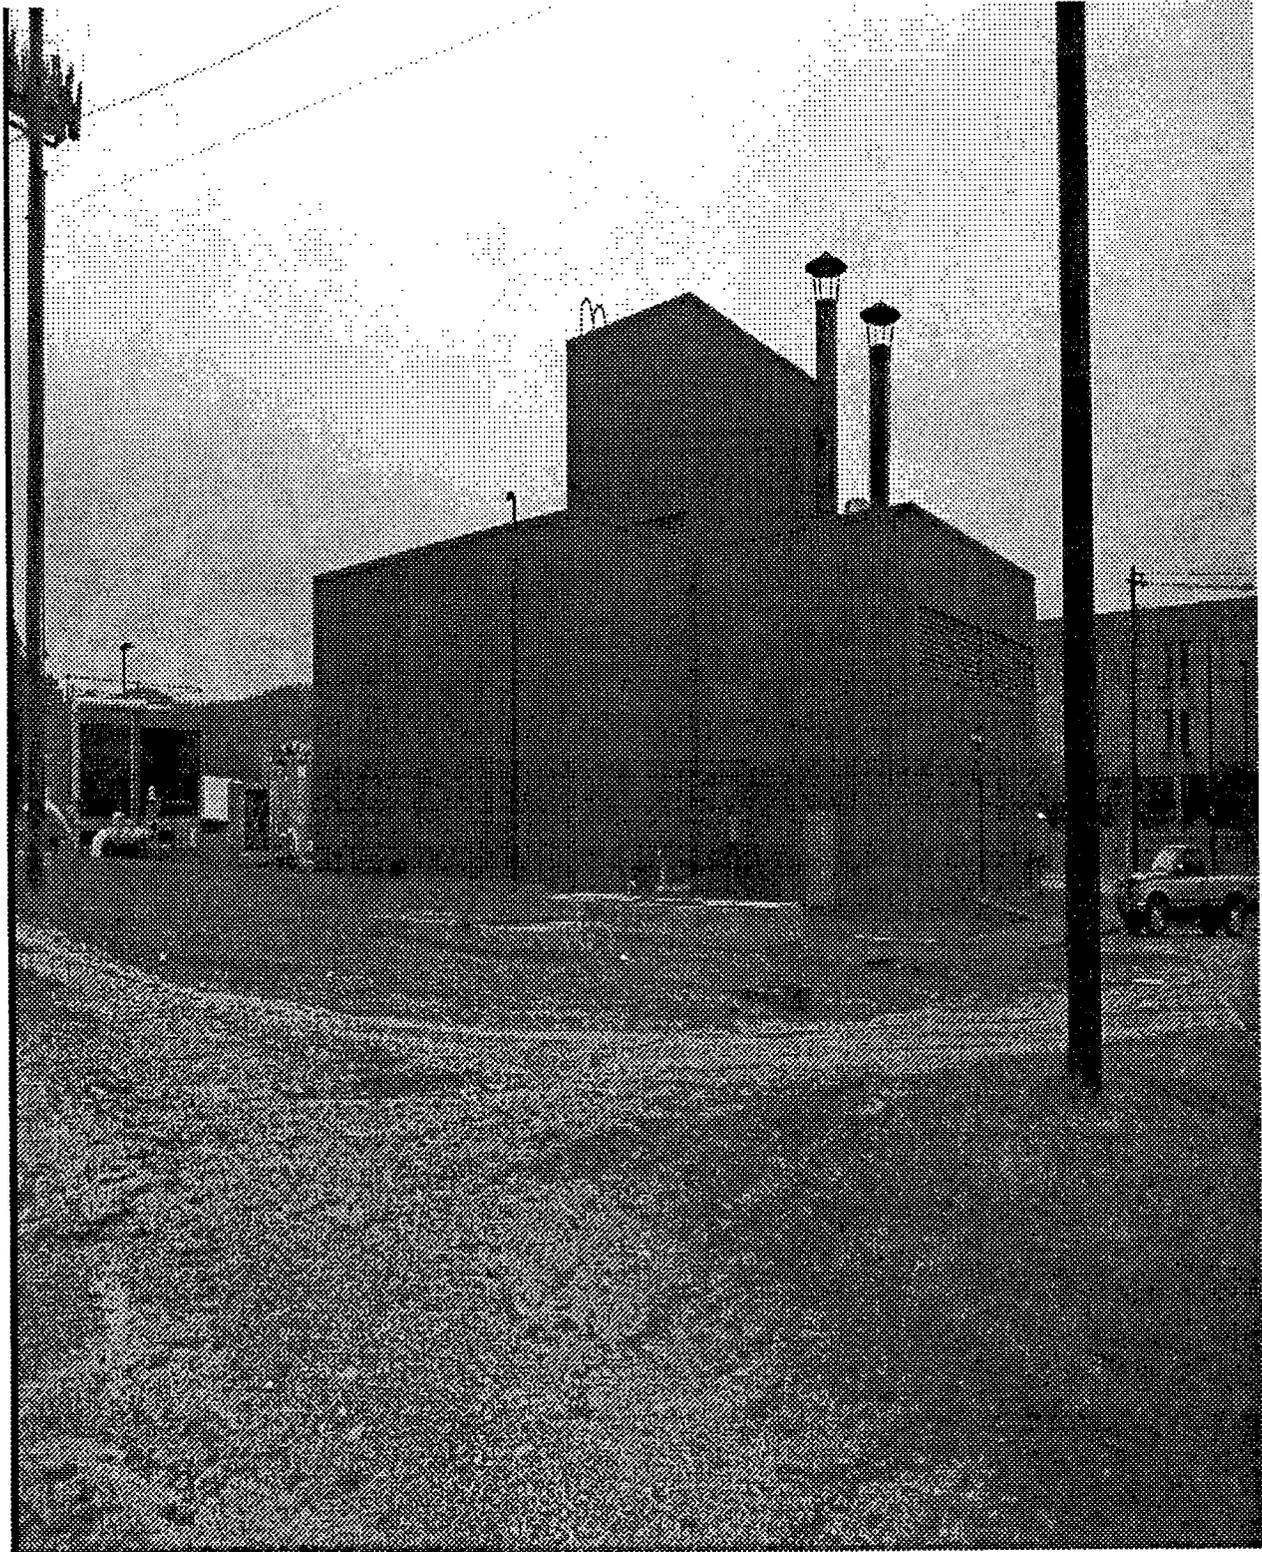
Photo F13 [3/5/98-3:32]

Two 50,000 gal. USTs for No. 4 heating oil, one 500-gal. Gasoline UST for a back-up generator are all associated with Boiler Plant No. 4. The photograph faces west and shows the main building of Boiler Plant No. 4. The site is a very open, developed area with sparse woods to the west of the building.

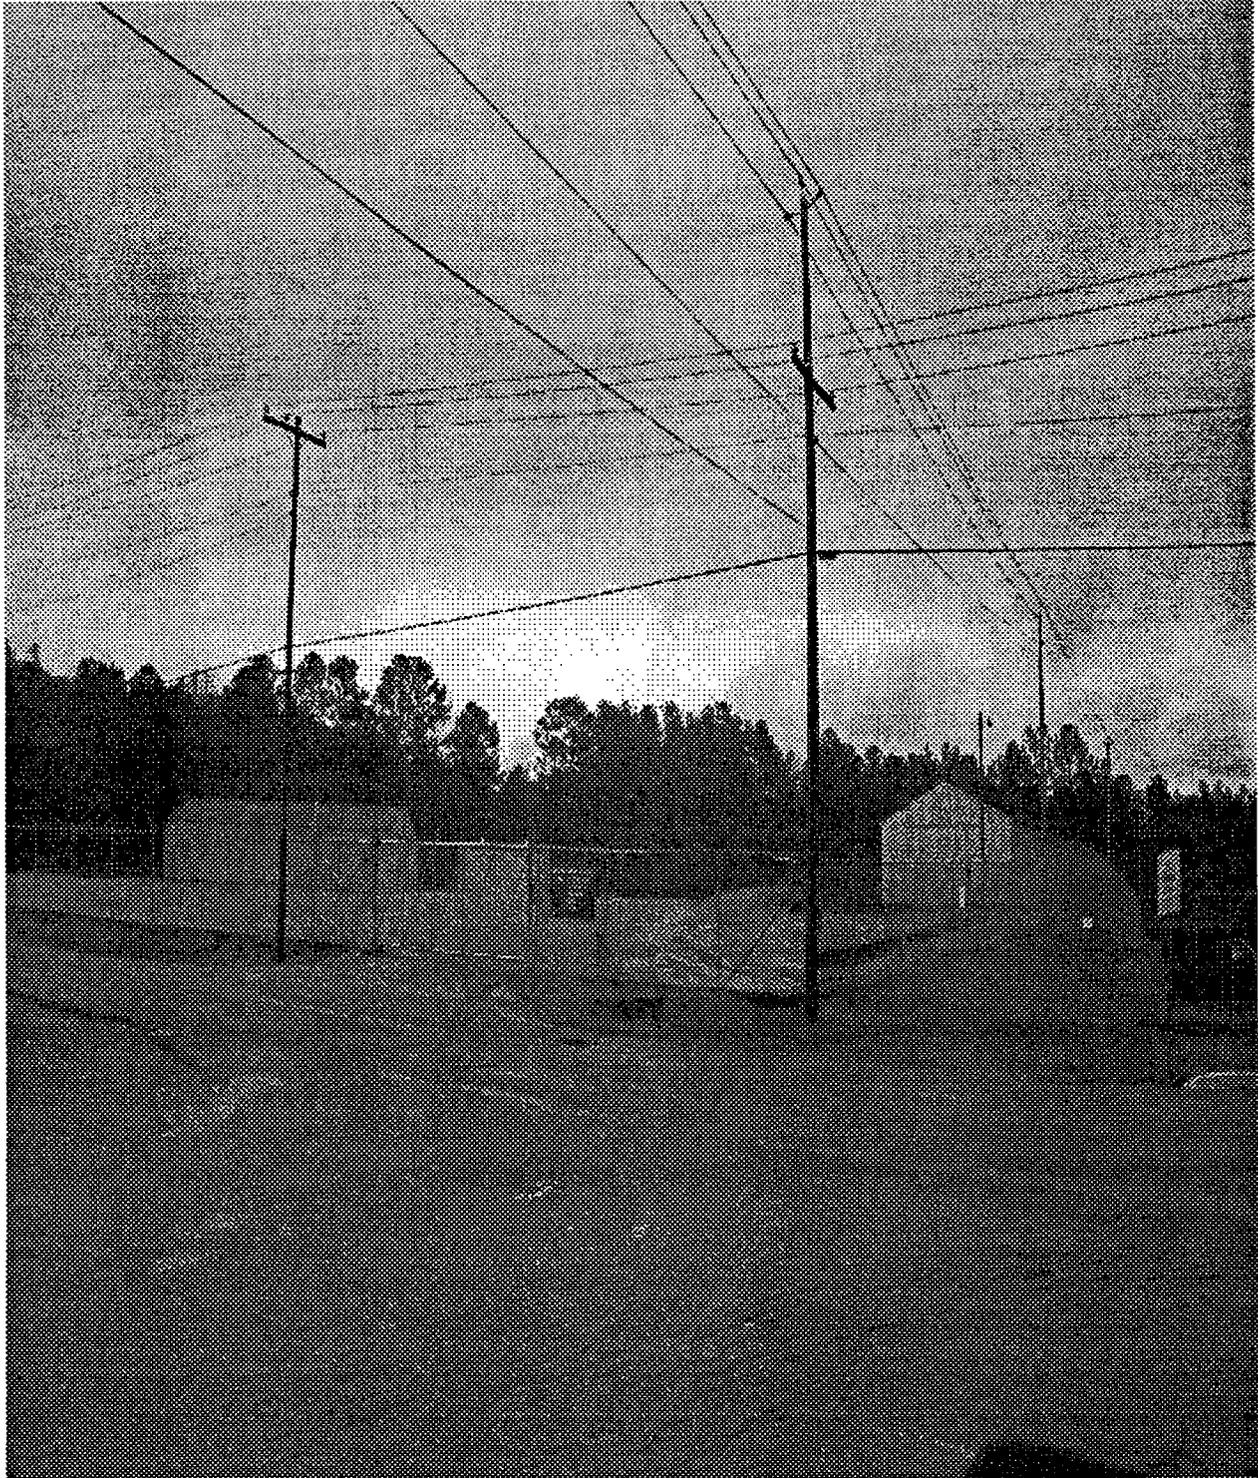
Photo F14 [3/5/98-3:40]

DRMO, Bldg. T-341-346, Site 85(4) Currently Recycling Metal Operations [CERFA Parcel Map 23,36] This site was a former RCRA Interim Status Storage Facility. The building currently stores old appliances, furniture, clothes, brass ammunition, old tires, scrap metal, surplus vehicles. The former RCRA site stored pesticides, solvents, batteries and POL. The photograph faces south and show the building complex and paved lot. There is a forested area directly behind the facility.

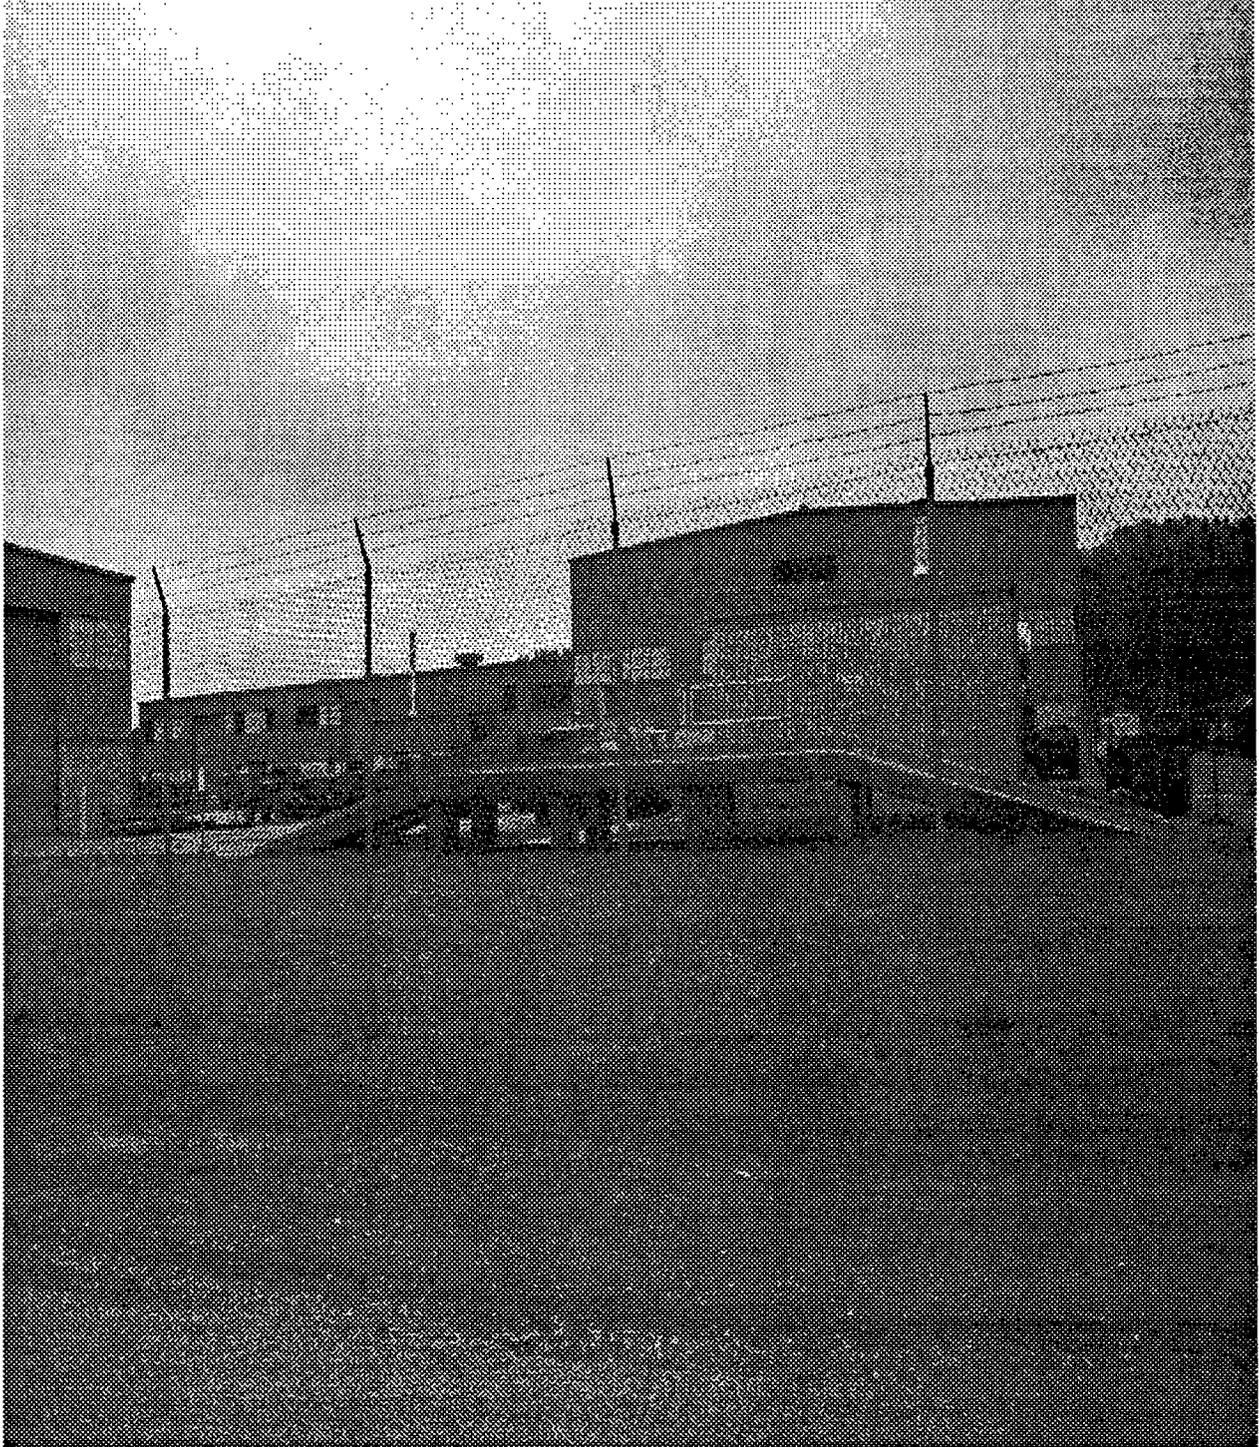
Photo F15 [3/5/98-3:44]

Consolidated Maintenance Facility, Bldg. 351, Wash Rack [Site 170(7)] , Former Fire Training Pit, located where Bldg. 350 is now [77(7)], and Bldg. 350 Site 7(7) [CERFA Parcel Map 22,35-36] This photograph faces north and shows building 351 (Consolidated Maintenance Facility). Site 77(7) and 7(7) are behind building 351. The site is a heavily developed industrial area. The site is drained by three storm water outfalls emptying under the road and into the woods behind (south west) the current Wildlife Management Office (Site 149(7)). This wooded area is the beginning of a tributary to Cave Creek.

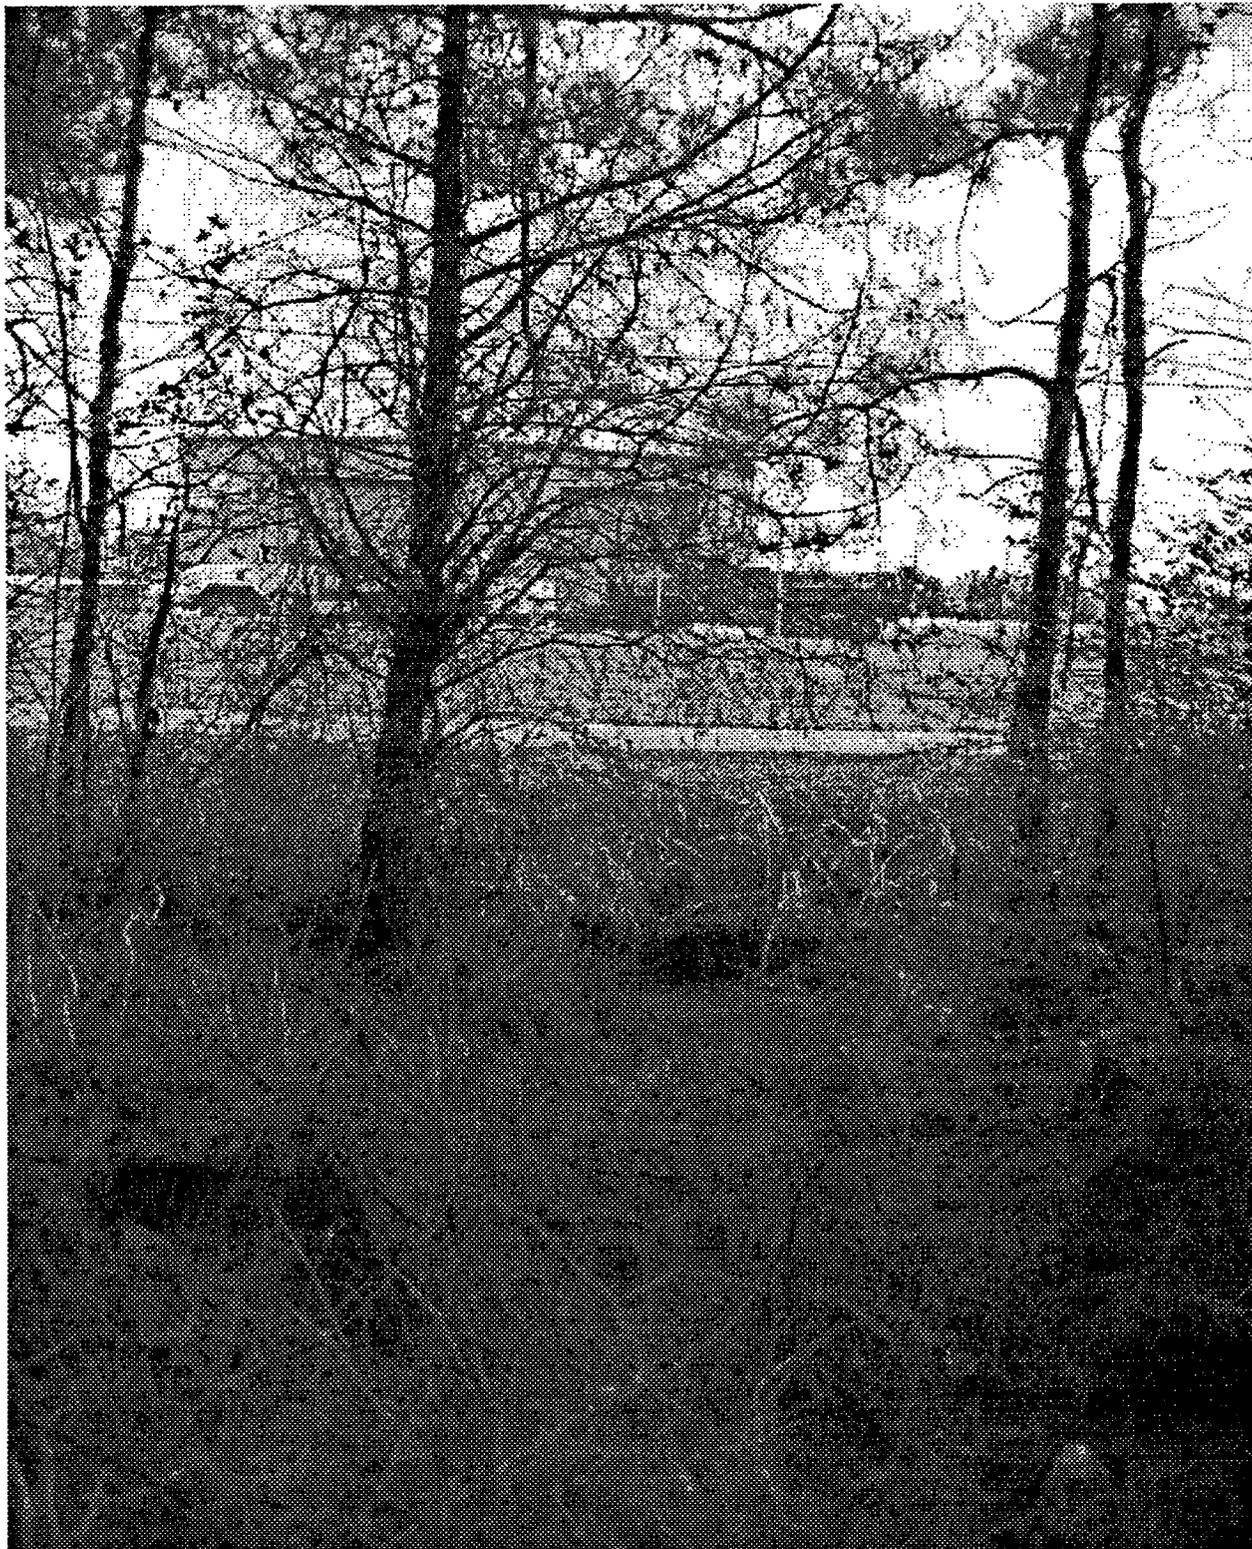
Photo F16 [3/5/98-4:00]

[CERFA Parcel Map 21,36] This photograph faces south and shows a sewer pipe in the foreground emptying into a stream across the street from bldg. 349, Site 170(7) complex. This stream is the beginning of a tributary to Cave Creek. Three outlets draining parcels 170, 77, and 7 converge at this point. The area is heavily wooded with dense undergrowth. This area is behind (south west) the current Wildlife Management Office (Site 149(7)).

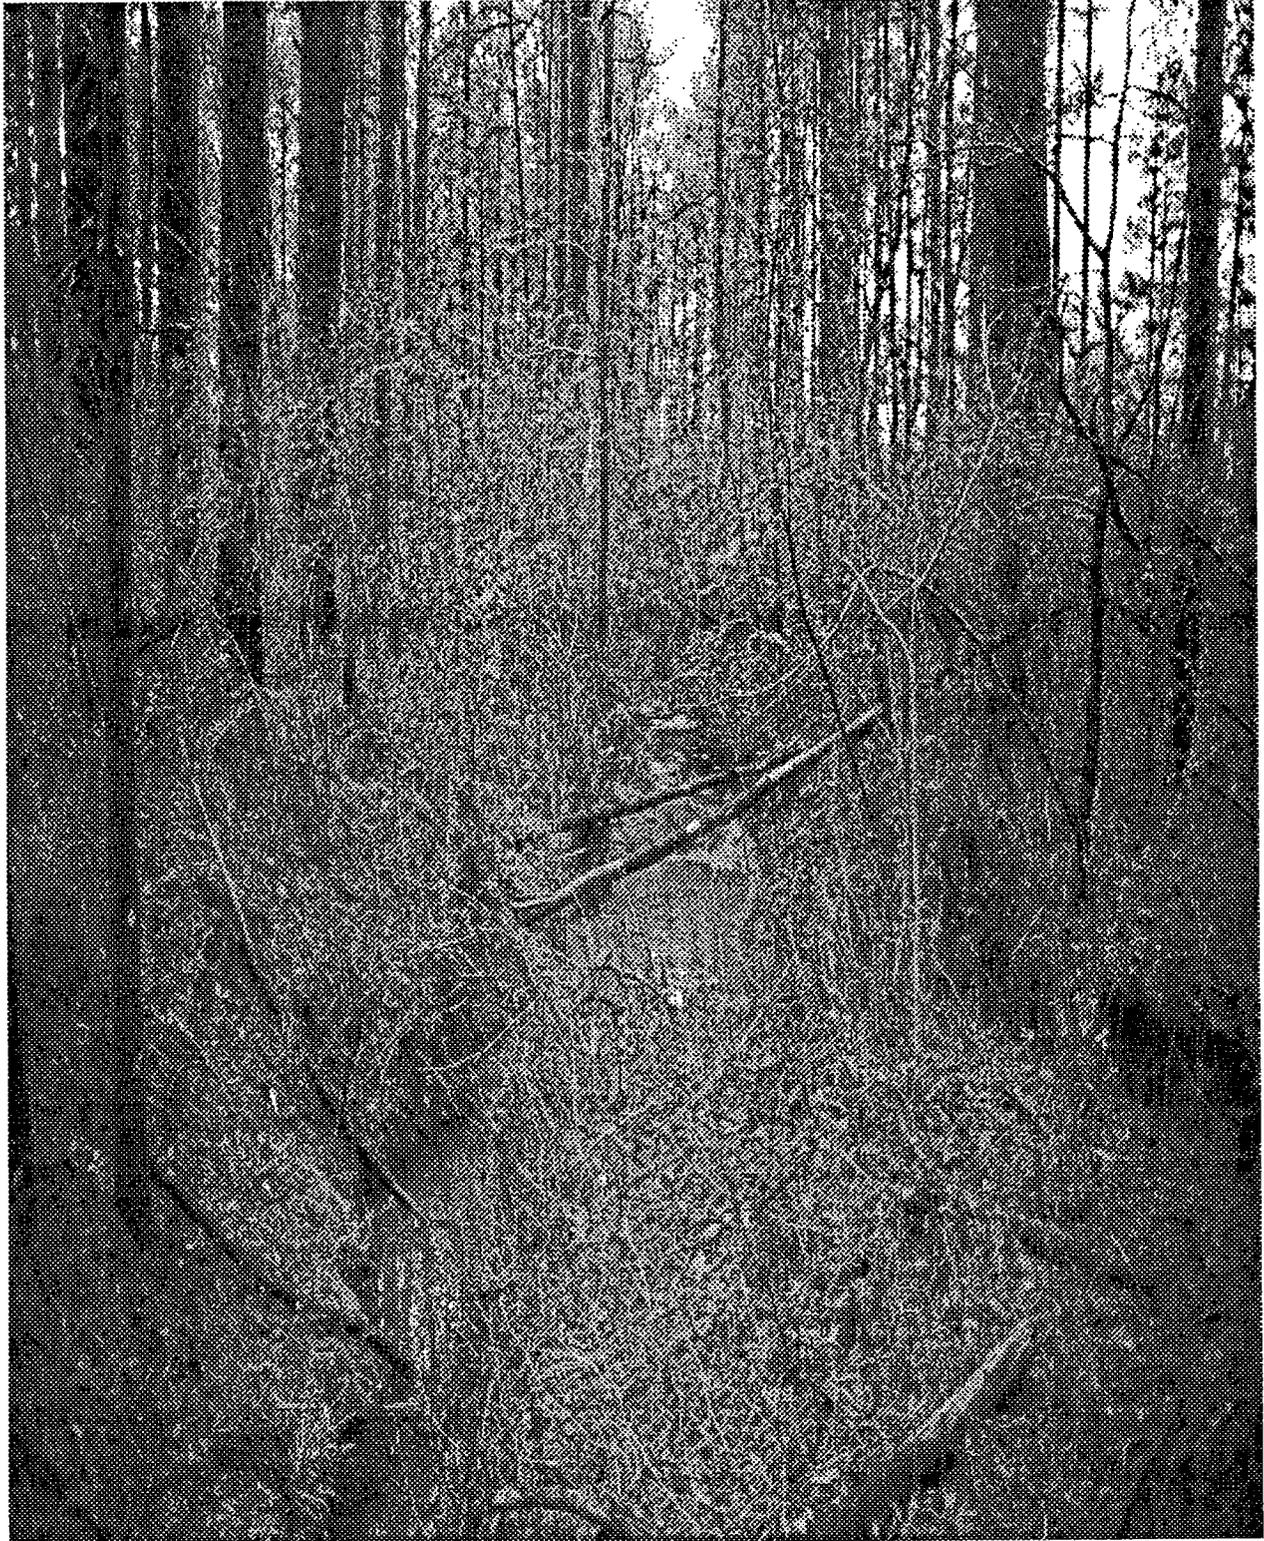
Photo F17 [3/5/98-4:05]

[CERFA Parcel Map 21,36] Confluence of streams in wooded area behind the current Wildlife Management Office (Site 149(7)). This photograph faces north and portrays the same tributary to Cave Creek mentioned in the previous photo description (F16) only further north downstream. The area is heavily wooded with dense undergrowth.

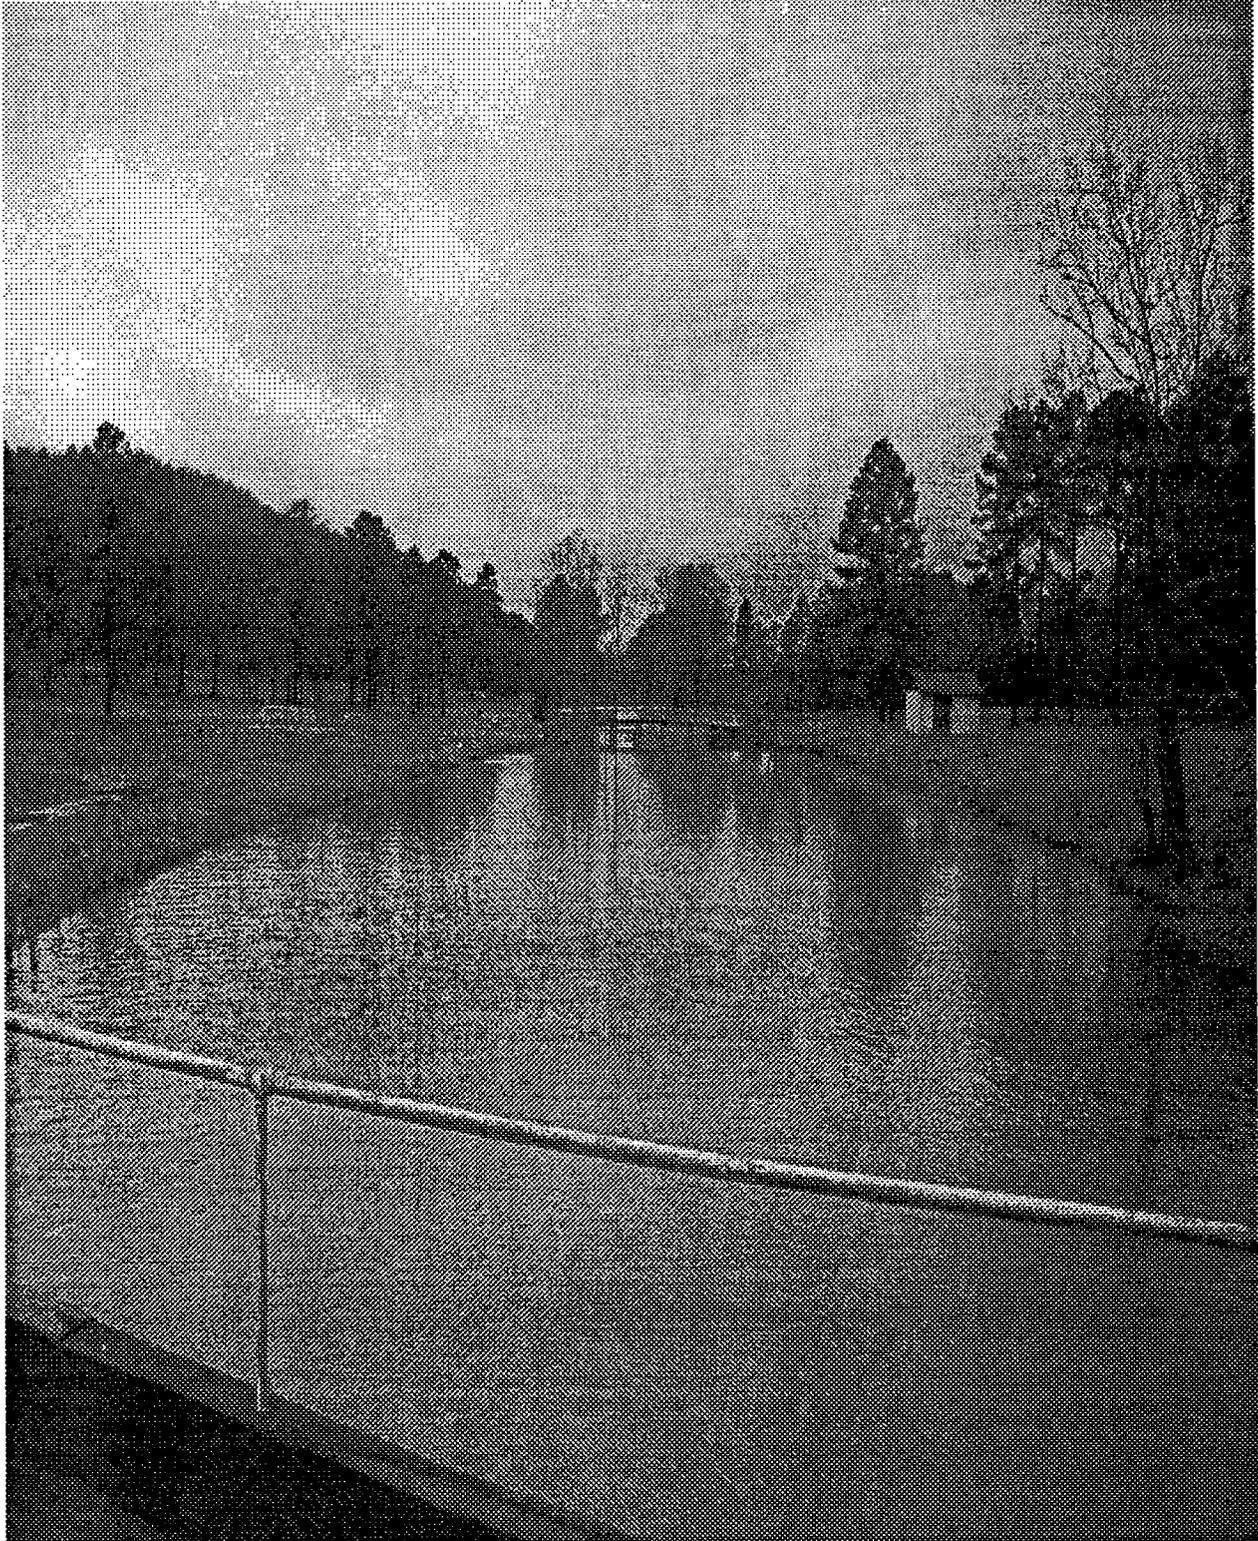
Photo F19 [3/5/98-4:30]

This photograph faces northwest and shows Cain Creek as it runs through the golf course. The topography is typical of golf courses.

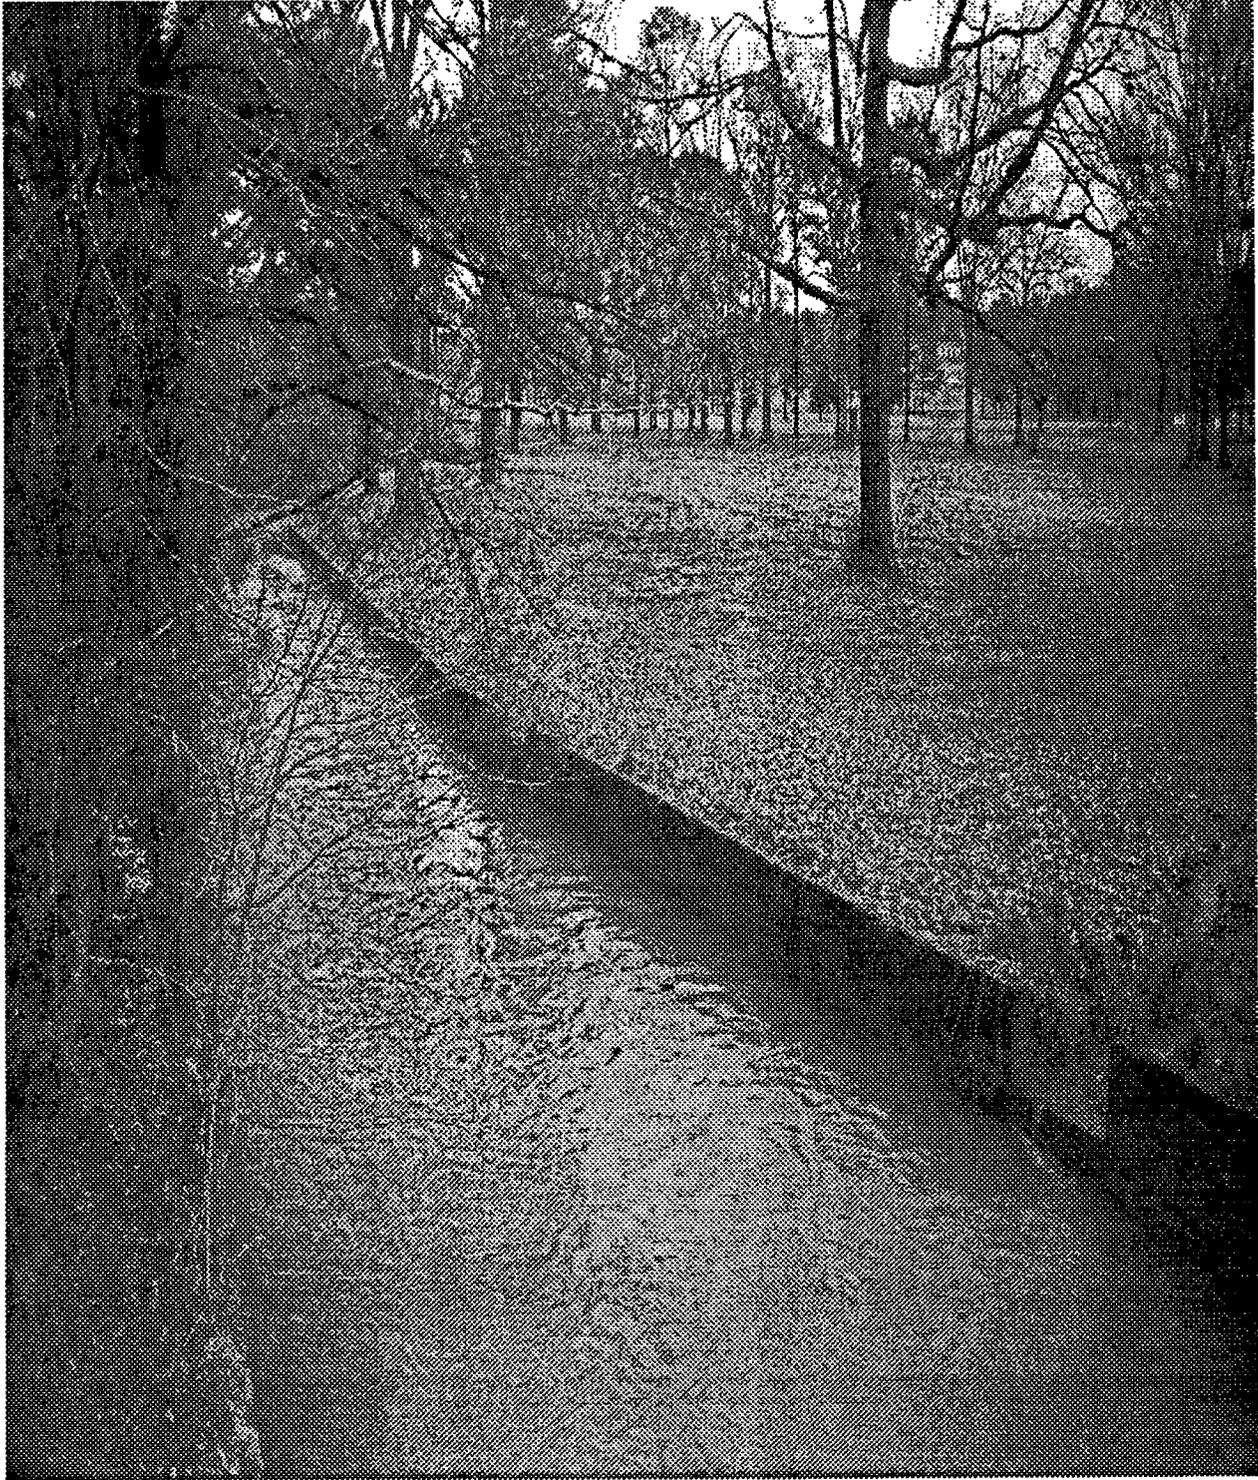
Photo F20 [3/5/98-4:30]

Cain Creek at golf course from foot bridge 4343 in the opposite direction (SE) [CERFA Parcel Map 12,37]. This photograph face to the southeast and shows the opposite view of F19 Cane Creek. The creek is highly channelized on this side of the foot bridge. The creek bank in concrete lined. A wooded area is to the left of the photo which contains stands of coniferous and deciduous trees. The right side of the photo shows the continuation of the golf course. A drainage ditch from the golf course area can be seen in the bottom right corner of the photo.

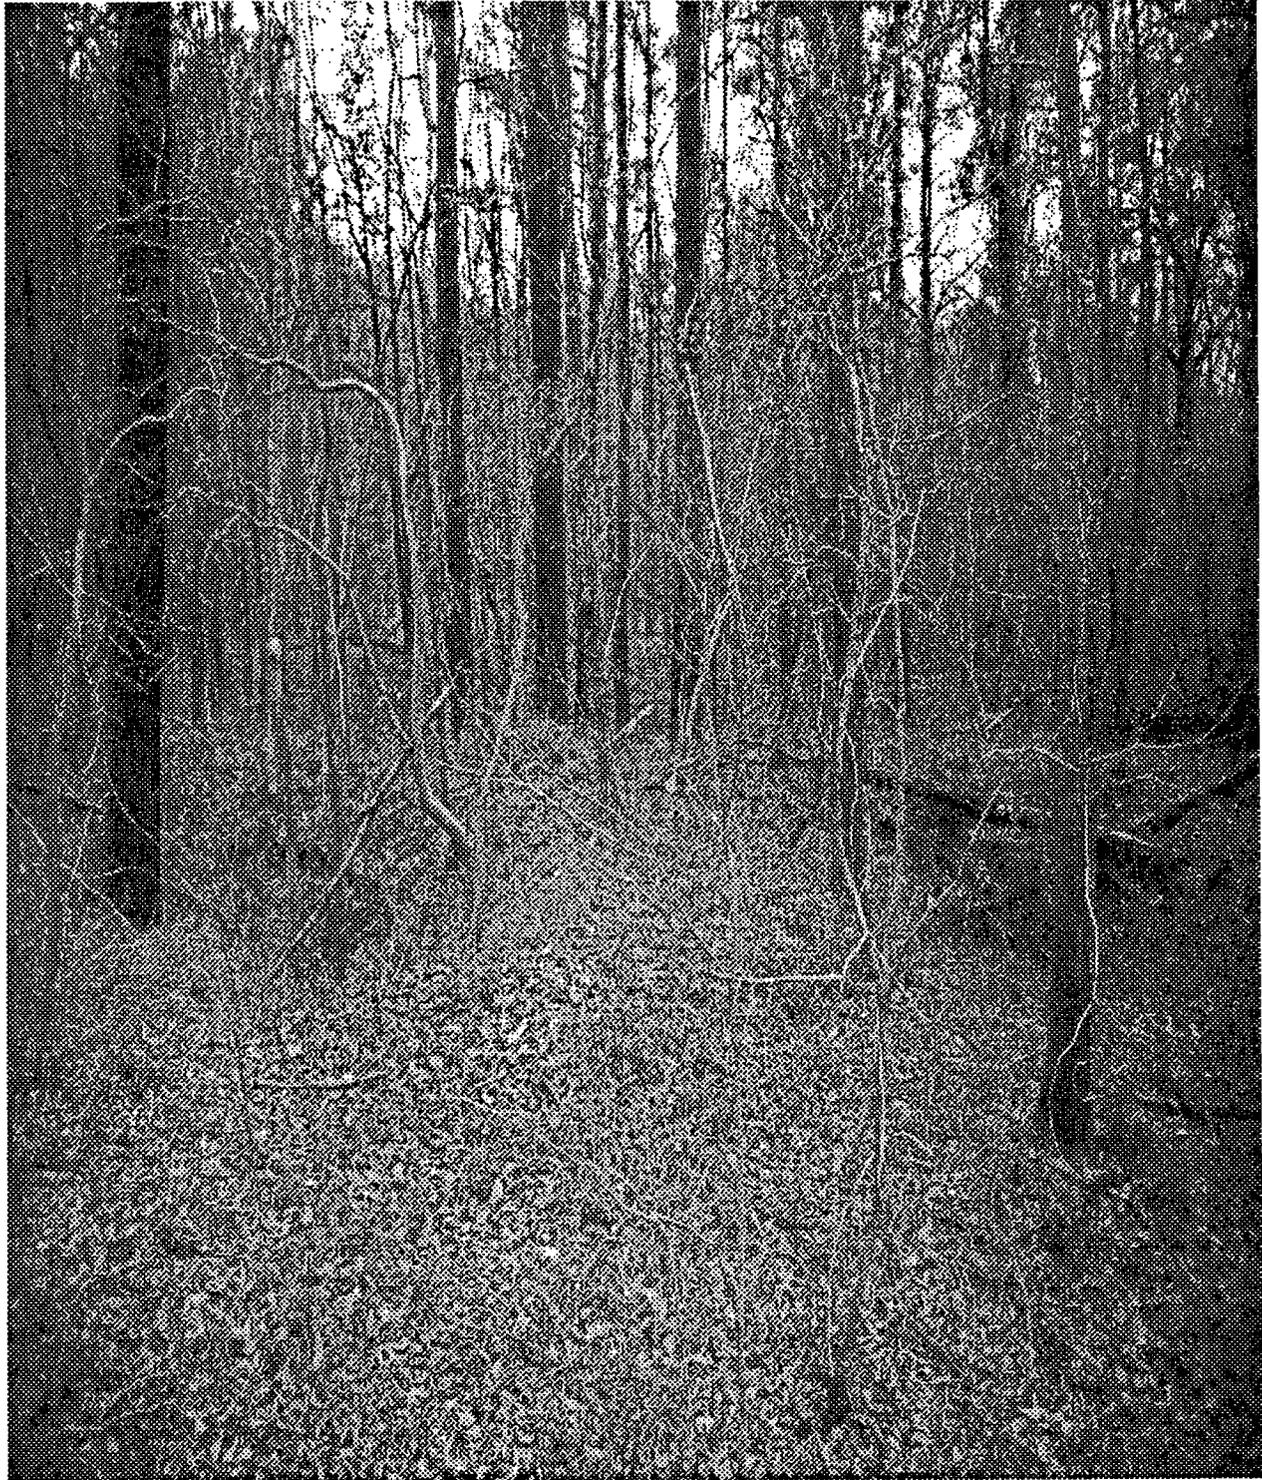
Photo F21 [3/6/98-10:23]

The site is just south of Lake Reilly swamp and wetland area. Noted open pits atop hill overlooking swamp/wetland. The photograph faces west and shows open pit area to the left and the right of photo. This area is area is sparsely wooded with thick undergrowth. Farther east of the open pit area there was a drainage ditch leading north to the wetland area (ditch was dry).

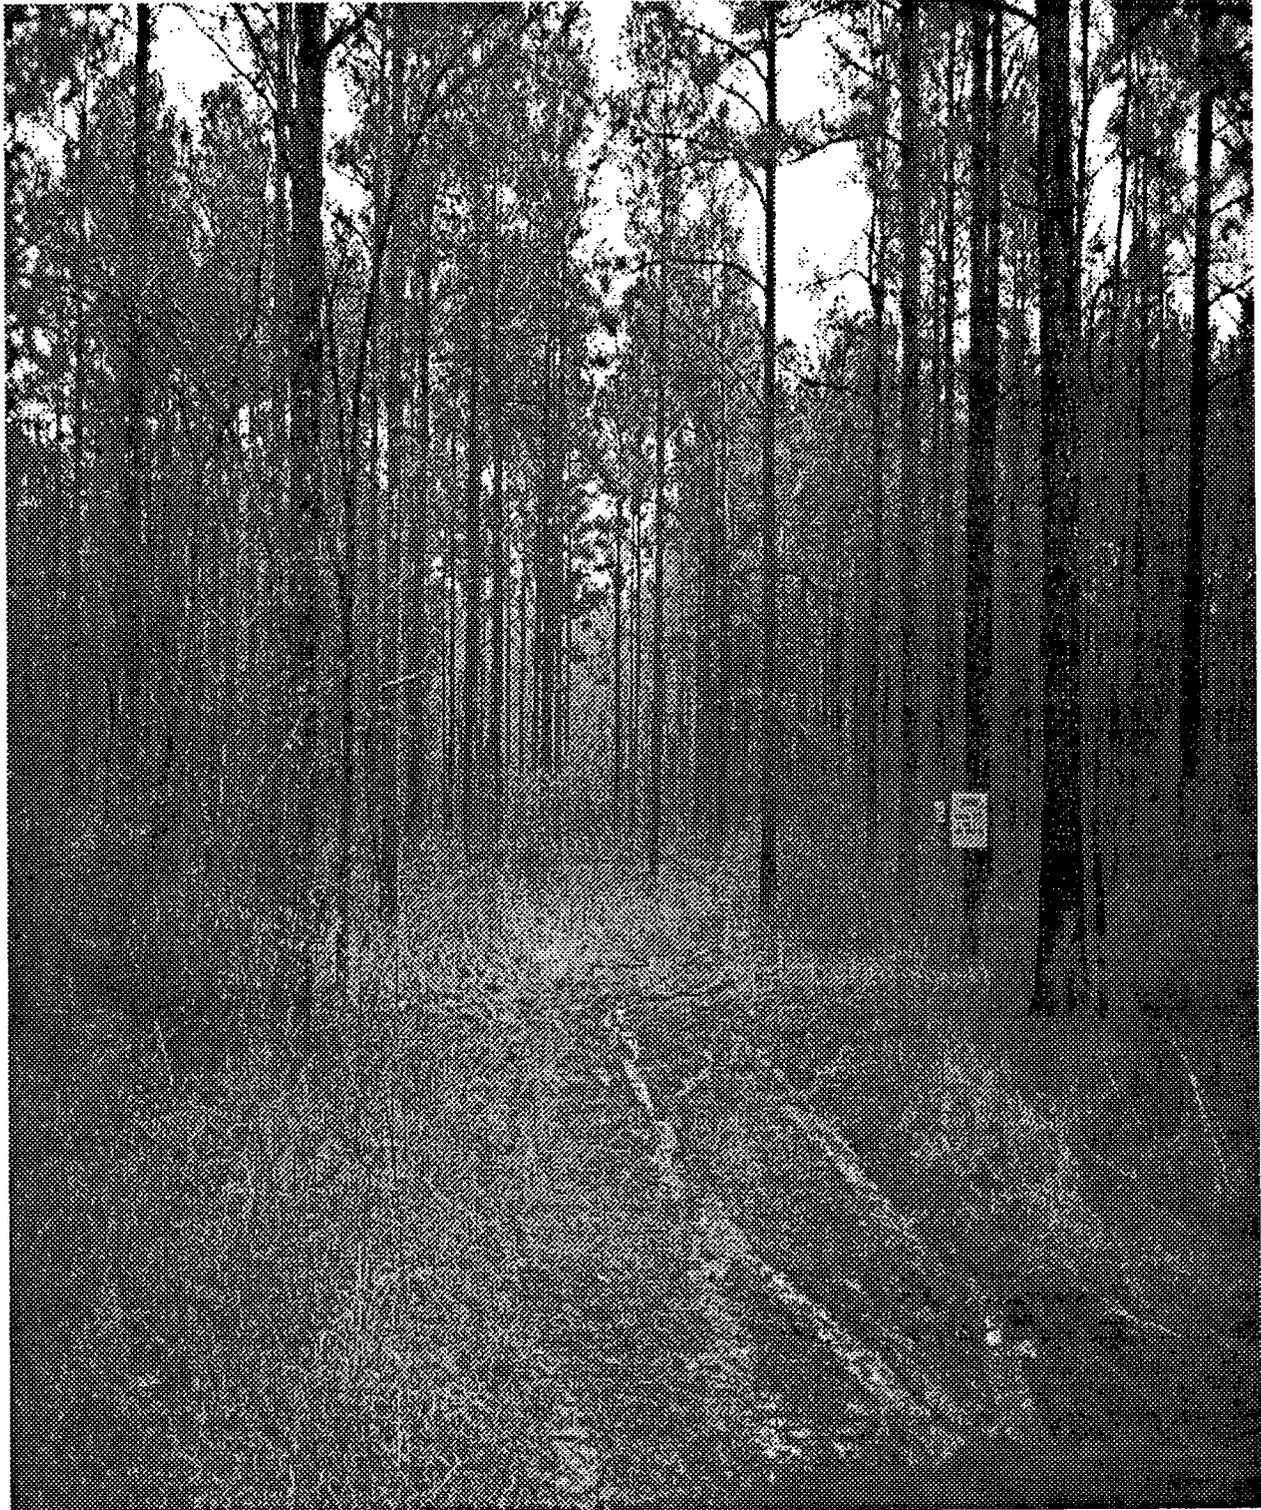
Photo F22 [3/6/98-11:39]

Pelham Range (Range K, Former Agent Training Area), Site 203(7) [CERFA Parcel Map 12,39]  
The site is located in the northwest corner of Pelham Range. The area is moderately forested (tall pines) with thick understory; dirt road access only. Area is delineated by small signs posted to trees. The photo faces southwest. This site was not explored due to caution signs posted on trees warning against going into the area.
