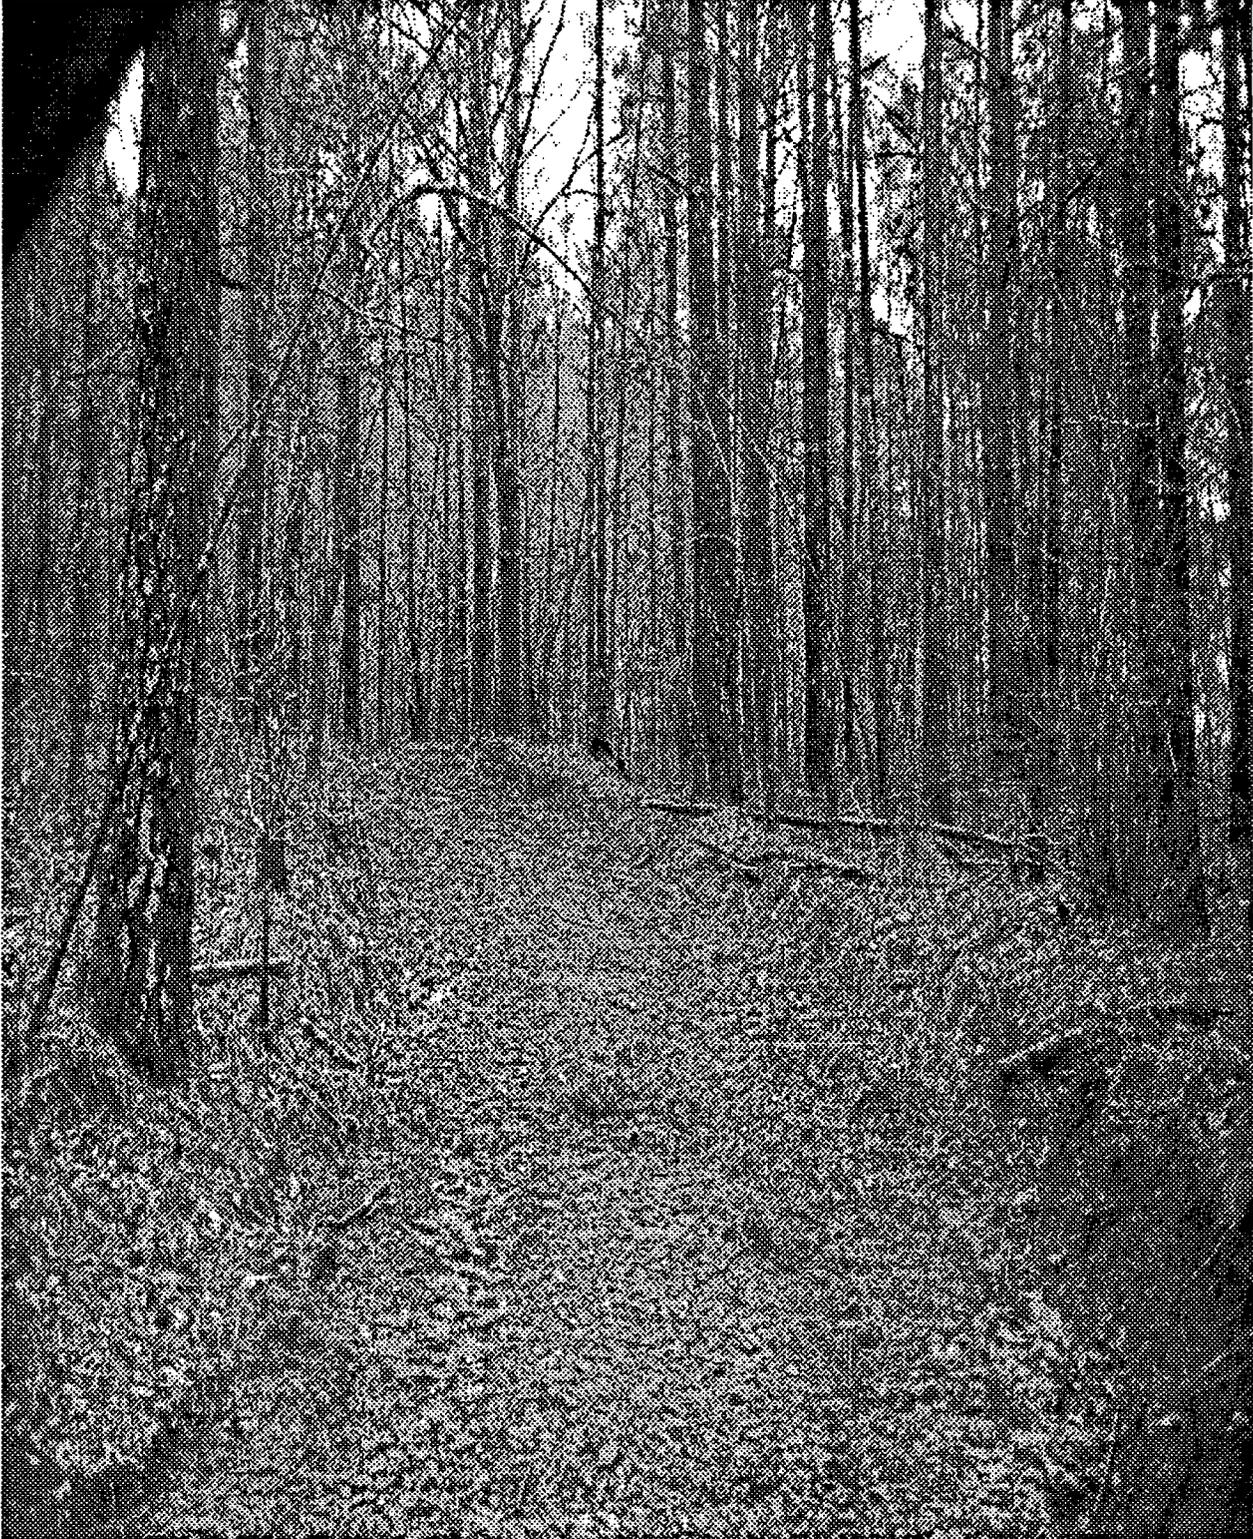
Photo F23 [3/6/98-12:02]

Thickly wooded area with sparse/clear understory. Drainage ditches exist adjacent to either side of the dirt access road. The photo faces to the south and shows the access road into the area.
