EASTERN BYPASS
ENGINEERING EVALUATION/
COST ANALYSIS

FORT McCLELLAN
FORT McCLELLAN, ALABAMA

PARADE GROUND GEOPHYSICAL INVESTIGATION AND REMOVAL

***Parade Ground Geophysical Investigation and Removal
Fort McClellan, Alabama
11 May 1999***

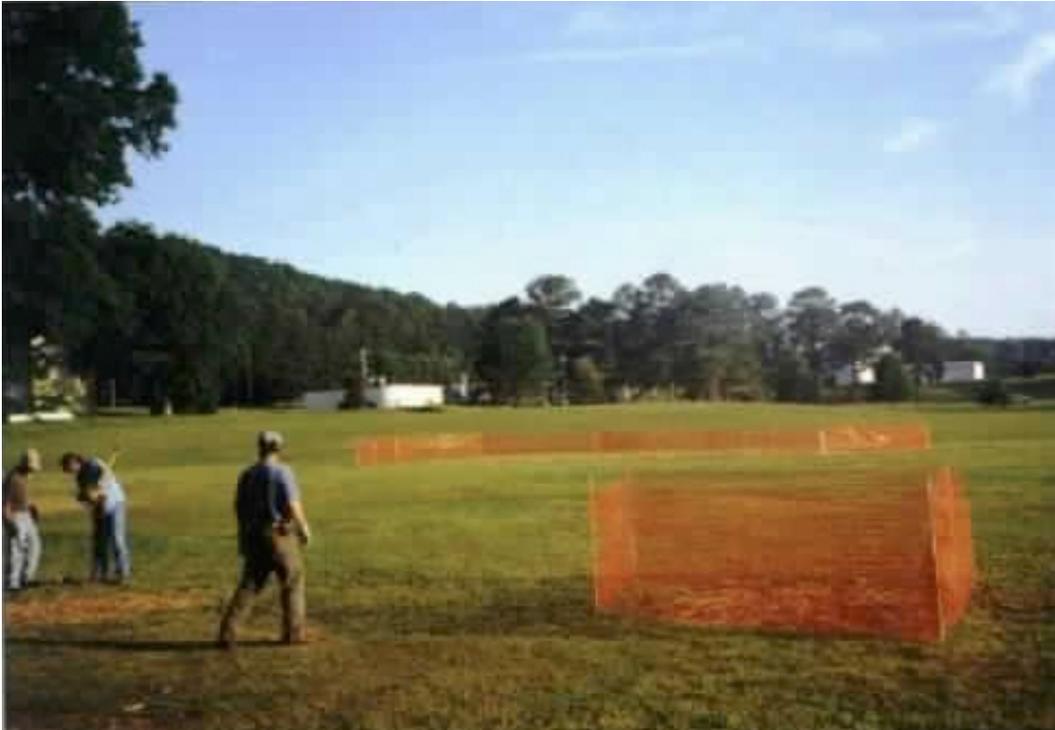
100 feet of the northeast corner of the parking lot north of 23rd Street, due west of the main reviewing stands, as depicted in Figure 2, Attachment A. An orange fence ran the perimeter of each of the four areas. Field Photograph 1, Attachment B shows two of the areas still marked with fencing.

1. One large and one smaller fenced area, prior to fence removal and investigation.

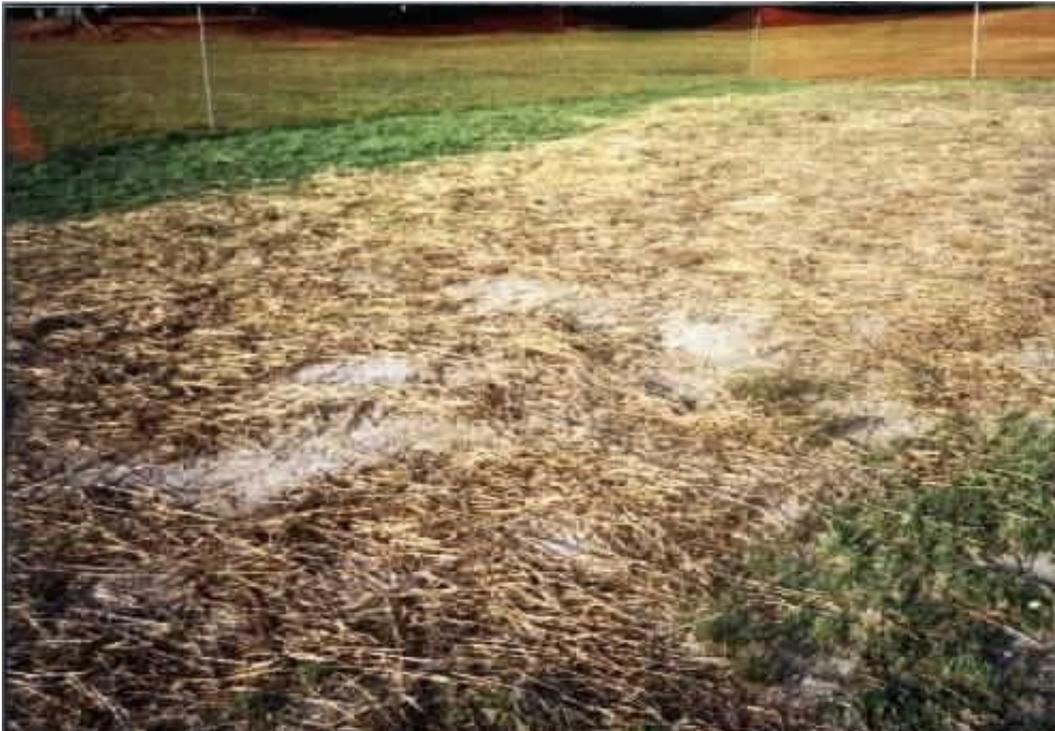
2. Straw covered, grass seeded fill dirt inside large fenced area.

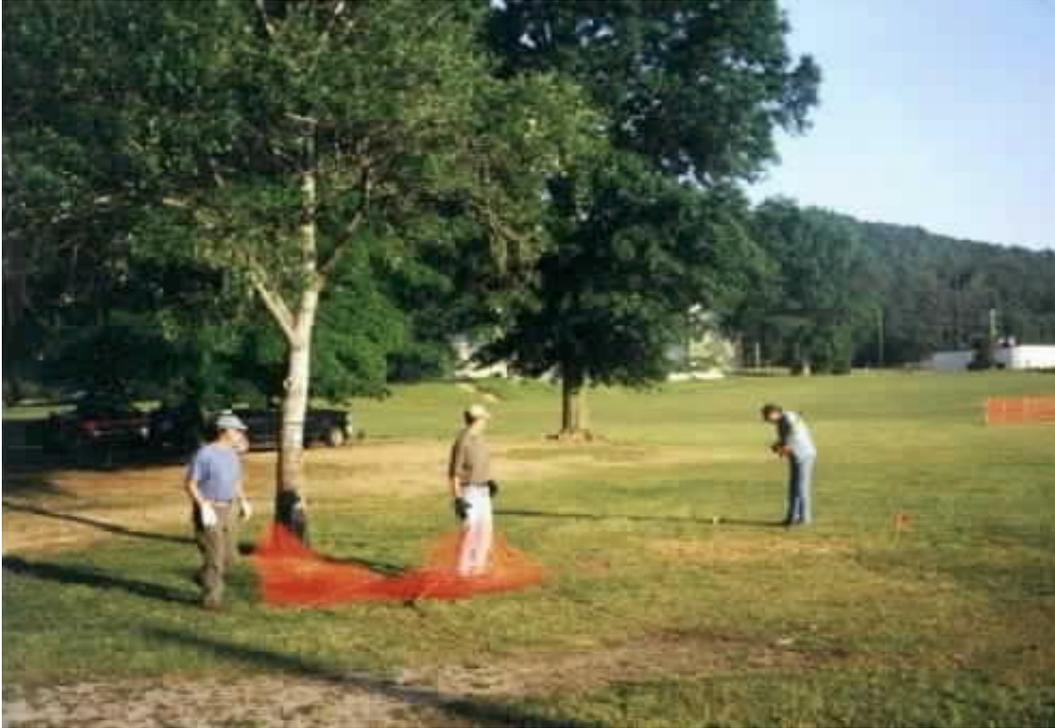
3. Fence removed from smaller area. Initial visual inspection conducted.

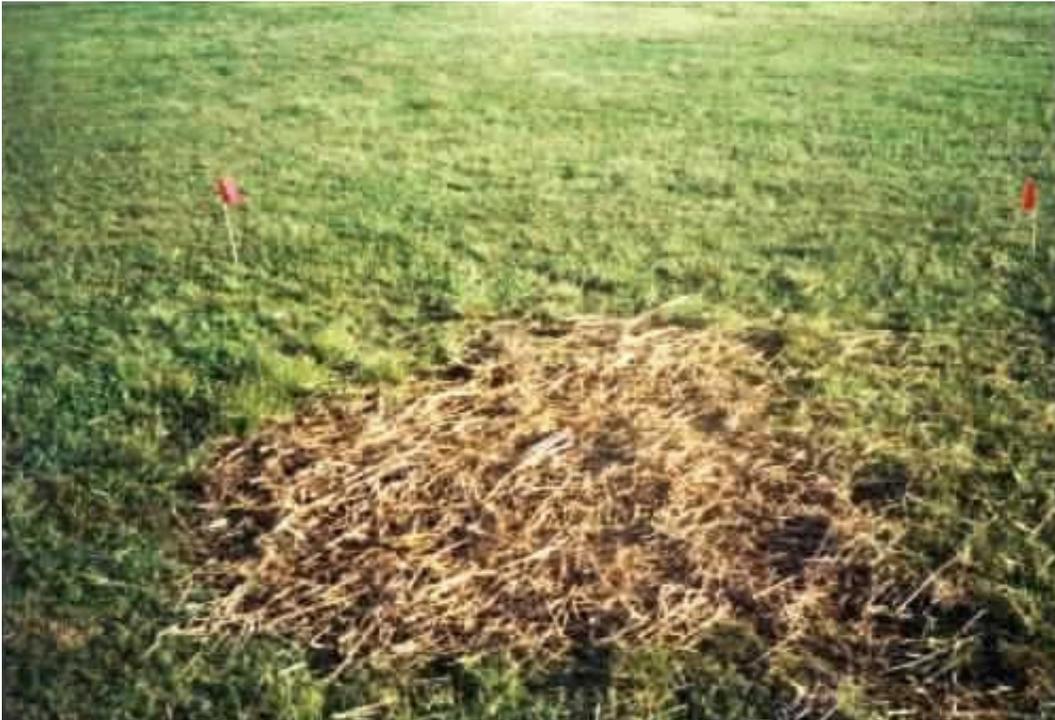
4. Seeded fill dirt inside smaller area. Flags mark former fence post locations.

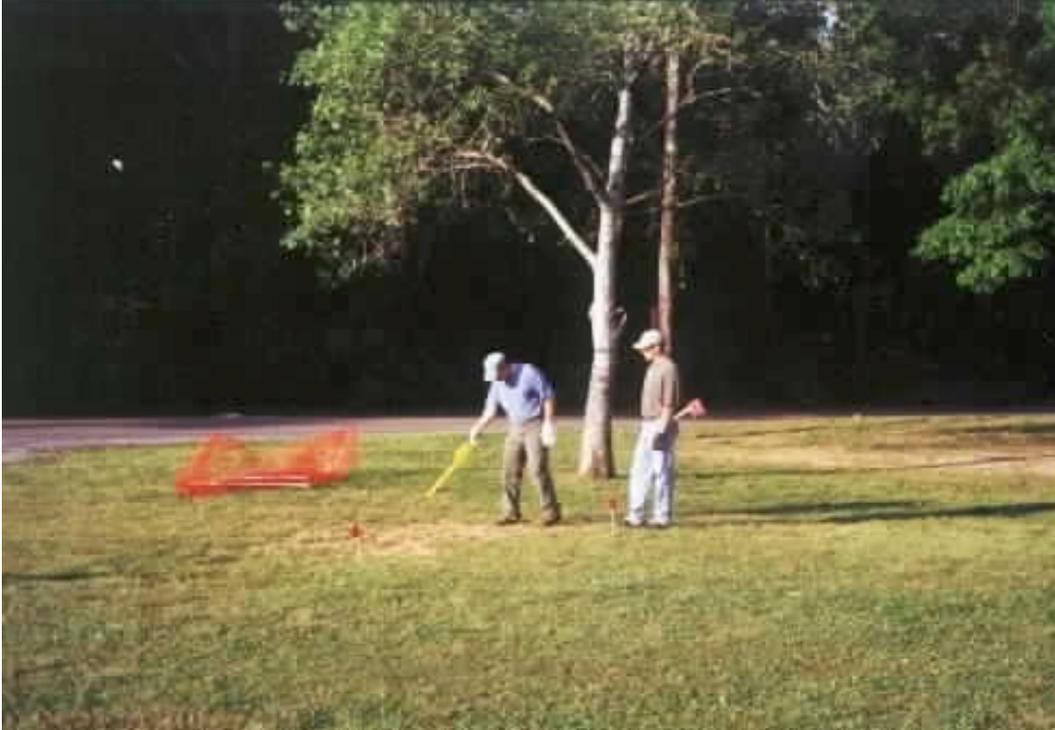
5. USA Environmental, Inc. conducts magnetometer investigation of small area.

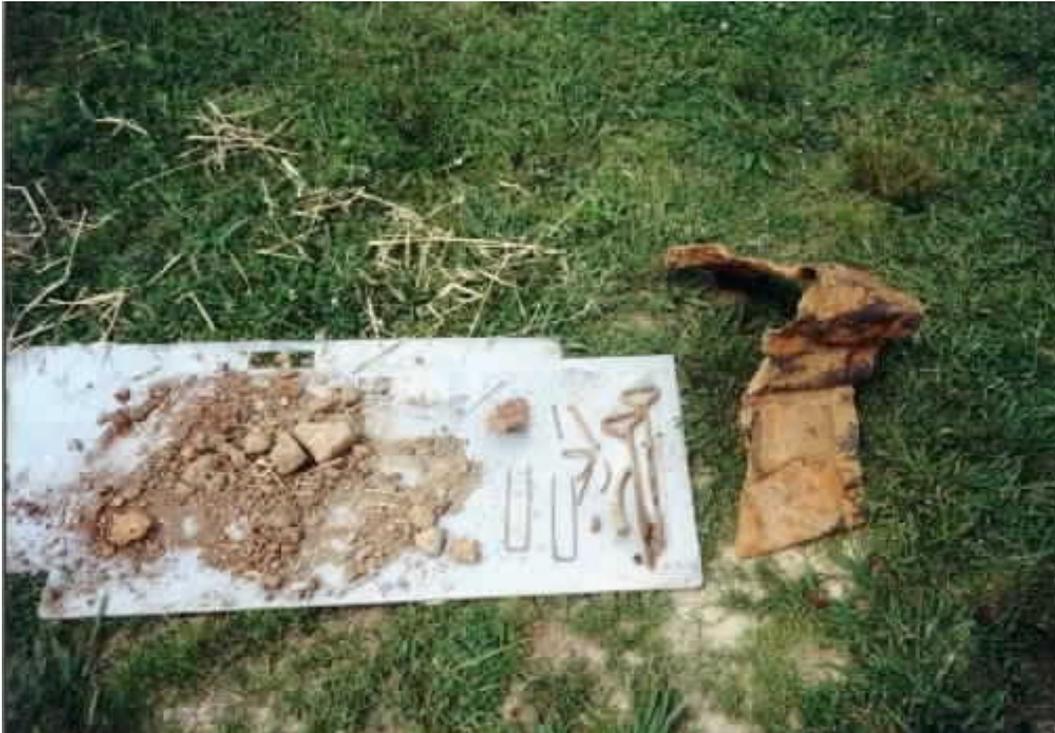
No OE items were discovered during the removal effort. Removed items included nails, stakes, rocks and metal pieces, as shown in Field Photograph 6 in Attachment B. All removed items were collected and transported to a trash bin for disposal. Hank Hubbard conducted a quality control check of each area after the sampling effort was complete and no additional items were discovered.

6. Items removed from large area include pins, nails, stakes, rocks and metal pieces.
