**ASBESTOS CONTAINING BUILDING MATERIALS
SURVEY REPORT**

**ASBESTOS CONTAINING BUILDING MATERIALS SURVEY
HEALTH CLINIC
BUILDING 295**

FORT McCLELLAN, ALABAMA

U.S. ARMY CONTRACT NO. DABT02-96-D-0005
DELIVERY ORDER 0005

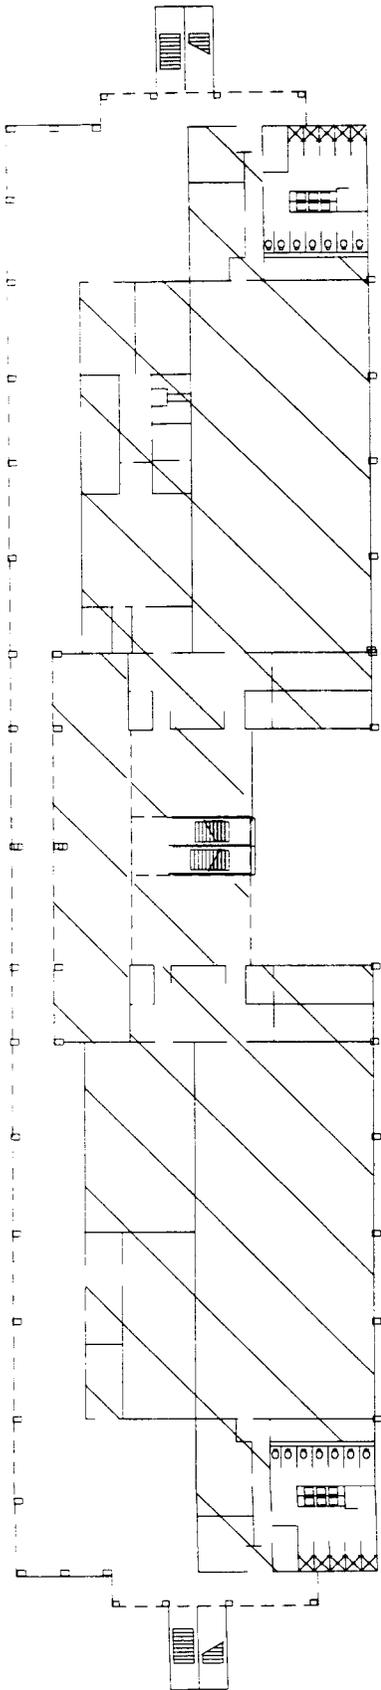
BUILDING 501

12 X 12 Tile & Mastic

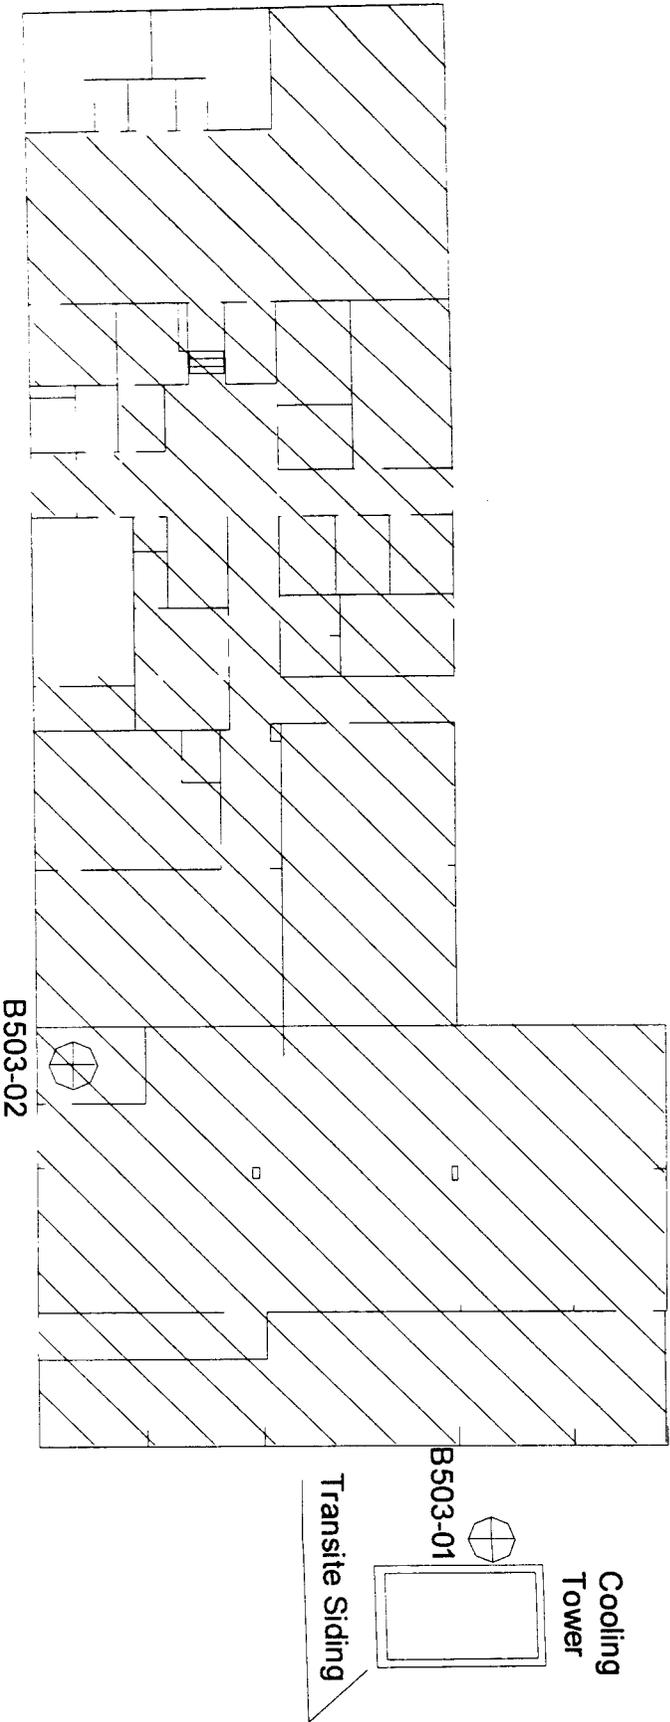
B503-01

- 1) Asbestos containing transite panels can be found on the cooling tower at Building 503.
- 2) Presumed asbestos containing 12x12 inch floor tile is found in all buildings excluding B504.
- 3) Black, presumed asbestos containing mastics are present below vinyl floor tiles found in all of the buildings.

Cooling Tower

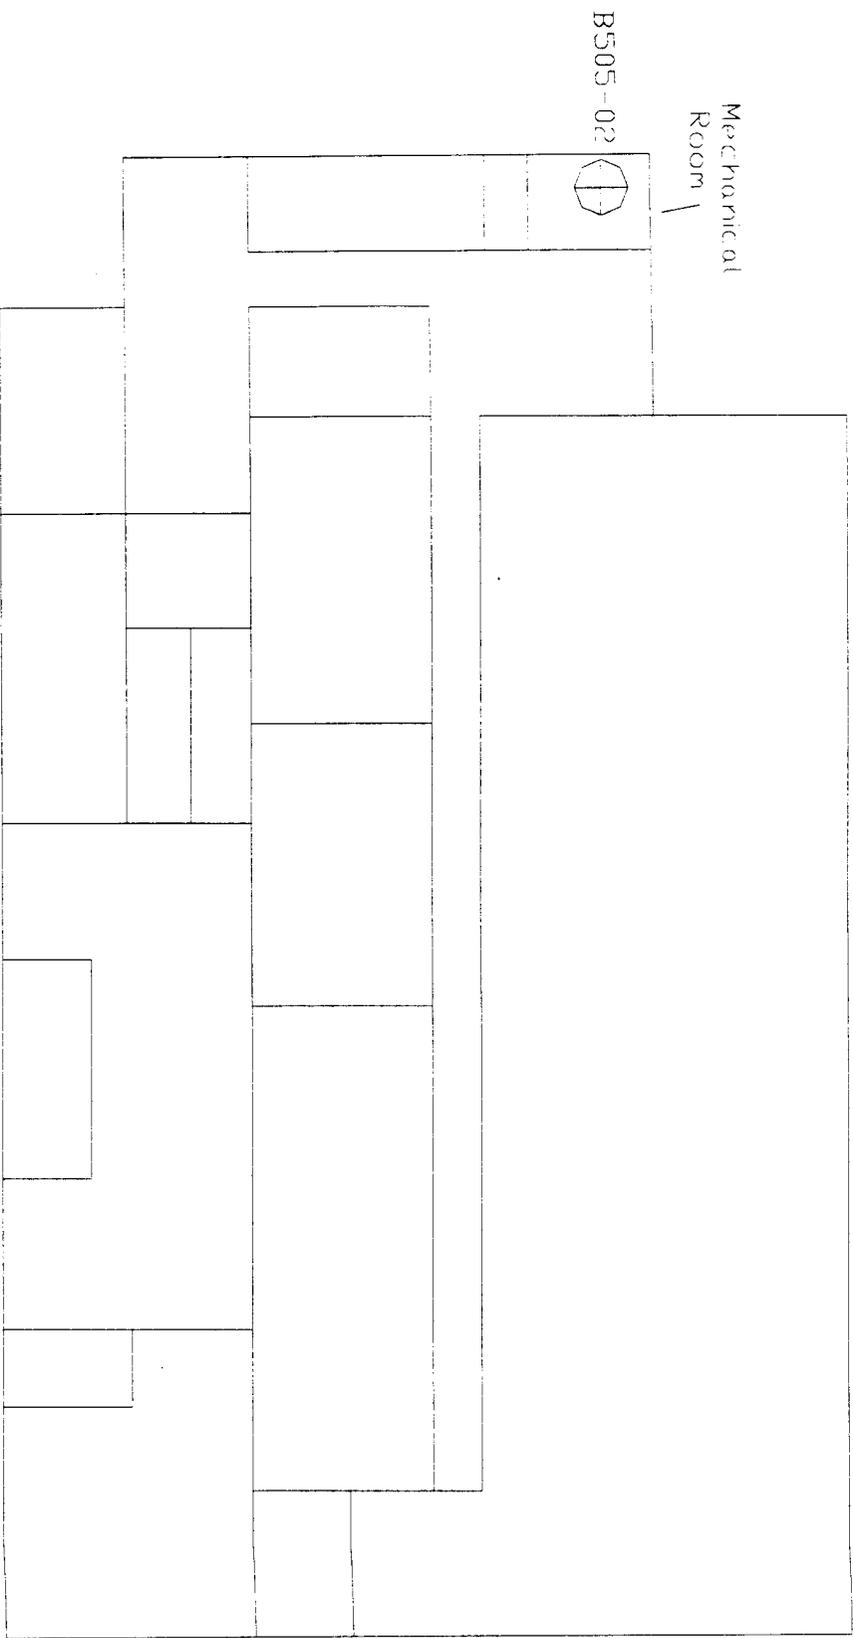
B505-02

- 1) An asbestos containing pipe tape (wrapping) is found on approximately 10 linear feet of pipe in the mechanical room of Building 505. The remaining piping in all buildings are either bare or insulated with fiberglass. The material was found to be in generally Good condition.

Mechanical Room

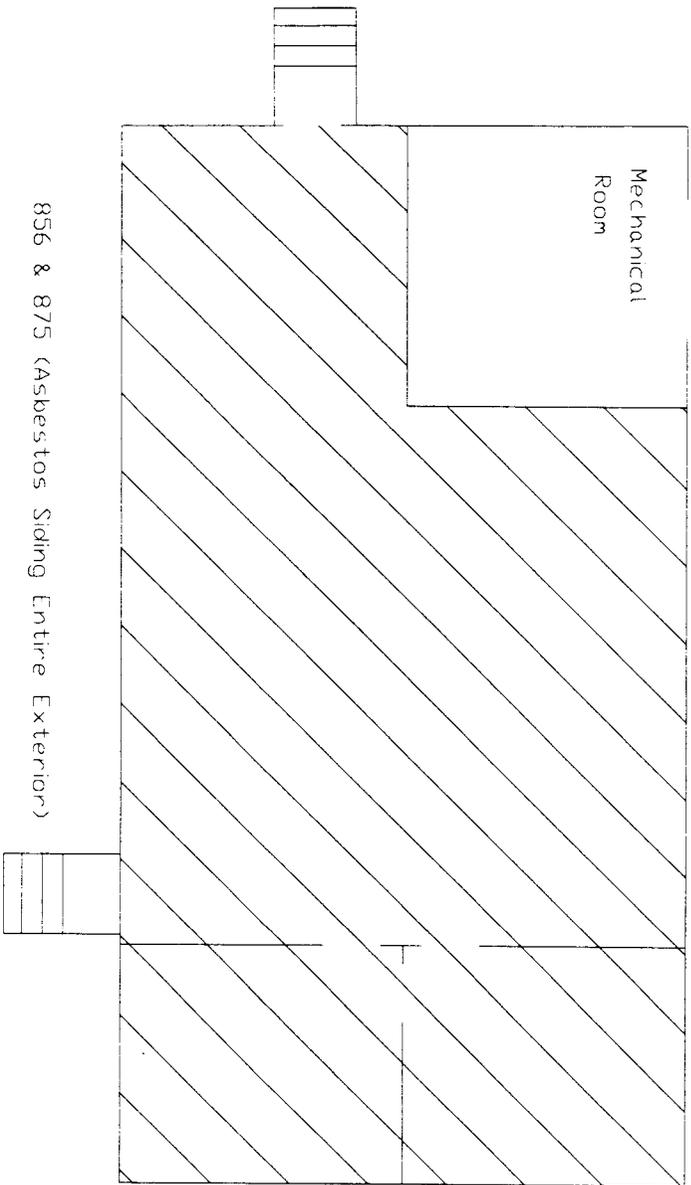
856 & 875 (Asbestos Siding Entire Exterior)
