**ASBESTOS CONTAINING BUILDING MATERIALS  
SURVEY REPORT**

**ASBESTOS CONTAINING BUILDING MATERIALS SURVEY  
MISCELLANEOUS BUILDINGS  
PACM**

**FORT McCLELLAN, ALABAMA**

U.S. ARMY CONTRACT NO. DABT02-96-D-0005  
DELIVERY ORDER 0033

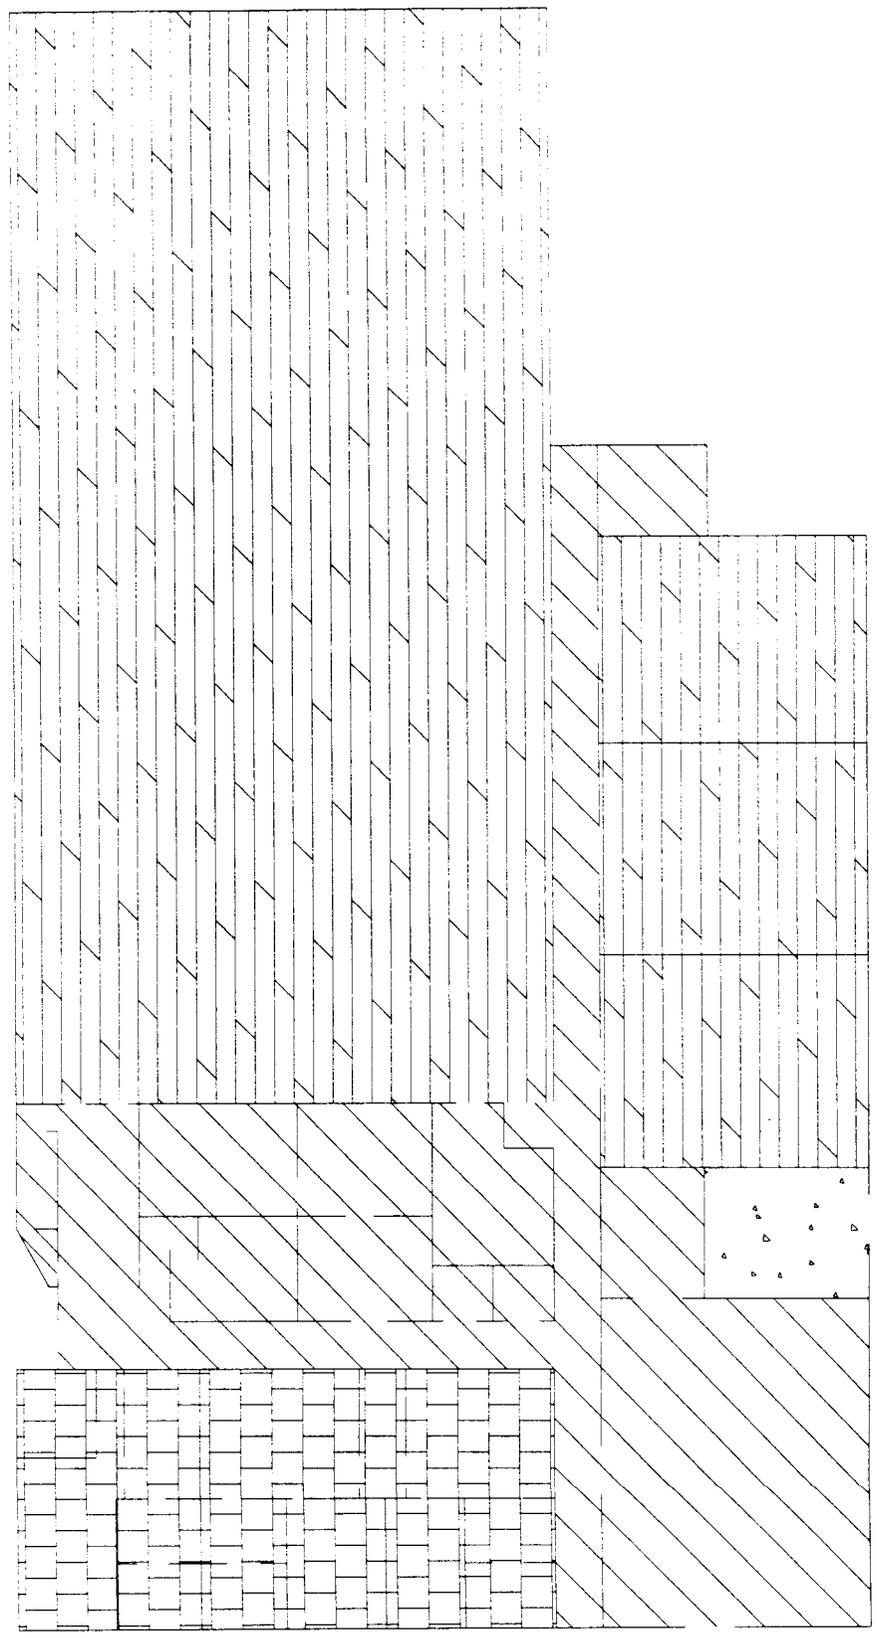
Wood Floors  
Mechanical Room  
(Cement floor)

12 x 12 Floor Tile  
Ceramic Floor Tile

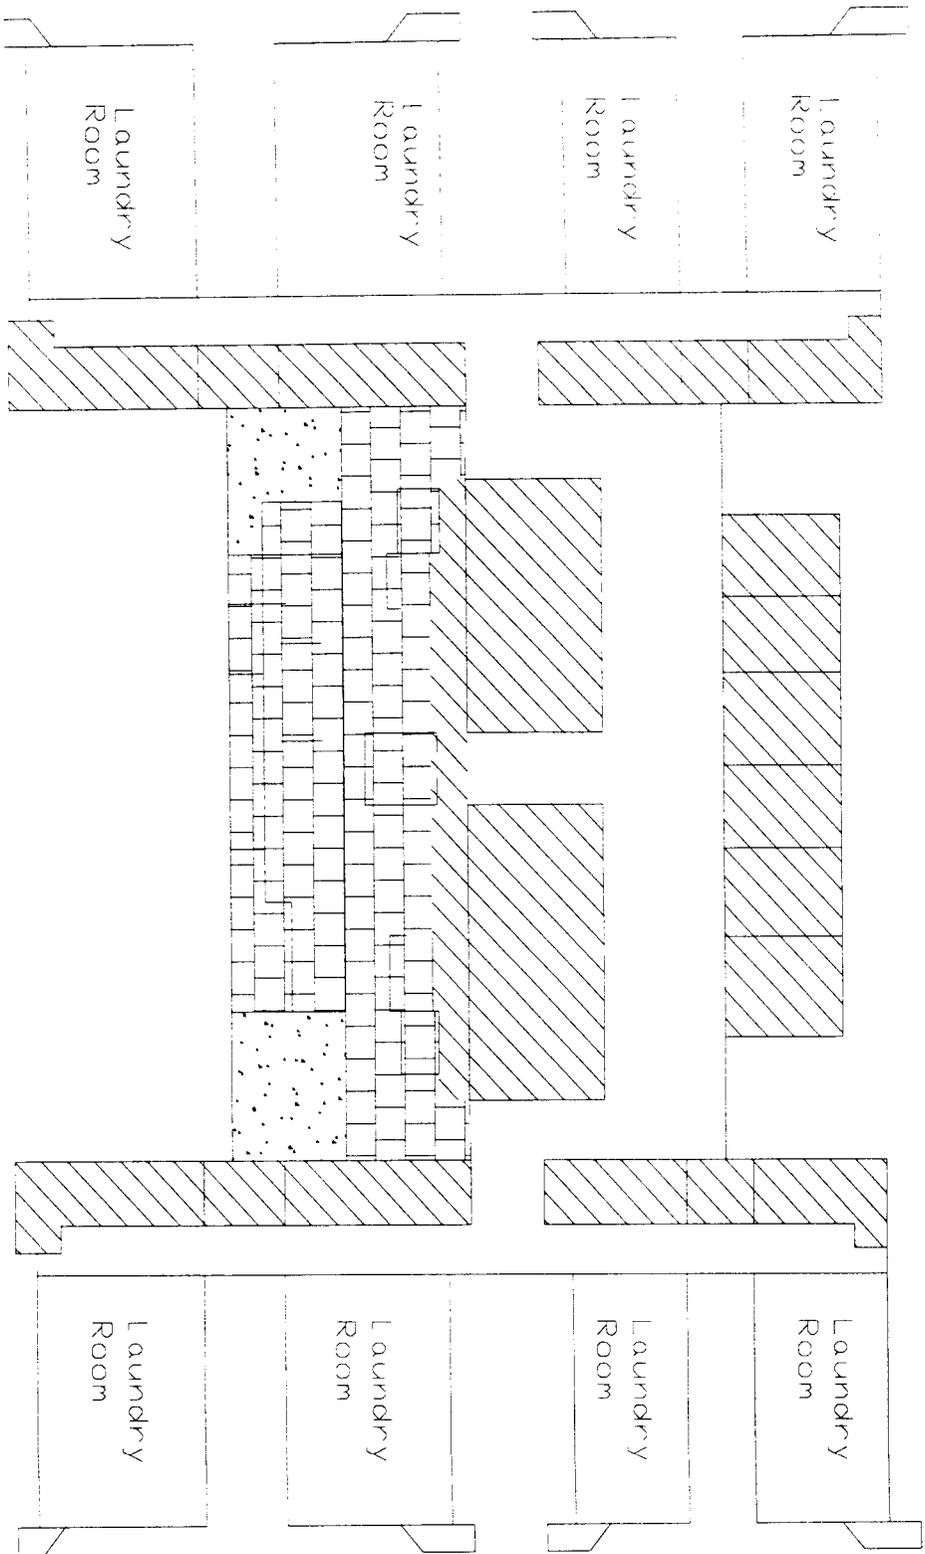
BUILDING 1801

- ▨ 12 x 12 Floor Tile
- ▨ Ceramic Floor Tile
- ▨ Mechanical Room (Cement floor)

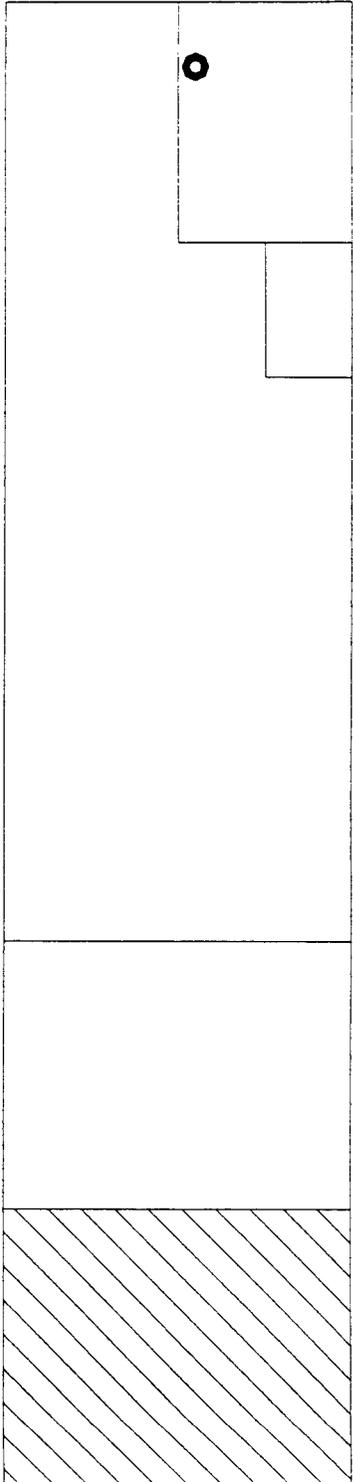
BUILDING: 337	FIG. 1 LAYOUT	ASBESTOS SURVEY DAB102-96-D-0005 FM705	<b>REISZ ENGINEERING</b>
---------------	---------------	--	--------------------------

- 1) Asbestos containing transite sheeting is found on the ceiling of one room in Building 337.  
A transite exhaust pipe is also located in this building.
- 2) Asbestos containing 9x9 inch floor tile and mastic is found in the following buildings:  
B256 B2102 B142 B267 B2098 B2091 B3213
- 3) Asbestos containing 12x12 inch floor tile and mastic is found in the following buildings:  
B1929 B1966 B3160 B3174 B2109 B337 B2051 B3213

○ Transite Exhaust Pipe

▨ Transite Ceiling Tile

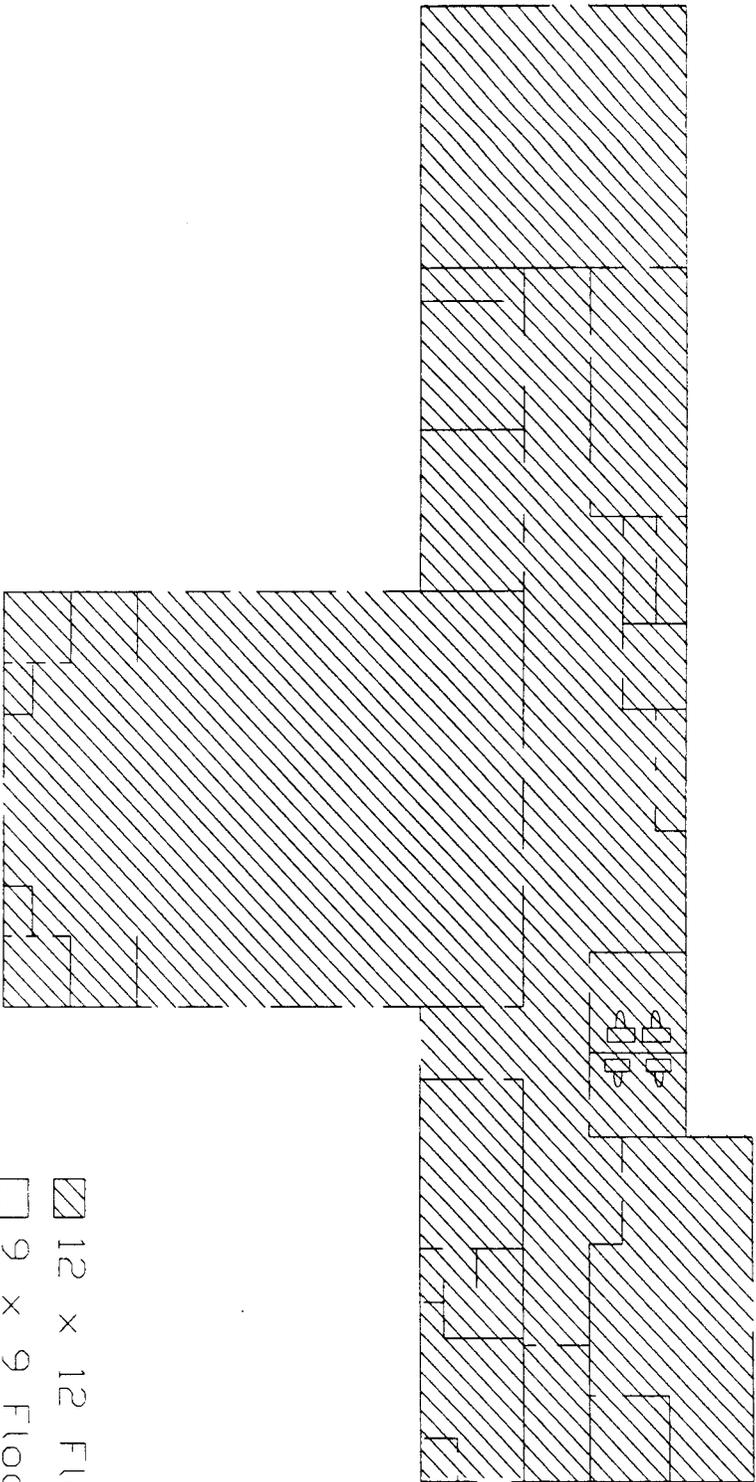
BUILDING: 3213

- 12 x 12 Floor Tile
- 9 x 9 Floor Tile
- Ceramic Tile
