**LBP SURVEY REPORTS**

**LEAD BASED PAINT  
SURVEY REPORT**

**BUILDING(S): 9 and 13**

**LEAD-BASED PAINT SURVEY  
REPORTS FOR BUCHNER FAMILY HOUSING UNITS  
FORT McCLELLAN, ALABAMA**

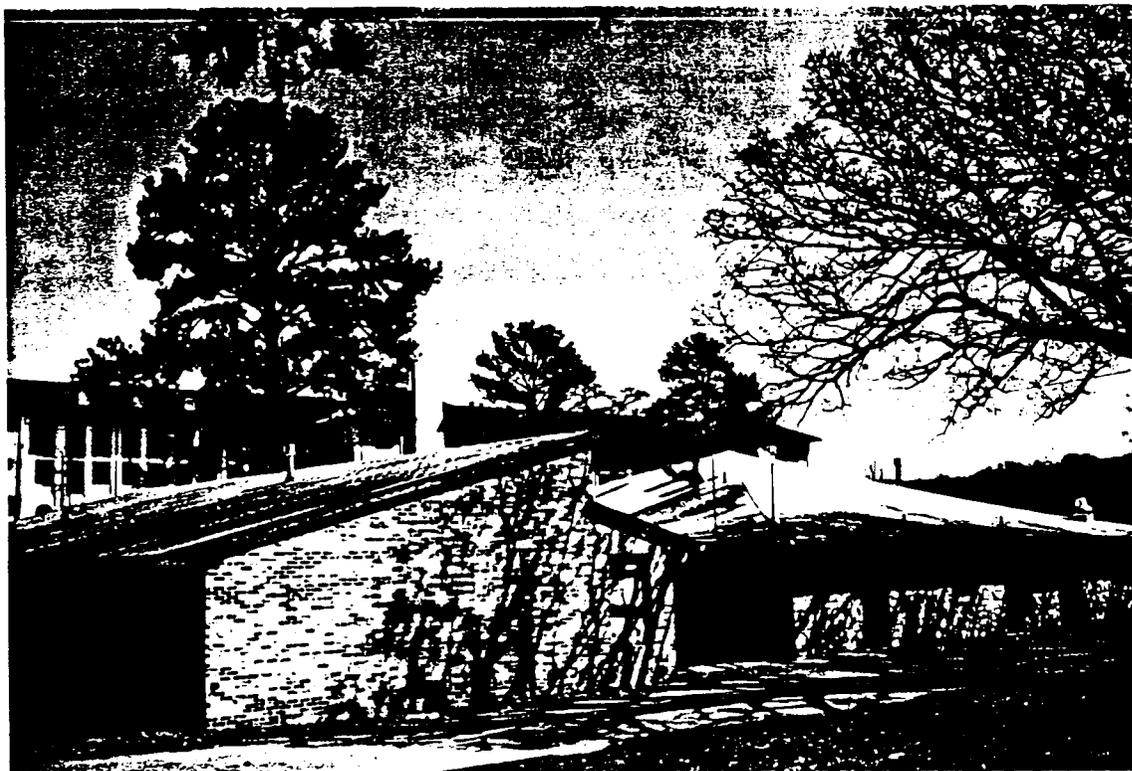
Figure 2. Side view of Building 66. Note newer brick wing and older rock wing.

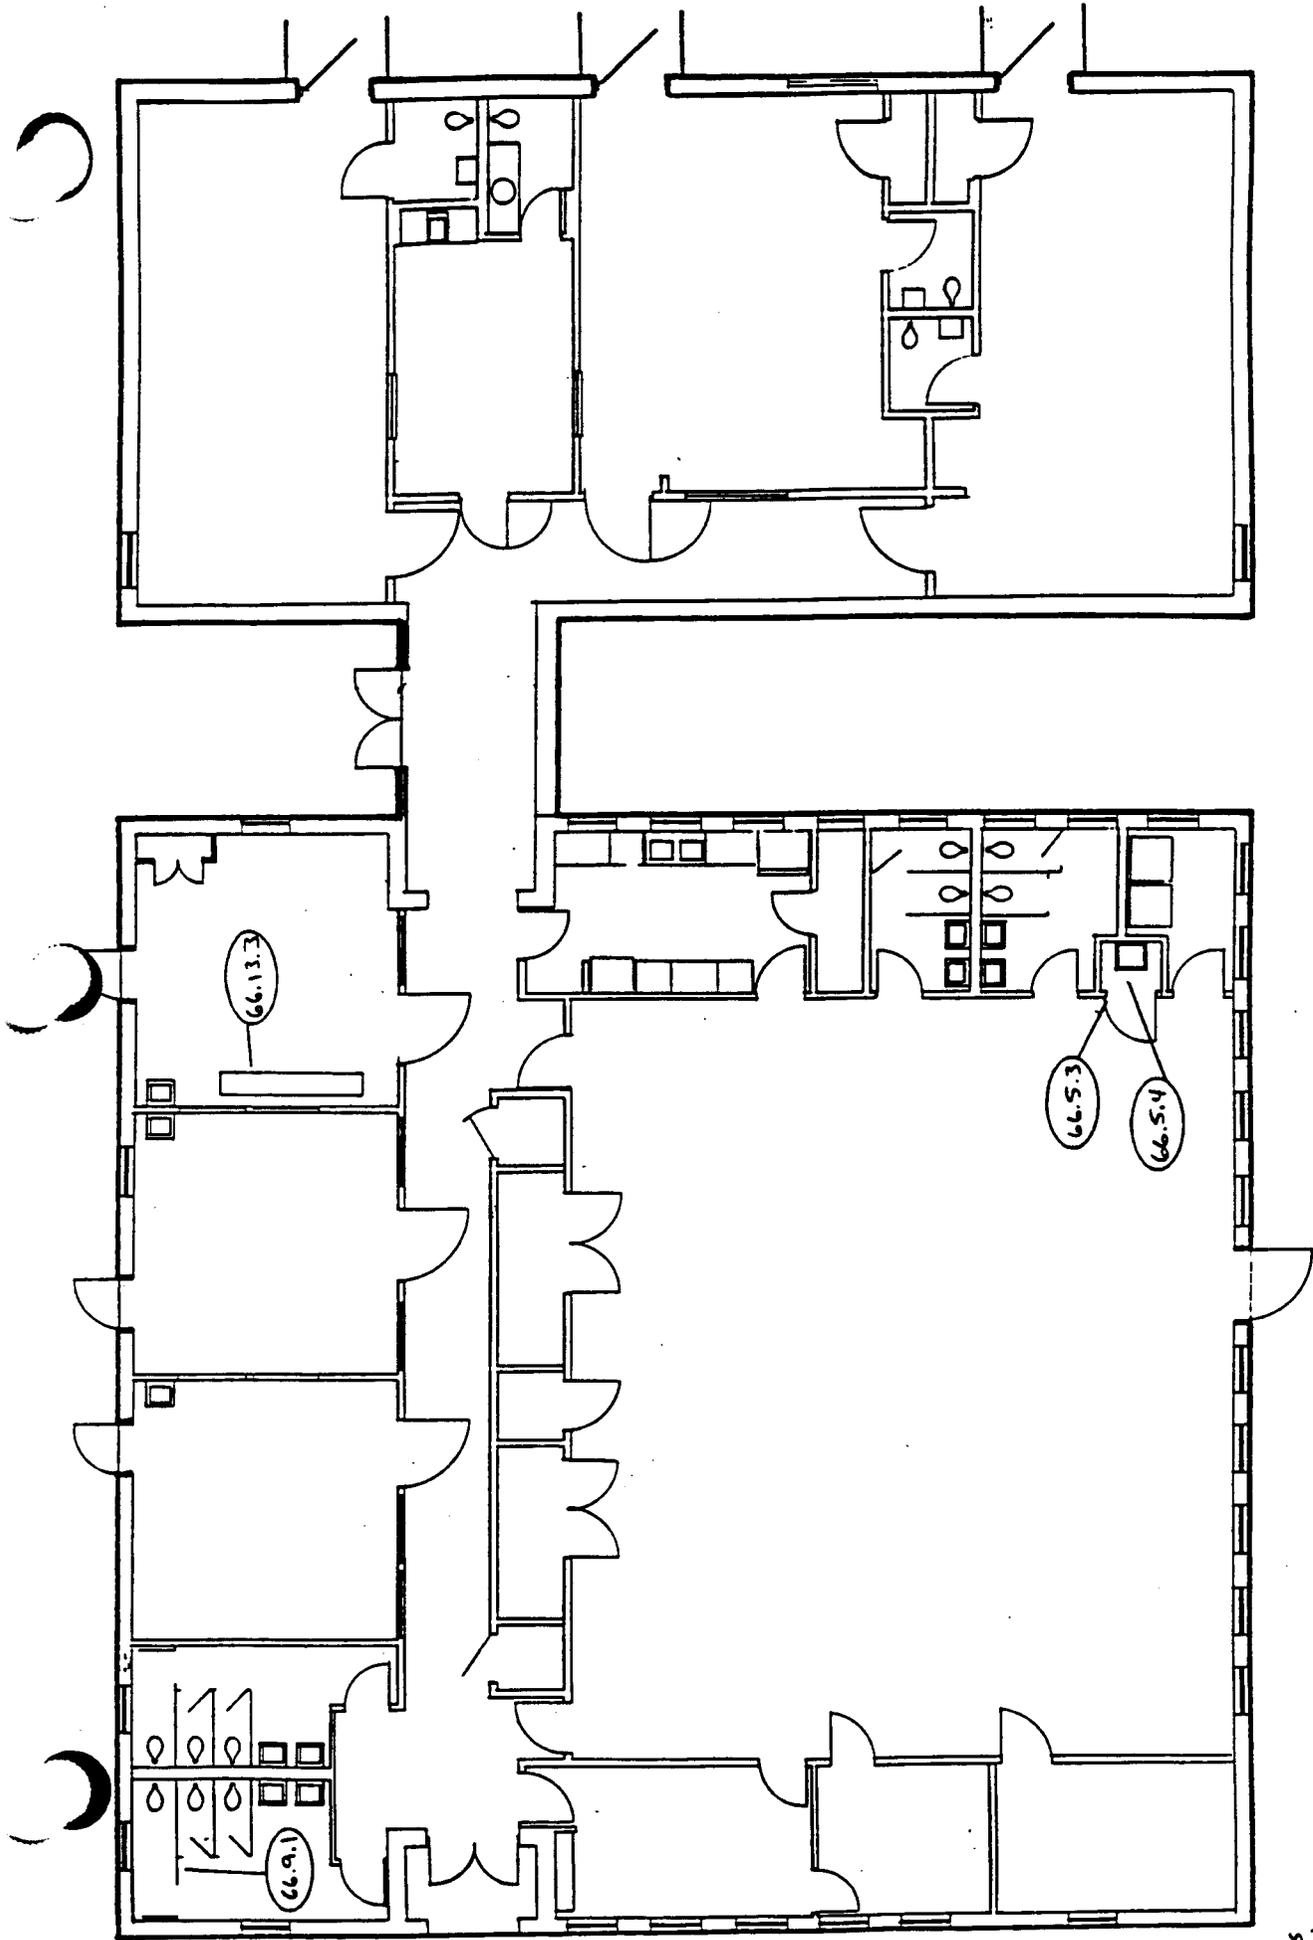
Generalized Floorplan - Not to Scale

Only Locations of Positive XRF Readings (if any) Are Shown

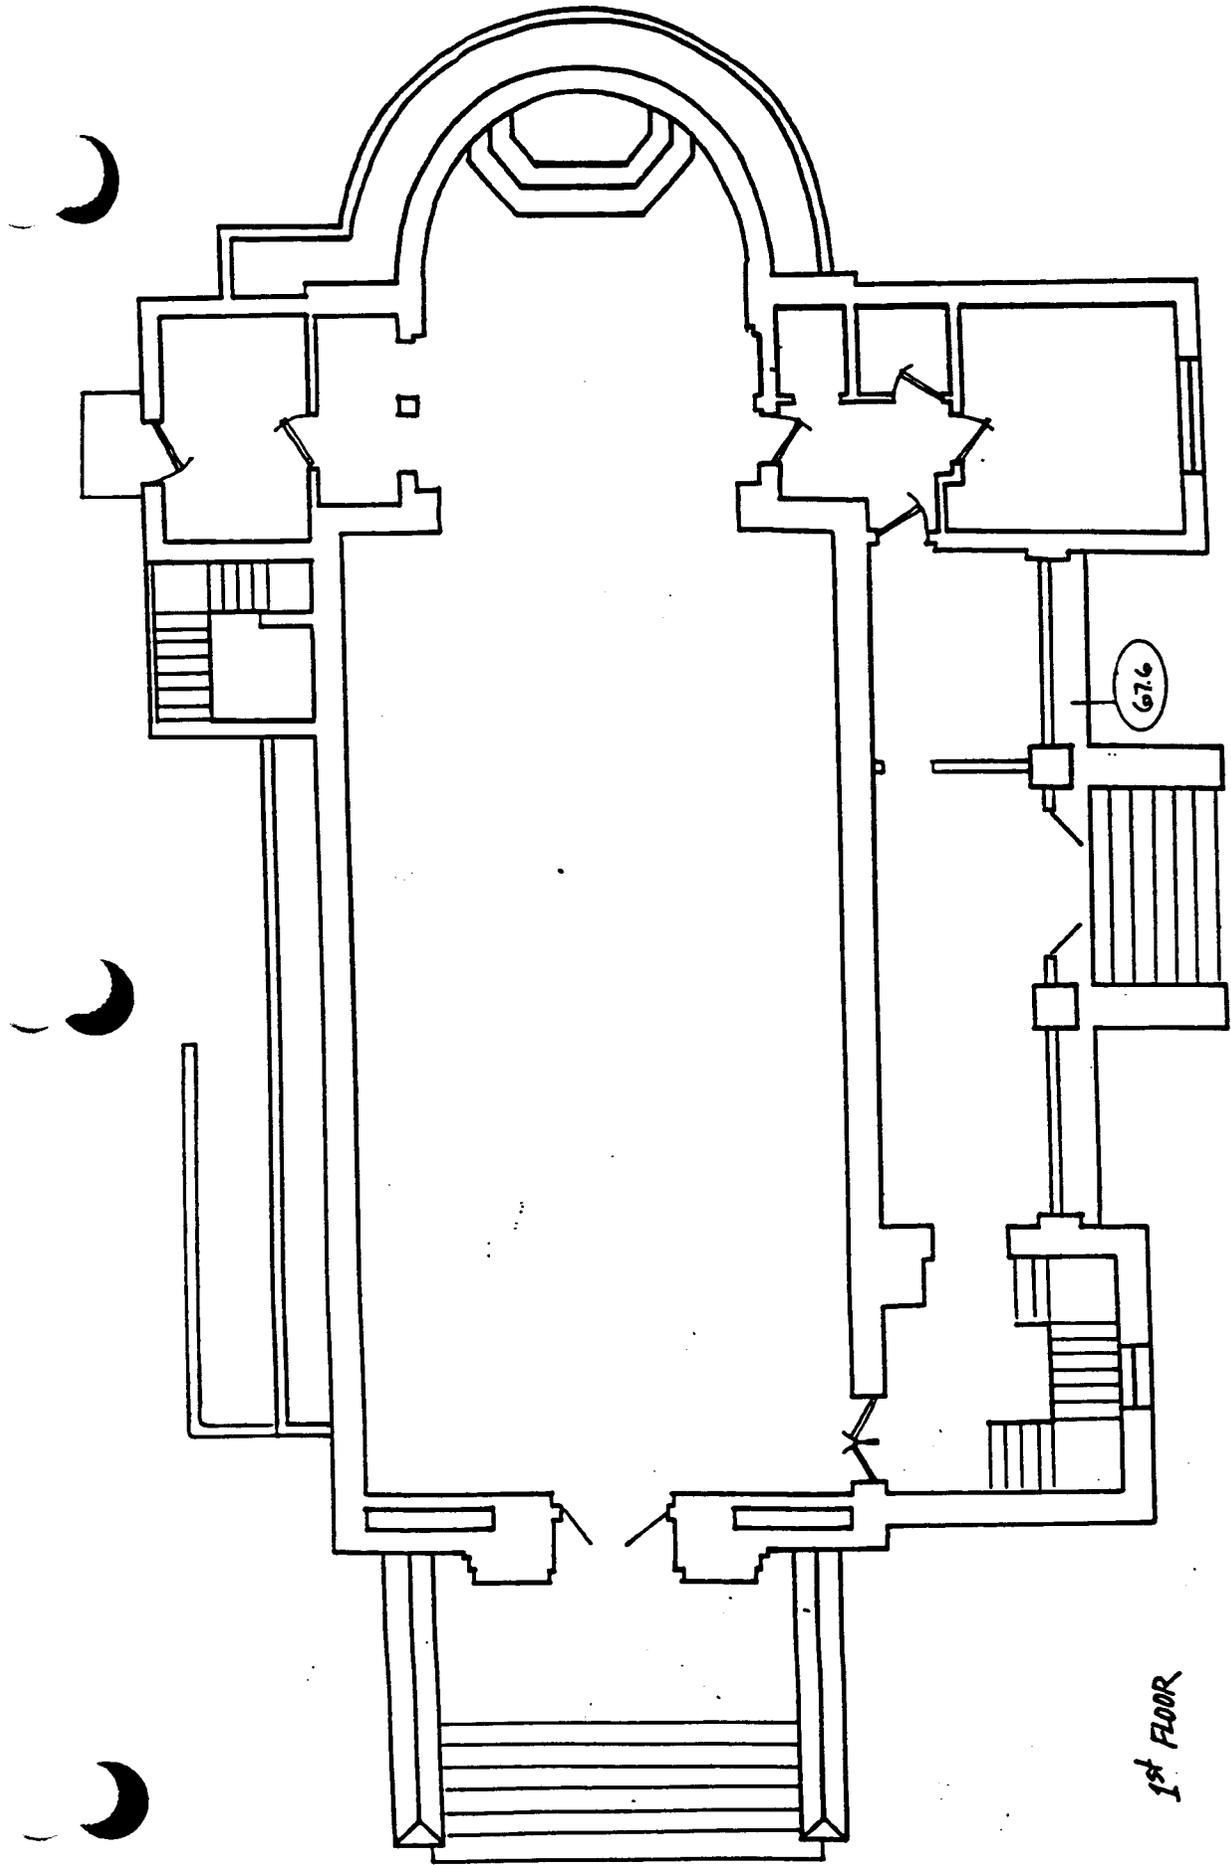
Unit No.	67
Plate No.	1

67.1.1	<b>1.9</b>	0.0	20	Good	White Concrete Window Sill
67.1.2	-0.2	-0.1	81	Good	White Concrete Wall
67.1.3	-0.2	-0.1	20	Good	White Concrete Wall
67.1.4	-0.0	0.0	20	Good	Brown Wood Door Jamb
67.1.5	-0.6	-0.0	20	Good	Brown Wood Door Header
67.1.6	-0.1	0.0	81	Fair	Brown Concrete Baseboard
67.1.7	0.2	-0.1	20	Good	White Wood Cabinet
67.1.8	-0.1	-0.1	20	Good	Stained Wood Window Frame

Generalized Floorplan - Not to Scale  
Only Locations of Positive XRF Readings (if any) Are Shown
