**LEAD BASED PAINT
SURVEY REPORT**

BUILDING(S):

81, 83, 85, 87, 89, 90, 103, 105, 106, 107

**LEAD-BASED PAINT SURVEY
 REPORTS FOR DRENNEN FAMILY HOUSING UNITS
 FORT McCLELLAN, ALABAMA**

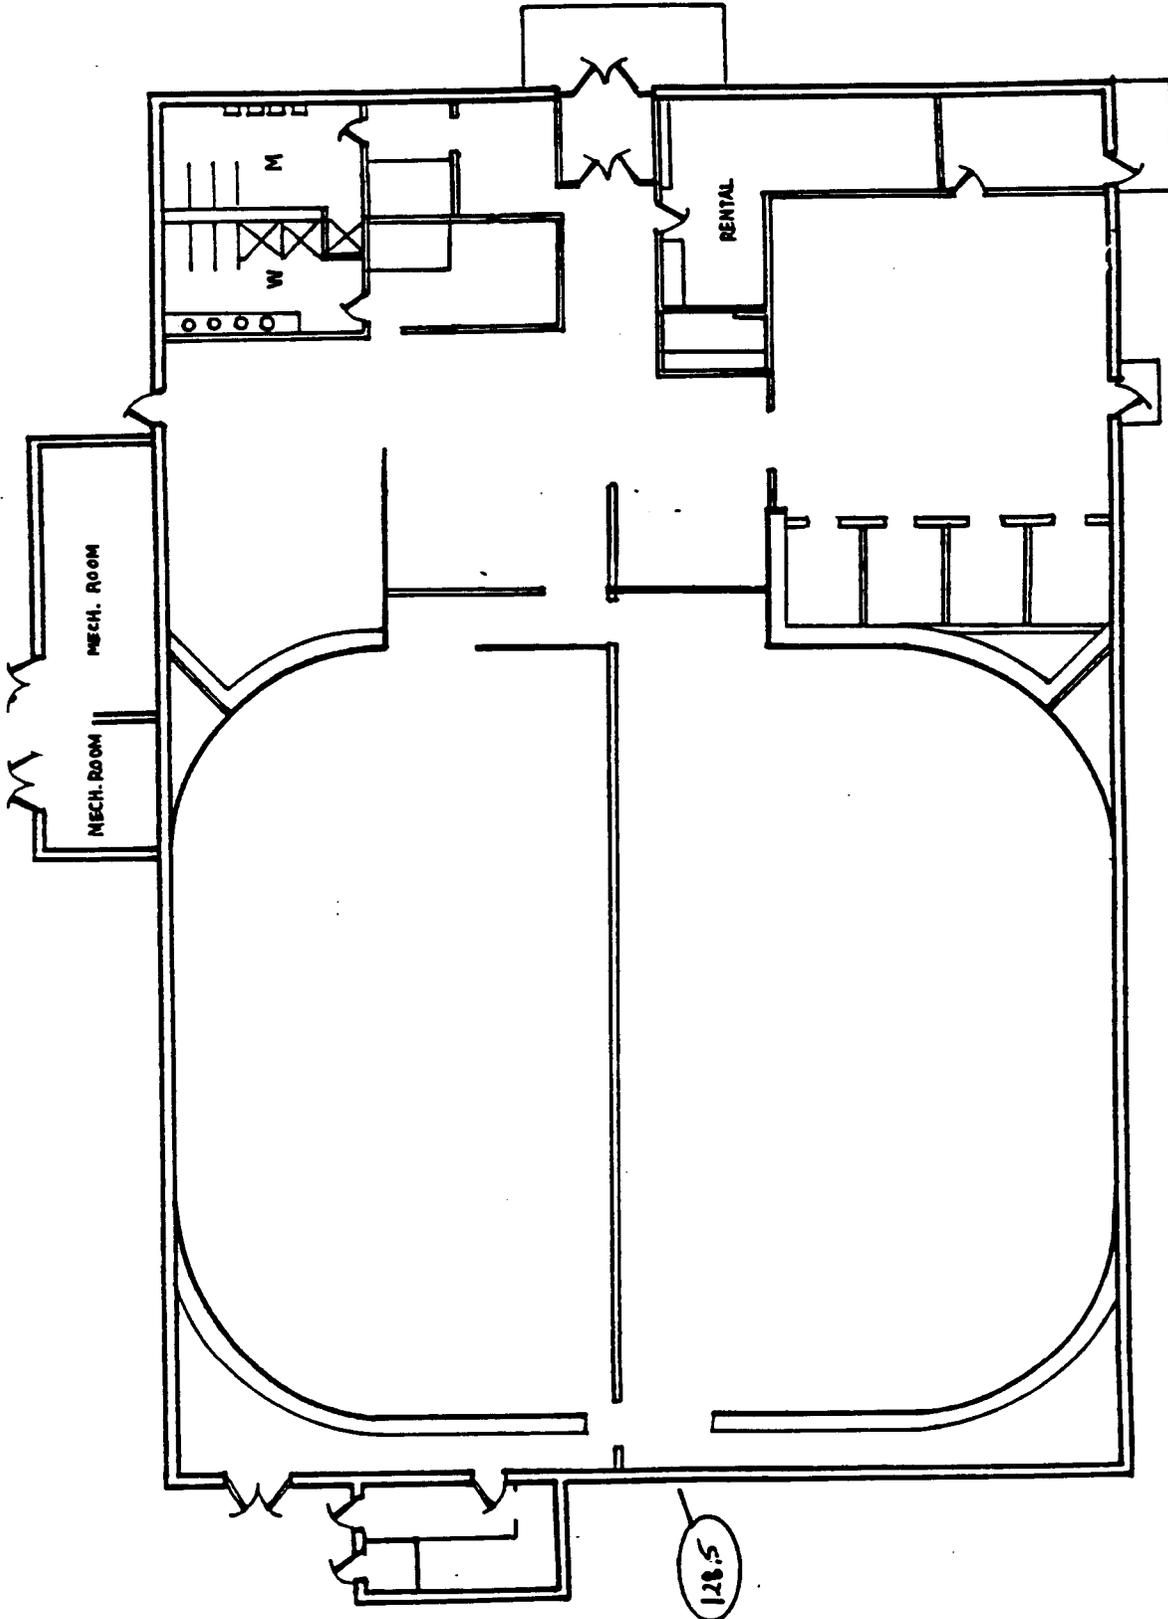
Unit No. 128 ;
 Plate No. 1

(3) Lab analysis positive. (Result = 2.21% Lead, Action level = 0.5% Lead)

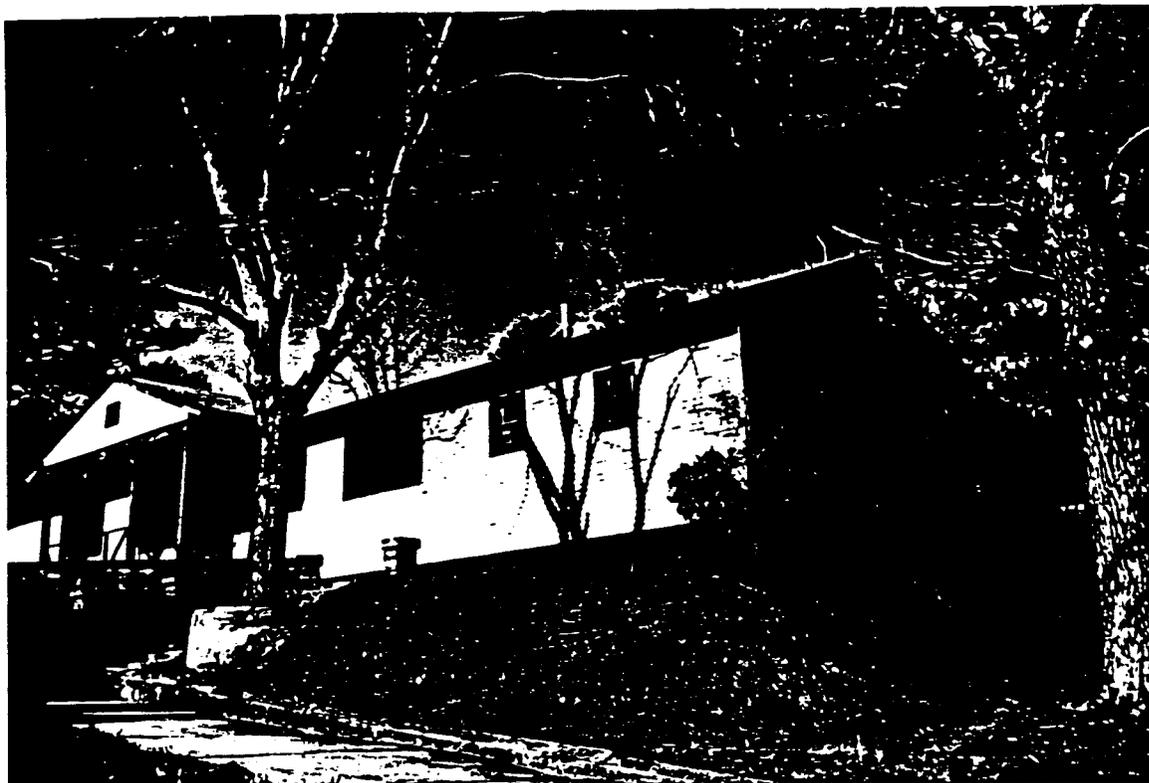
Figure 1. Front view of Building 992. Note, this is the porch with positive components.

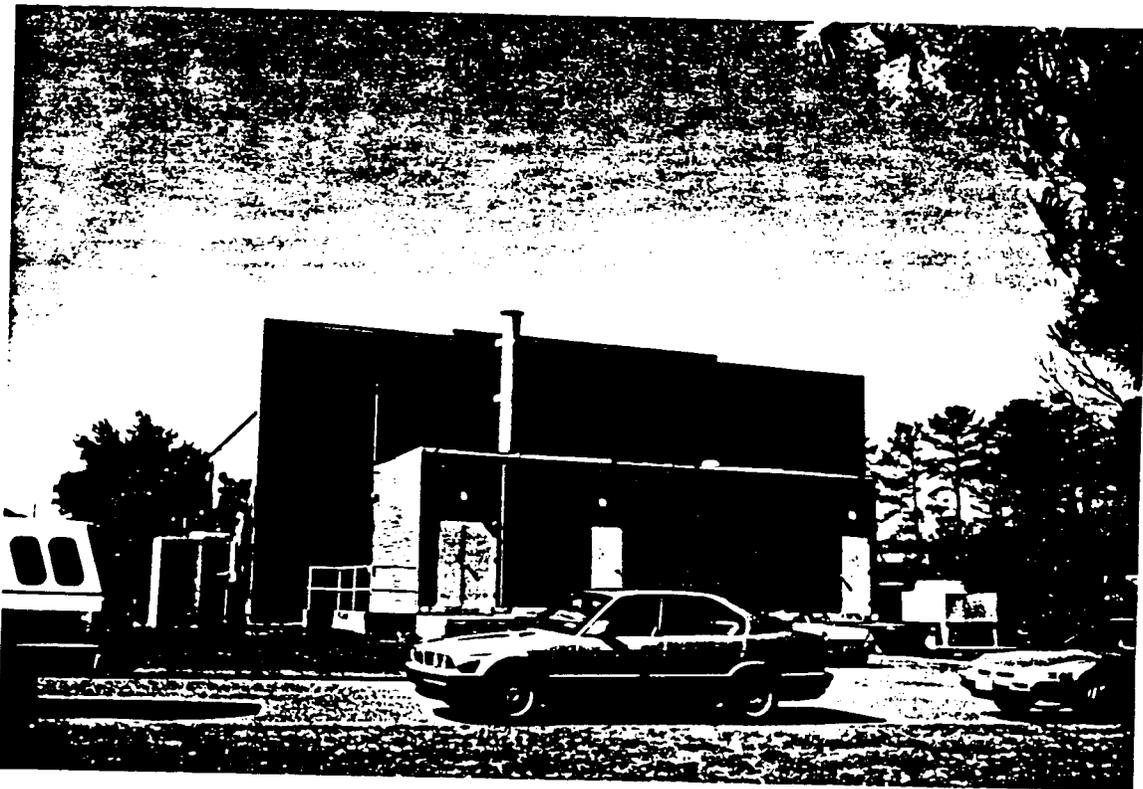
Figure 2. Rear view of Building 2101. Note positive pink metal components (e.g., doors, door components, railings, etc.).

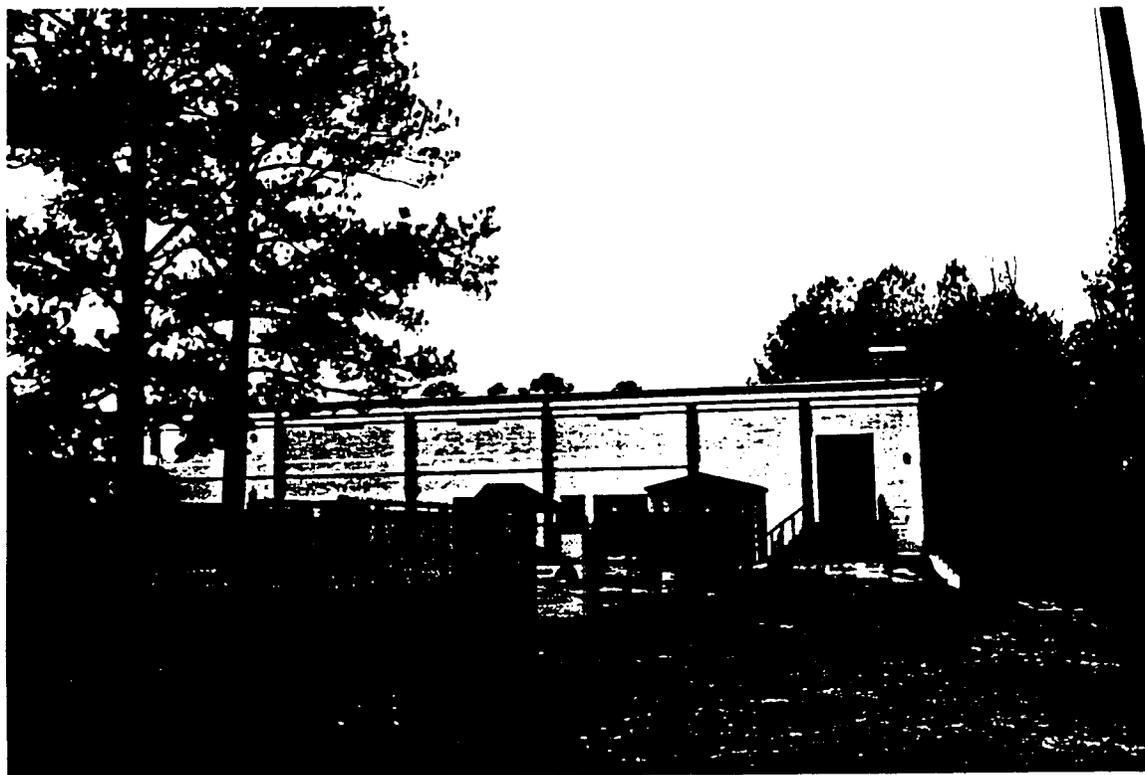
Figure 2. Side view of Building 2213. Note the positive wood door and door components.

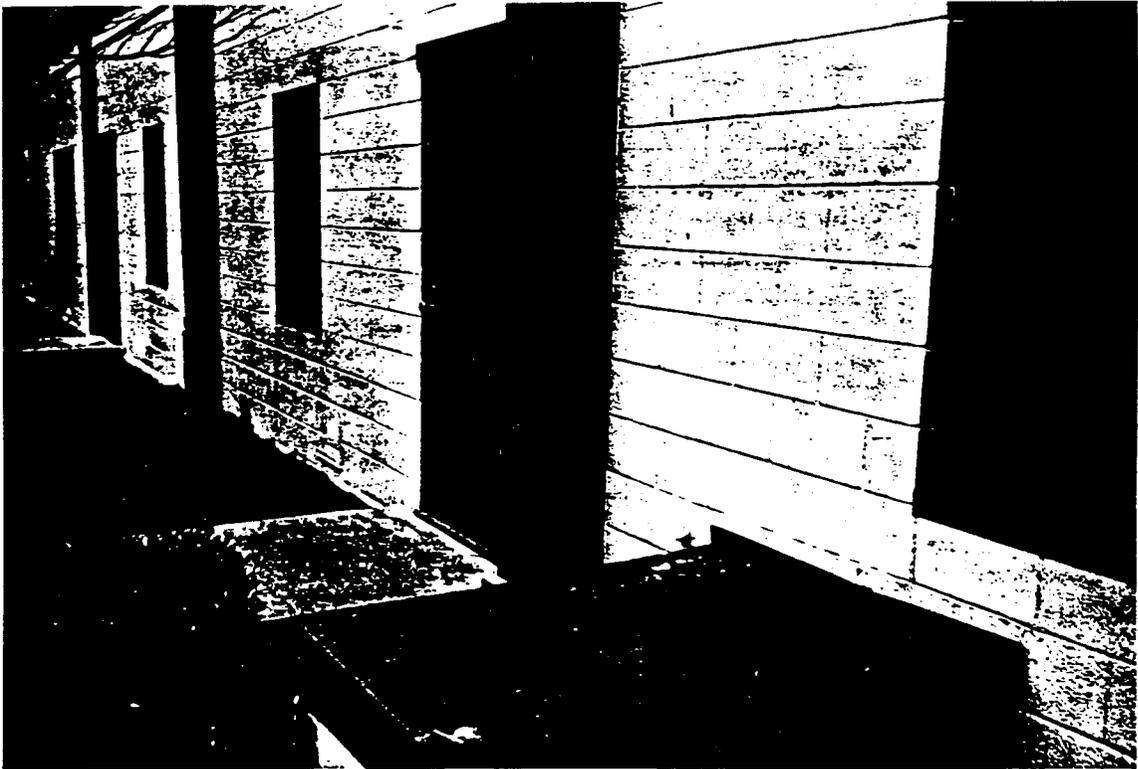
Figure 3. Front side of Building 2213. Note the positive metal panel (cover) and the positive lower tan section of the downspout.
