**LEAD BASED PAINT
SURVEY REPORT**

BUILDING: 2290

**LEAD-BASED PAINT SURVEY
 REPORT FOR BUILDING NO. 2290, PREVENTATIVE MEDICINE BLDG.
 FORT McCLELLAN, ALABAMA**

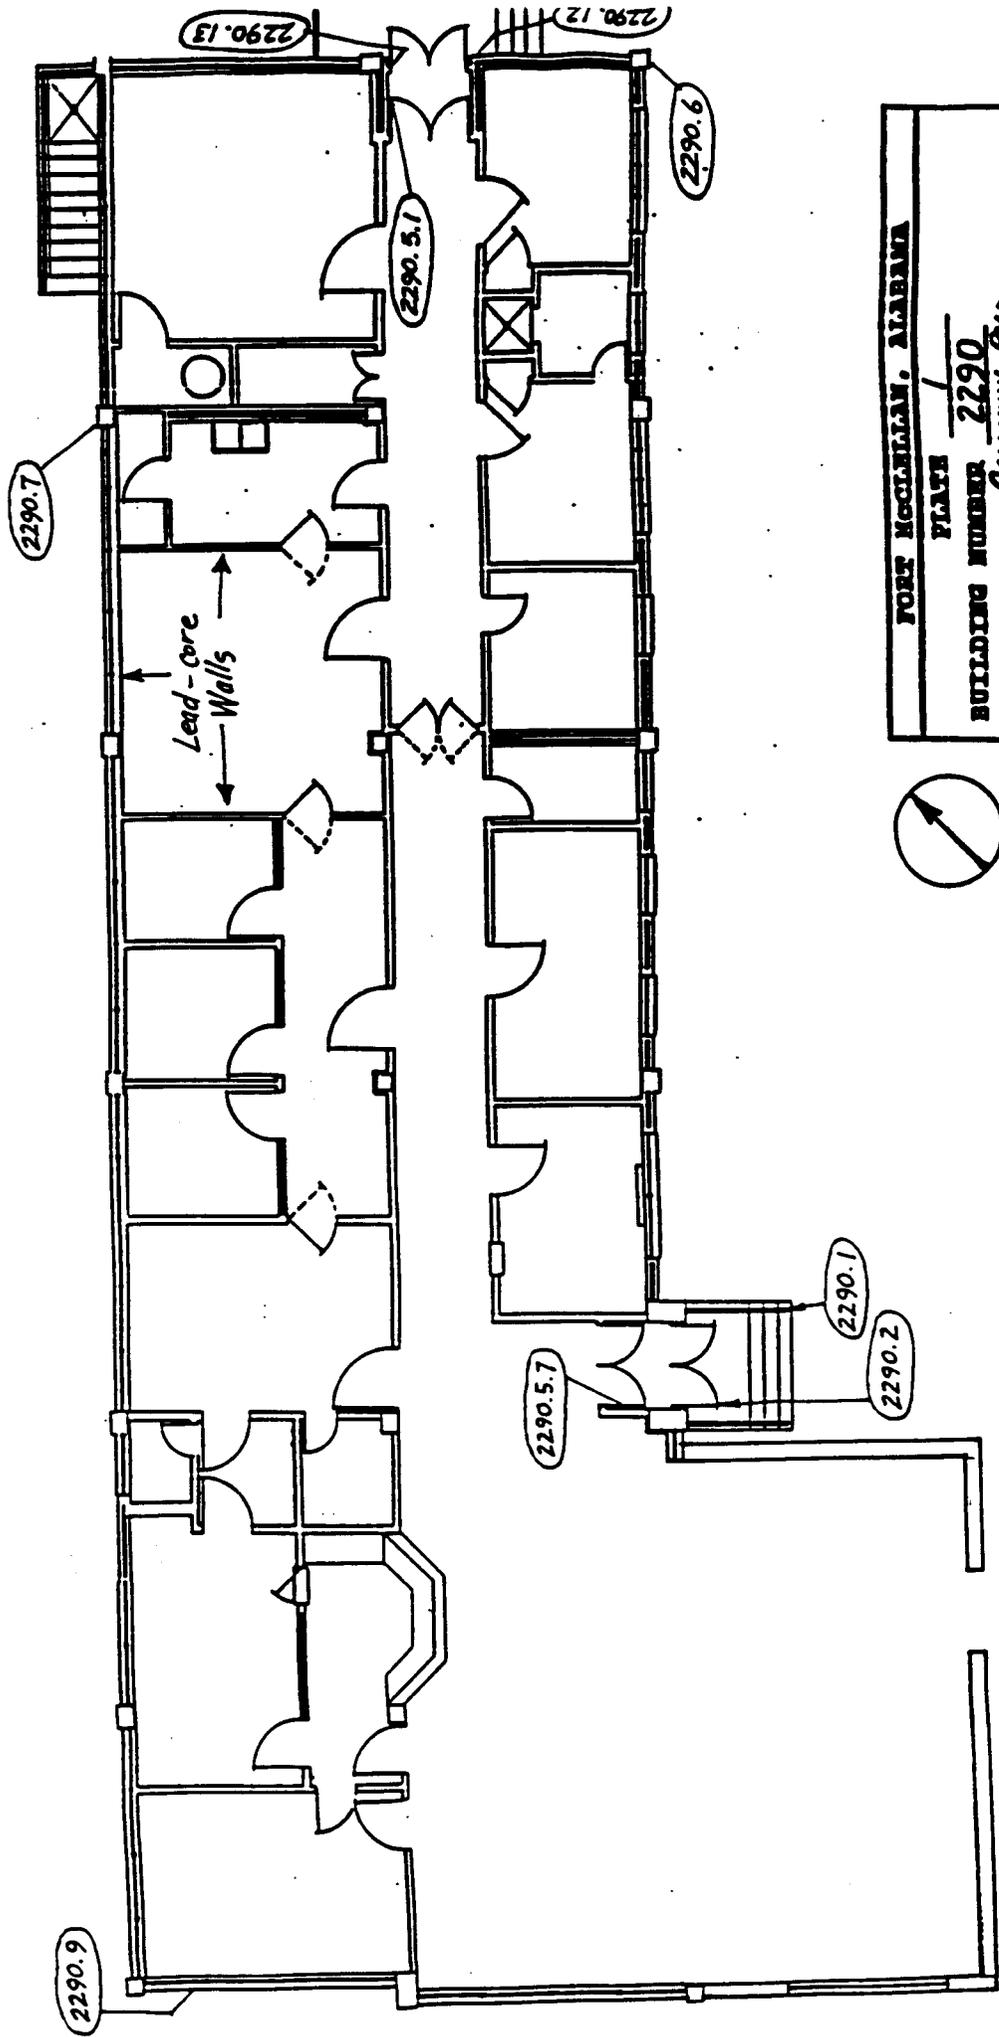
FORT McCLELLAN, ALABAMA
 PLATE 1
 BUILDING NUMBER 2290
 LOCATION: GILLOMY RD

9. With the exception of the brown screened doors at the entryways, there was no lead-based paint found in the interior of Building No. 2290. These doors appeared to be older than the other door components in the building.

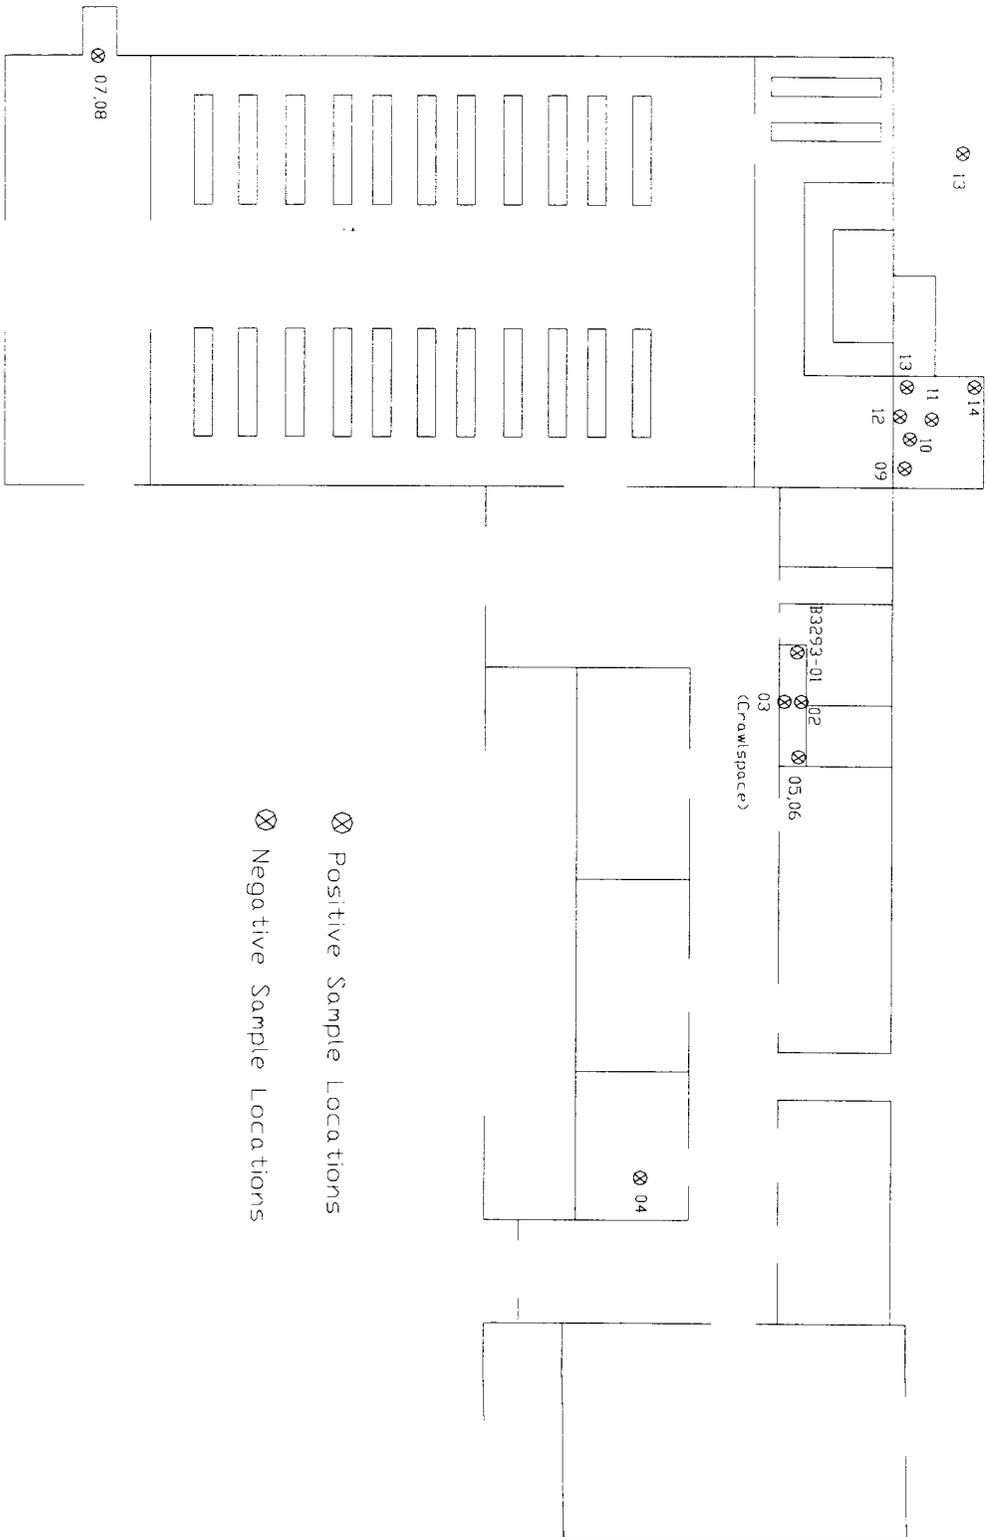
BUILDING:	3293	FIG. 1 LAYOUT	ASBESTOS SURVEY DAB102-96-D-0005 FM705	REISZ ENGINEERING
-----------	------	---------------	--	--------------------------

Two types of non-friable ACM were found to be present in the building: 1) 9x9 inch vinyl floor tile, and 2) mastics associated with 9x9 inch vinyl floor tile.

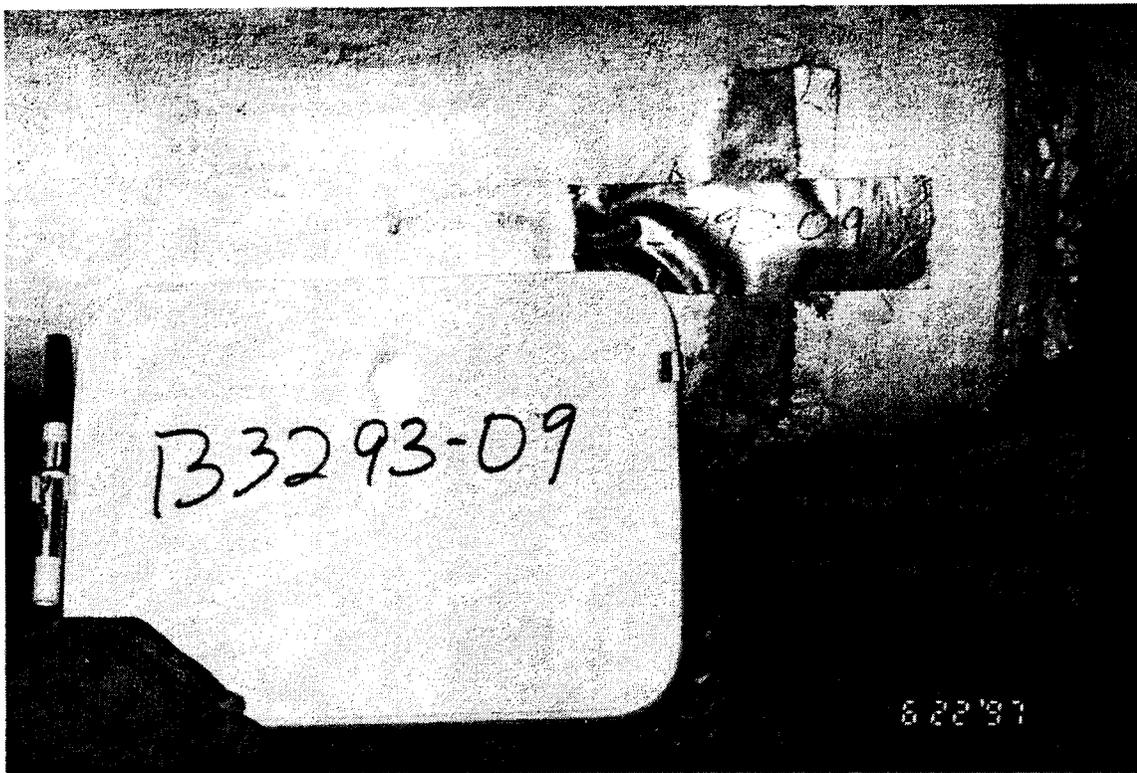
B3293-09: White powdery asbestos containing pipe insulation.

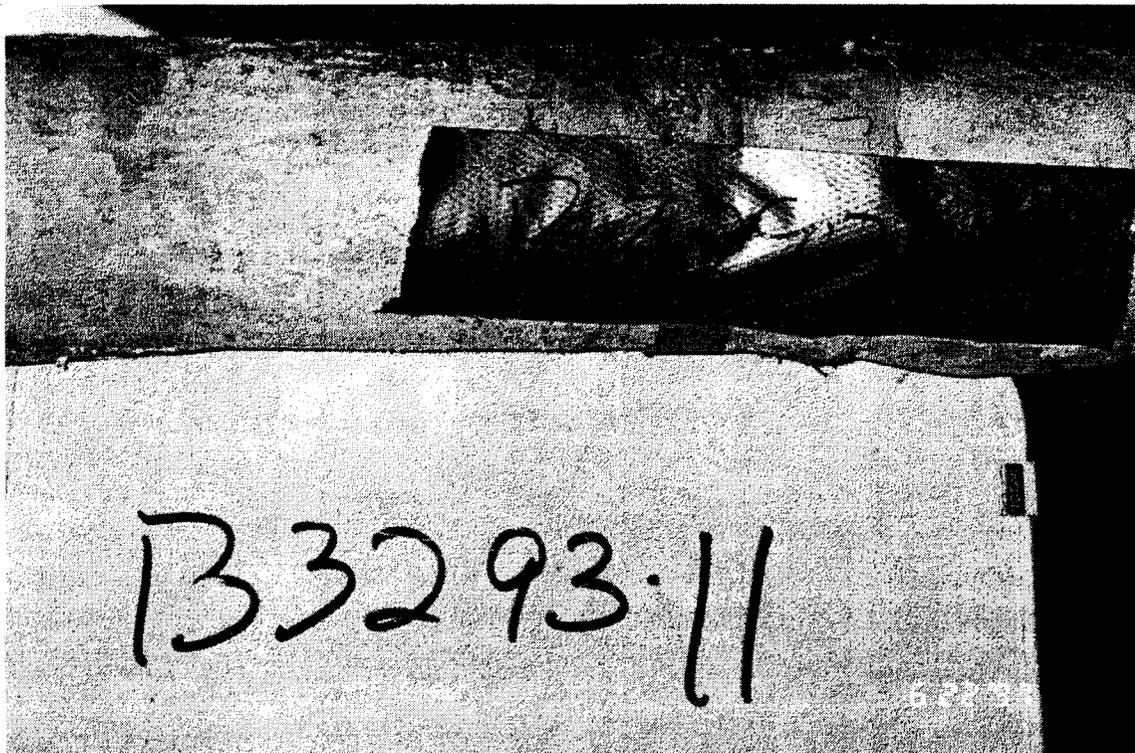
B3293-11: White powdery asbestos containing pipe insulation.
