## **Appendix B-3**

### **Quality Assurance Documentation**

<b>CORRECTIVE ACTION REQUEST   NO. :CEHNC-ED-CS-G-FY04_0002</b>	
<b>Originator:</b> Bob Selfridge	<b>Date Issued:</b> 31 October 2003
<b>Issued to:</b> Art Holcomb of Foster Wheeler Environmental /Tetra Tech <b>Project:</b> Ft. McClellan Removal Action "Y" Junction Bypass – 40 acre additional area <b>CEHNC Project Manager:</b> Dan Copeland <b>CEHNC Project Engineer:</b> Alonzo Andrews <b>Response Due:</b> 7 November 2003	
<b>Description of Condition Found: (As observed or reported)</b>	
Government Blind seed items were <b>not</b> removed during the Removal Action. <b>Failure FY04_0002</b> - 60 mm mortar buried at 1.0 foot deep in grid 67.	
(Appropriate personnel, i.e. contractor PM, Safety Officer, Team Leader, etc., receiving the CAR will provide the following information to the originator by the "Response Due" date above. Please contact the originator if you have any questions)	
<b>Actual Cause:</b> The 60 mm mortar in this grid was located just over 1 ft off of anomaly #30. Anomaly #30 was a Rommel stake sticking out of the ground. The photo at the bottom of this CEHNC report shows the distance between the Rommel stak

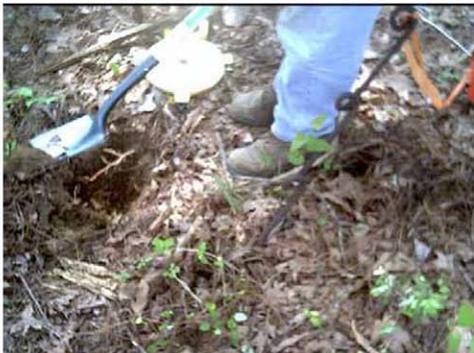
<b>Action Taken to Correct Condition:</b> A thorough examination of the procedures resulting in the above mentioned condition was performed. The first course of action was to determine whether or not the geophysical sensors detected the item. The site geophysicist interpreting the geophysical data feels that the seeded item was detected, however the items proximity to the highly ferrous Rommel stake and presence of large amounts of ferrous material caused the anomalies to merge into one subsurface disturbance. The interpreting geophysicist selected the entire disturbance as a single anomaly.	
The source of the condition was determined.

<b>Action Taken to Prevent Recurrence:</b> Intrusive teams have been instructed to verify that a 3-foot radius about the selected location has been cleared. Regardless if a large metallic surface item is present. In

addition, interpreting geophysicist has been instructed to select more the one target location on large subsurface anomalies. This will encourage the intrusive teams to continue their investigation until the anomaly (or anomalies) has been uncovered.

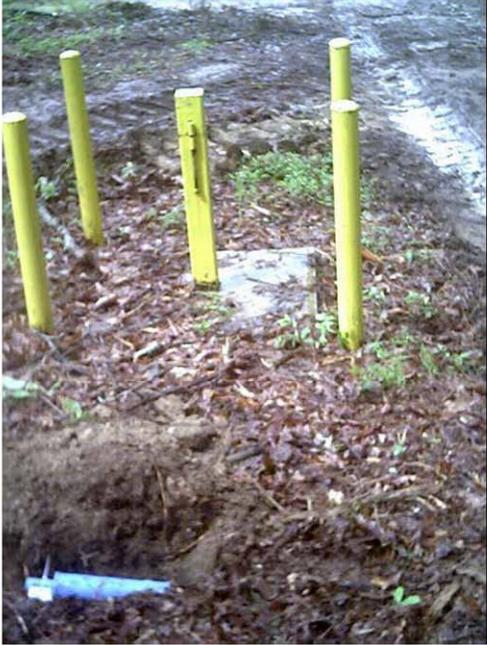
<b>Actual Cause:</b> The 3" stoke was seeded in close proximity to a monitoring well. The geophysics was able to detect the item, however, the handheld metal detectors used by the intrusive teams for pinpointing the location of a buried item was heavily influenced by the ferrous well components. The item was classified as a "monitoring well".								
Another contributing factor to the failure to recover the seeded item was the fact that the immediate area around a well location is "cleared" prior to well installation. For this reason after consultation between the intrusive teams and the site geophysicist, it was decided that an intrusive investigation of the anomaly in question was not warranted. It is required that monitoring wells be placed in areas that have been swept by UXO personnel prior to the well being placed.								
<b>Action Taken to Correct Condition:</b> The first course of action was to determine whether or not the geophysical sensors detected the item. The EM61 MKII detected the item. Secondly was the item selected as a "dig". The item was selected. The mortar seeded in grid 123 was item #19. It was reported as "monitoring well" but if a comparison is made between the excerpt from the dig sheet (table 1 below), you can see that the xy coordinate is x-663223.3 y-1165921.8. If you look at the location of the seeded item on the bottom of this CEHNC report, you will see that this is the same coordinate.
