# FINAL ENVIRONMENTAL BASELINE SURVEY Fort McClellan, Alabama

## Volume I of II

Contract DACA31-94-D-0065  
Task Order Number 0001

**Environmental Science & Engineering, Inc.**  
404 SW 140 Terrace  
Newberry, Florida

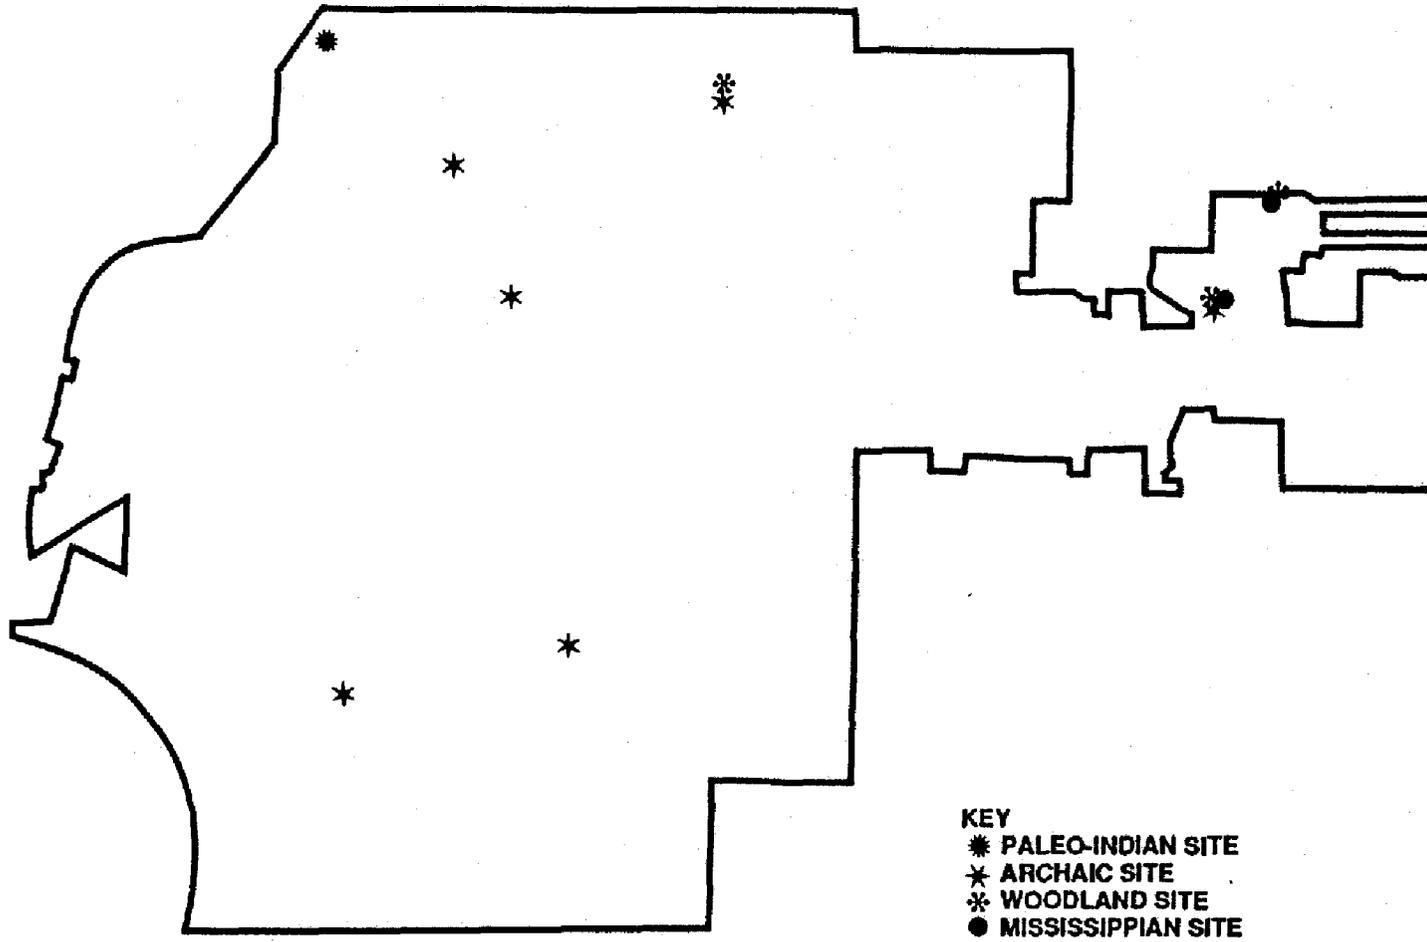
Figure 4.5-1  
MAIN POST - HISTORIC SETTLEMENT SITES

Prehistoric occupation of FTMC by man has been confirmed by archeological studies conducted in northeast Alabama. Chronological periods of prehistoric presence by man have been established for this area based on unique cultural traditions and date back as far as the Paleo-Indian Period, approximately 12,000 years before present (BP). Subsequent periods following the Paleo-Indian Period are the Archaic Period, the Woodland Period, the Mississippian Period, and Early Historic Indian Period. Occupation during the Paleo-Indian Period is marked by distinct projectile point forms used to hunt now extinct megafauna. The Main Post has the only Paleo-Indian site at FTMC, shown in Fig. 4.5-1.

mortuary practices. A total of 14 Woodland Period sites have been found on FTMC, 3 on the Main Post (shown in Fig. 4.5-1) and 11 on Pelham Range (shown in Fig. 4.5-2). Figs. 4.5-3 and 4.5-4 show the locations of stone features and earthen mounds discovered at FTMC and believed to have been constructed during this period.

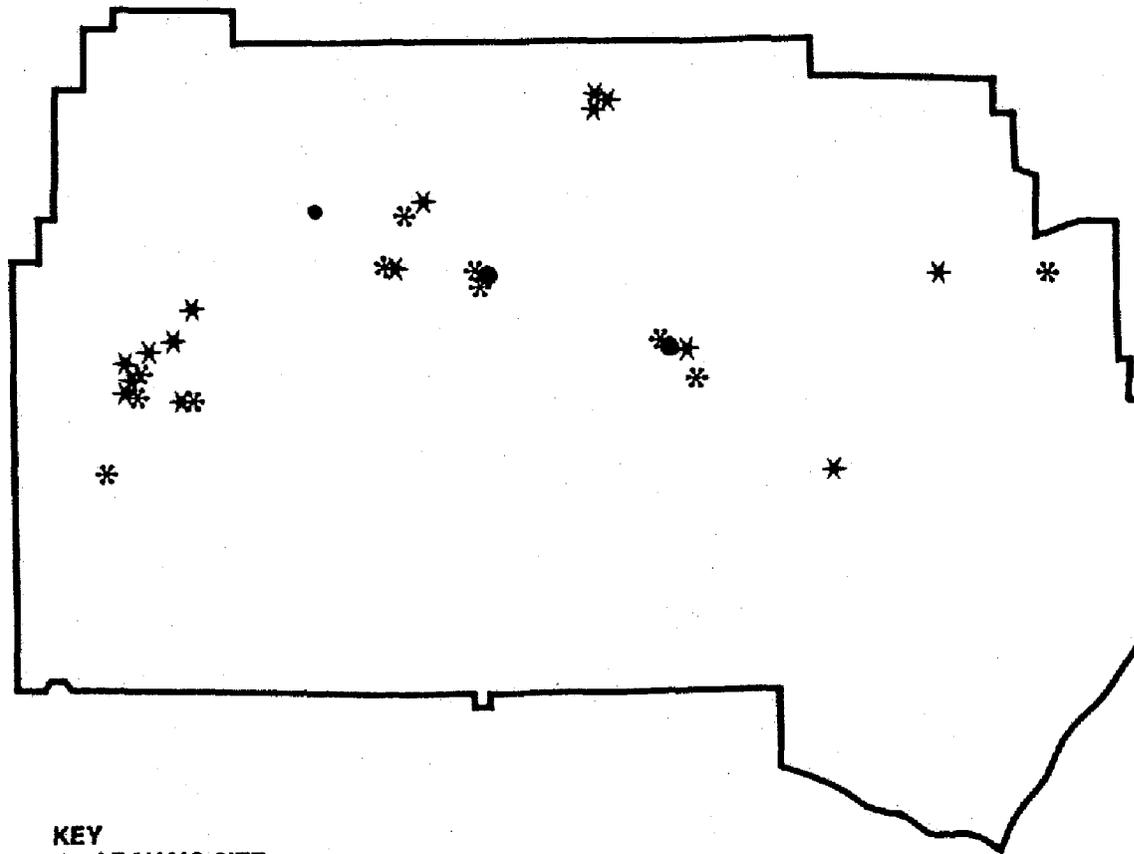
**Figure 4.5-2**  
**PELHAM RANGE - HISTORIC SETTLEMENT SITES**

- KEY**  
\* ARCHAIC SITE  
\* WOODLAND SITE  
● MISSISSIPPIAN SITE

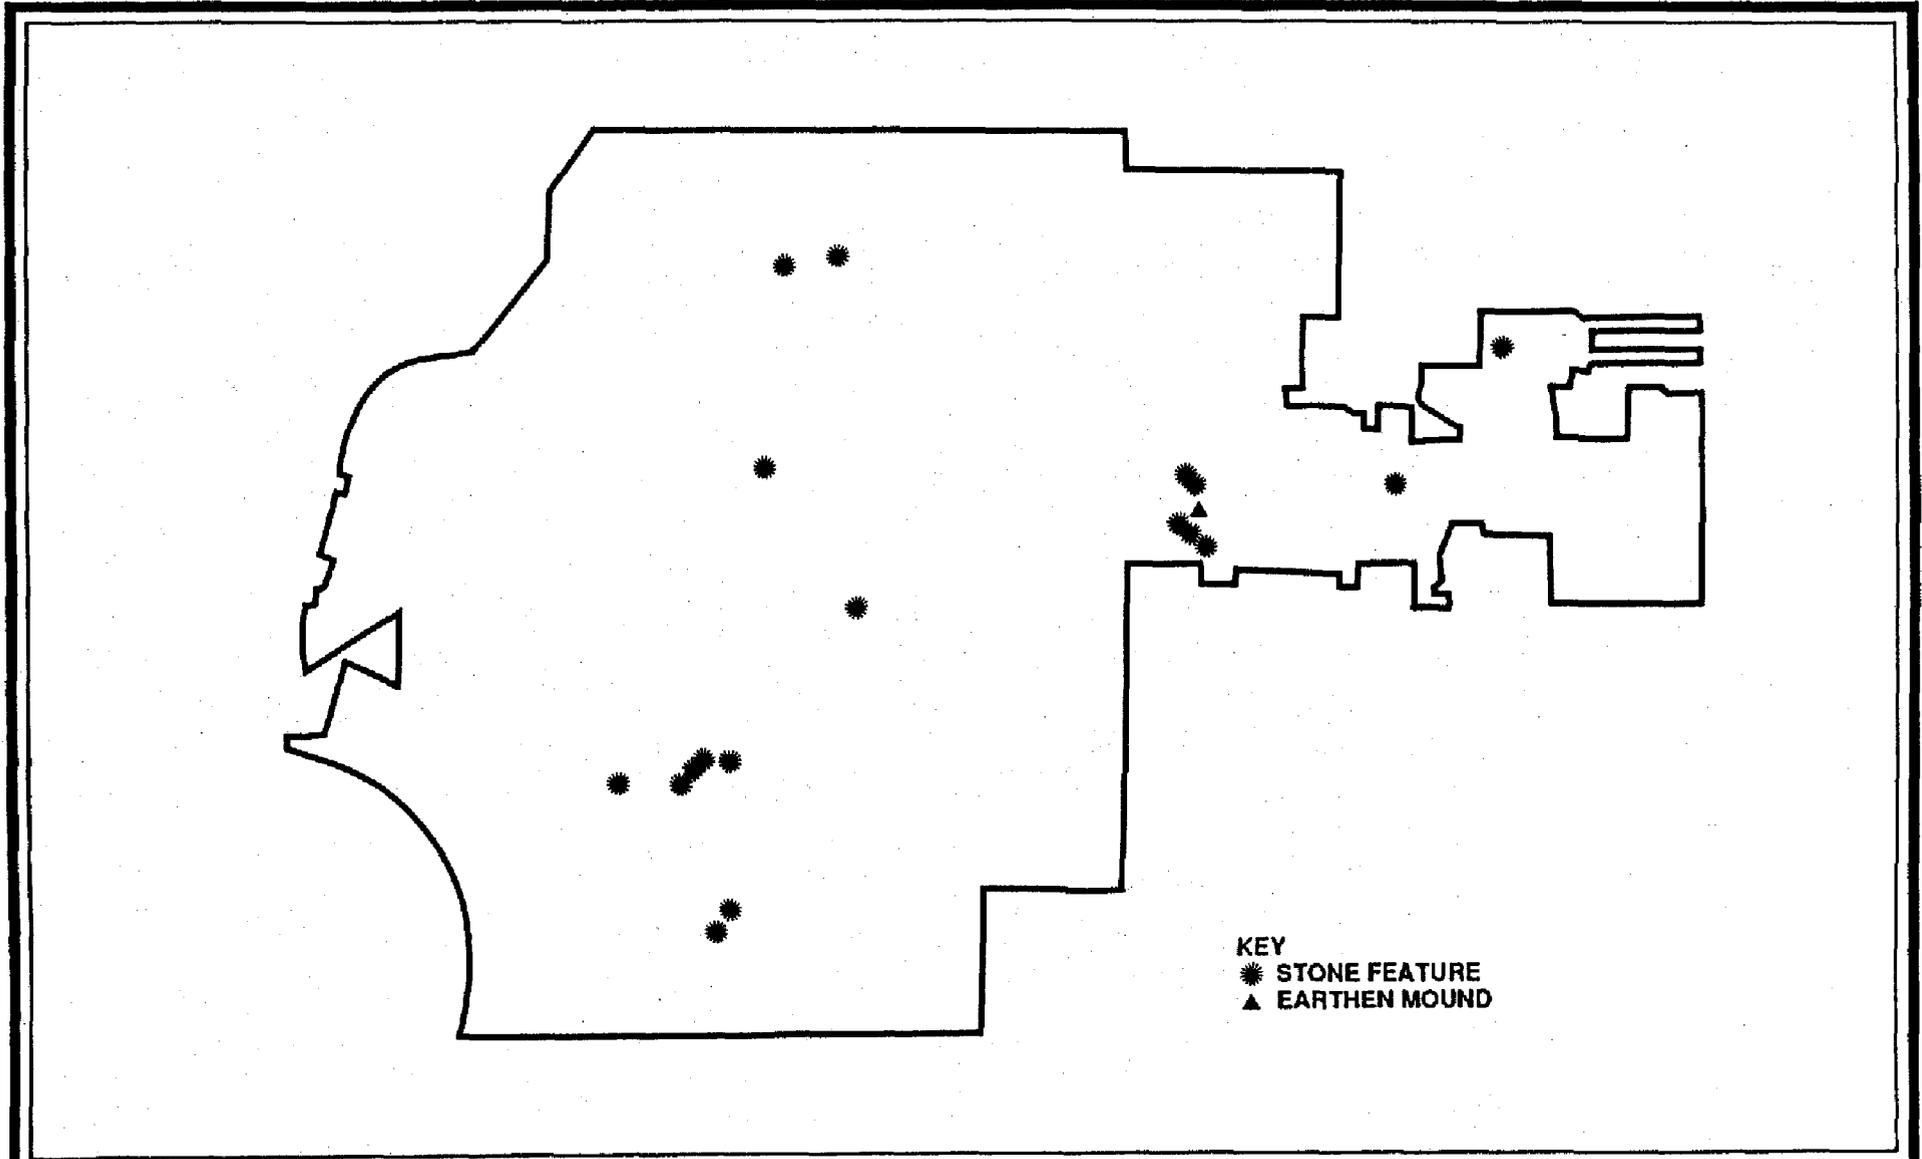
**Figure 4.5-3**  
**MAIN POST – MAN-MADE STONE FEATURES**  
**AND EARTHEN MOUNDS**

KEY  
\* STONE FEATURE  
▲ EARTHEN MOUND
