**Quality Assurance Audit Evaluation
On
Tetra Tech Environmental Corporation
Digital Geophysical Survey Results
for**

The Ft. McClellan Eastern Bypass Construction Debris Area

**Debra Edwards
Geotechnical Branch
USAESCH-ED-CS-G**

November 10, 2005

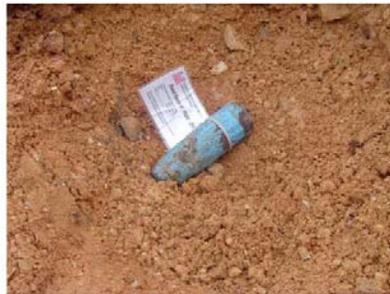
Figure 9. Item H20-20

All the seeded items were detected and unearthed by the Contractor with the exception of H20-20, which was planted on a slope. The USACE Onsite Safety Representative attempted to relocate the item, but it was no longer in the seeded location. After the seeded items were buried and prior to geophysical surveying, rainstorms occurred that creating wash-outs. The most plausible explanation for the non-detect is that the item was washed out during a rainstorm.
