ABBREVIATED SITE SAFETY AND HEALTH PLAN (SSHP)

EASTERN BYPASS
ENGINEERING EVALUATION/
COST ANALYSIS

FORT MCCLELLAN
FORT MCCLELLAN, ALABAMA

JULY 1998

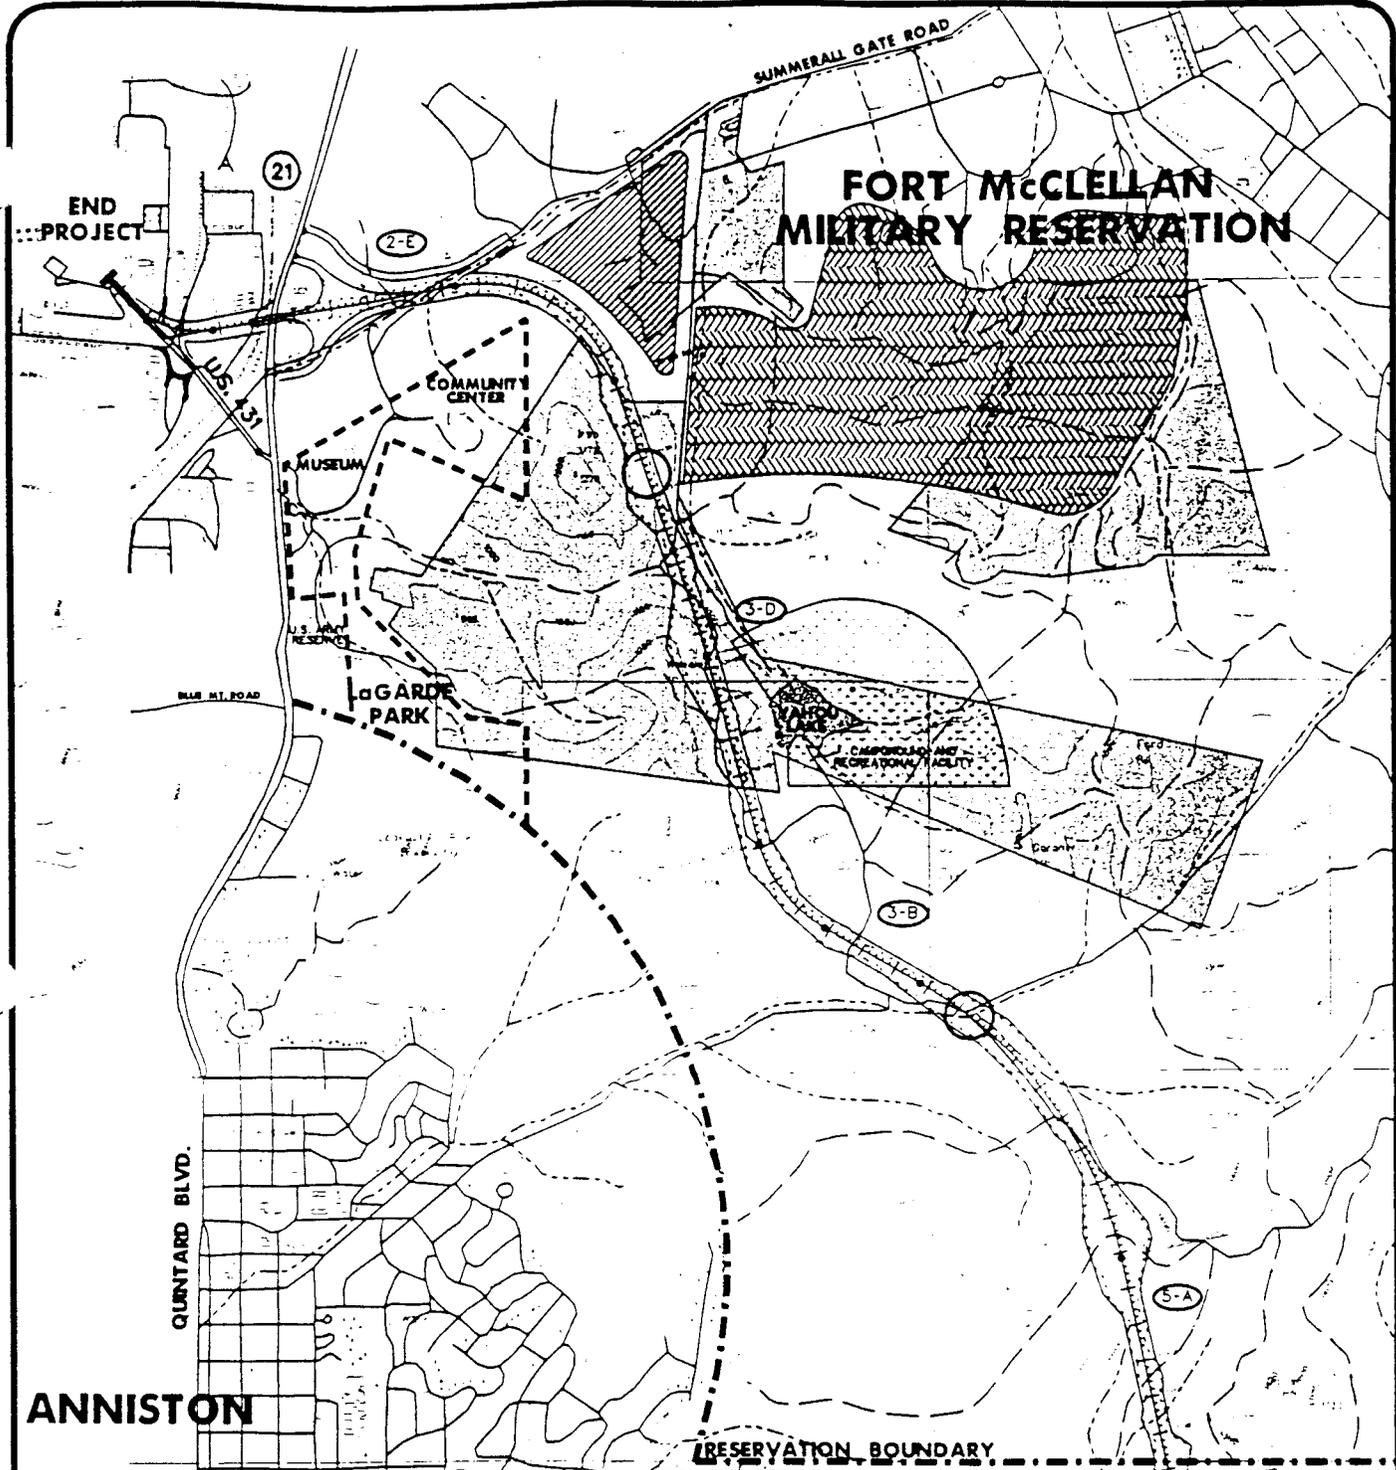
FORT McCLELLAN MILITARY RESERVATION

- POSSIBLE EXPLOSIVE ORDNANCE IMPACT AREAS
- PROPOSED McCLELLAN COMMERCIAL CENTER (APPROXIMATE)
- PROPOSED YAMOU RETREAT (APPROXIMATE)
- PROPOSED McCLELLAN RETIREMENT GOLF COMMUNITY (APPROXIMATE)
- PROPOSED BYPASS ALIGNMENT
- POSSIBLE INTERCHANGE LOCATION

**4-LANE
MEDIAN
DIVIDED
SECTION**

**5-LANE
SECTION**

Fort McClellan has been used for artillery training of troops and the National Guard as early as 1912 to present day, and is located in Calhoun County, Alabama, northeast of Anniston (Figure 1). The proposed eastern bypass route begins on the western boundary of the installation in the vicinity of Summerall Gate and proceeds due east approximately one (1) mile, then turns due south for approximately 3.5 miles to the southern boundary.

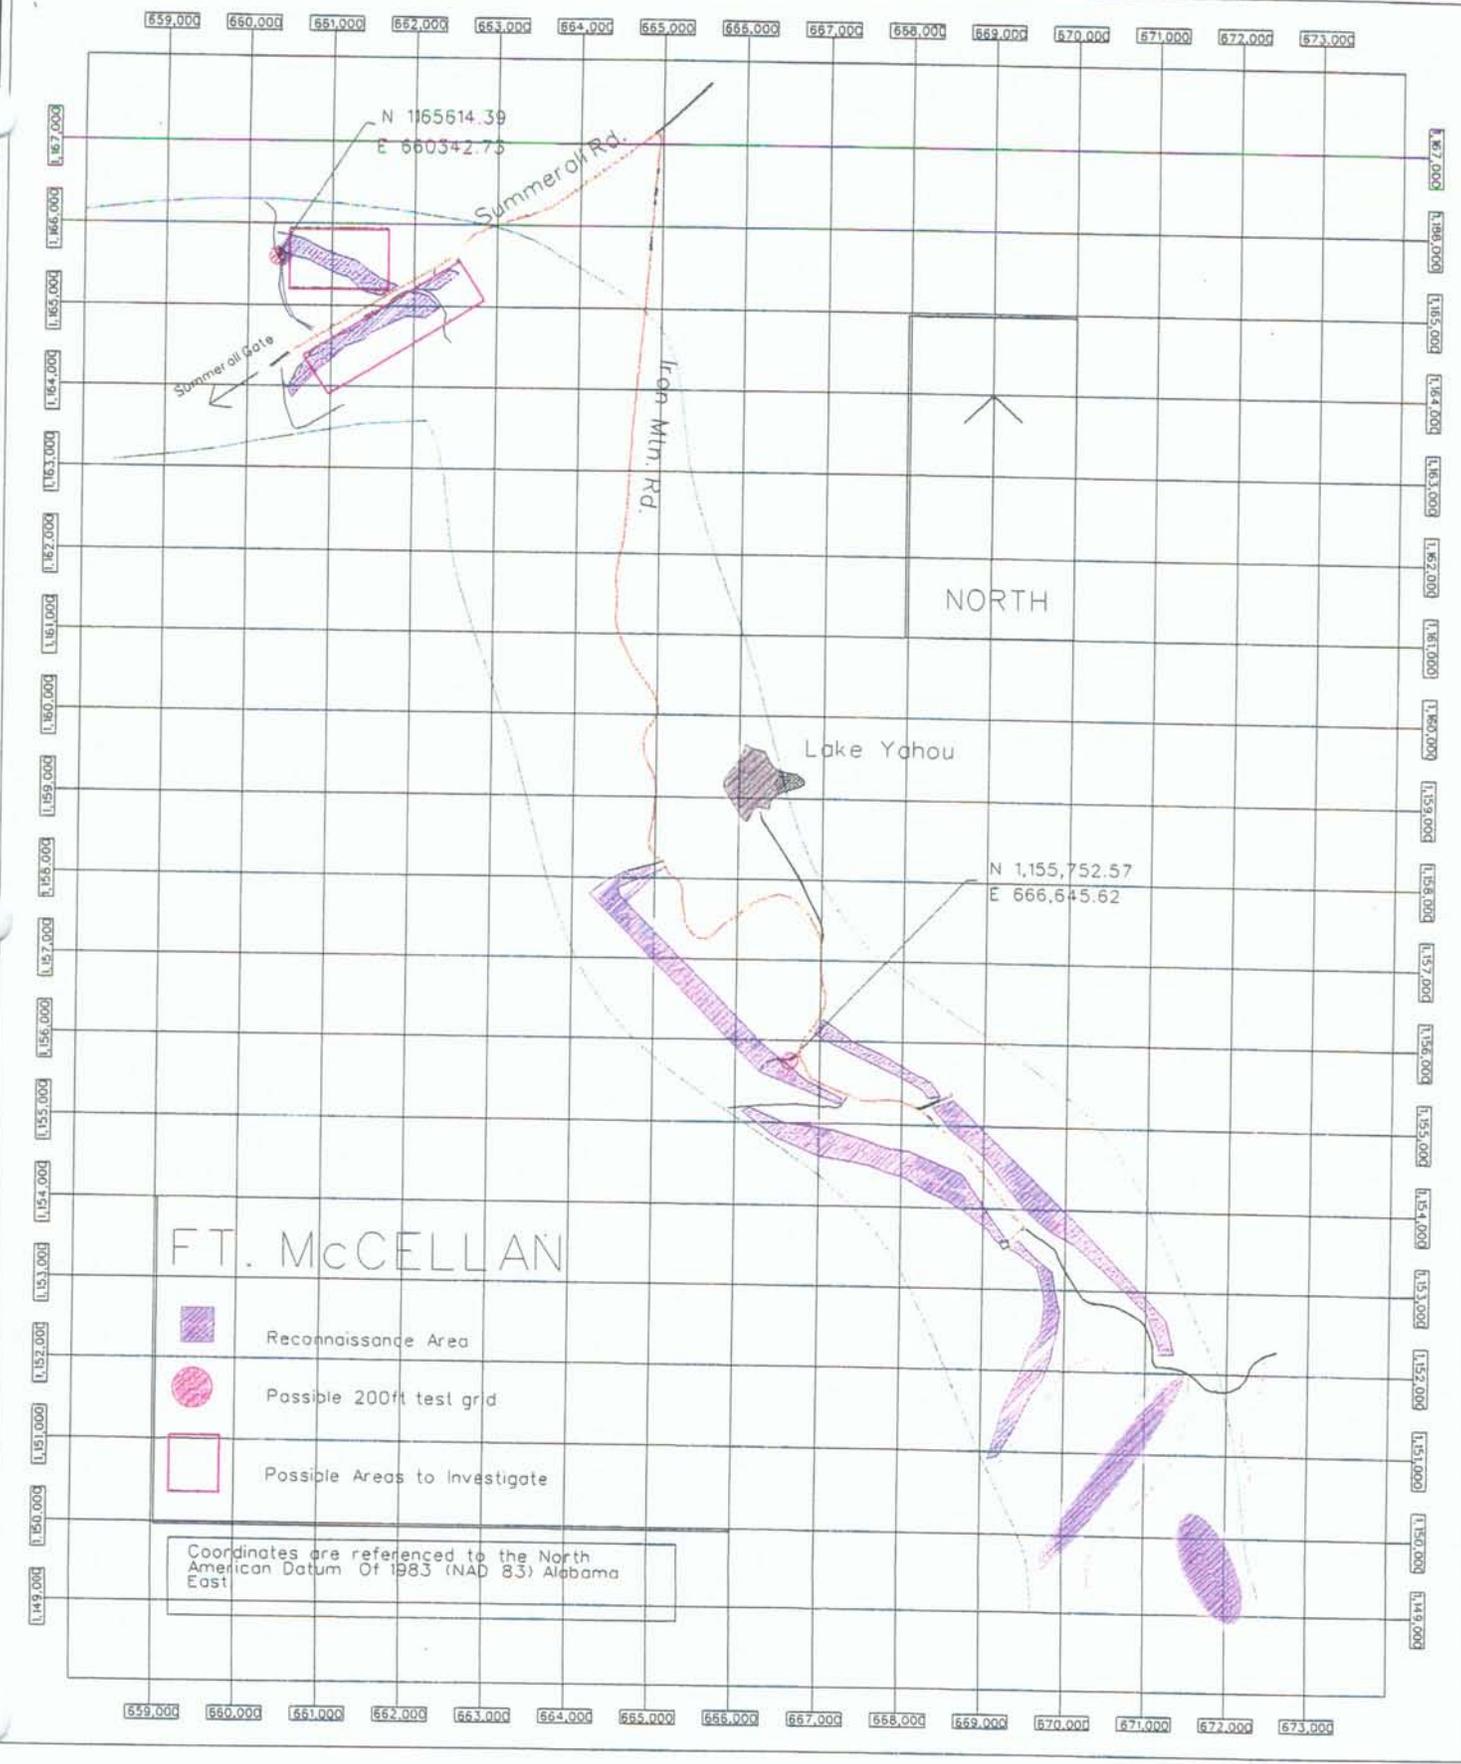
PROJECT TITLE: FORT McCLELLAN EASTERN BYPASS
DRAWING TITLE: GPS GRID

Coordinates are referenced to the North American Datum Of 1983 (NAD 83) Alabama East

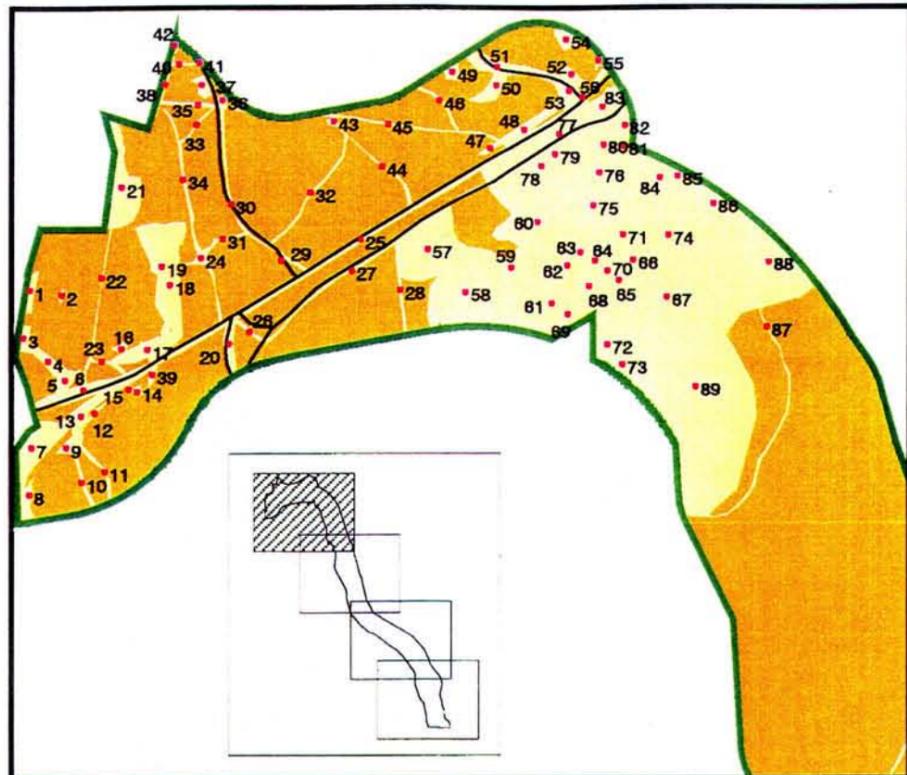
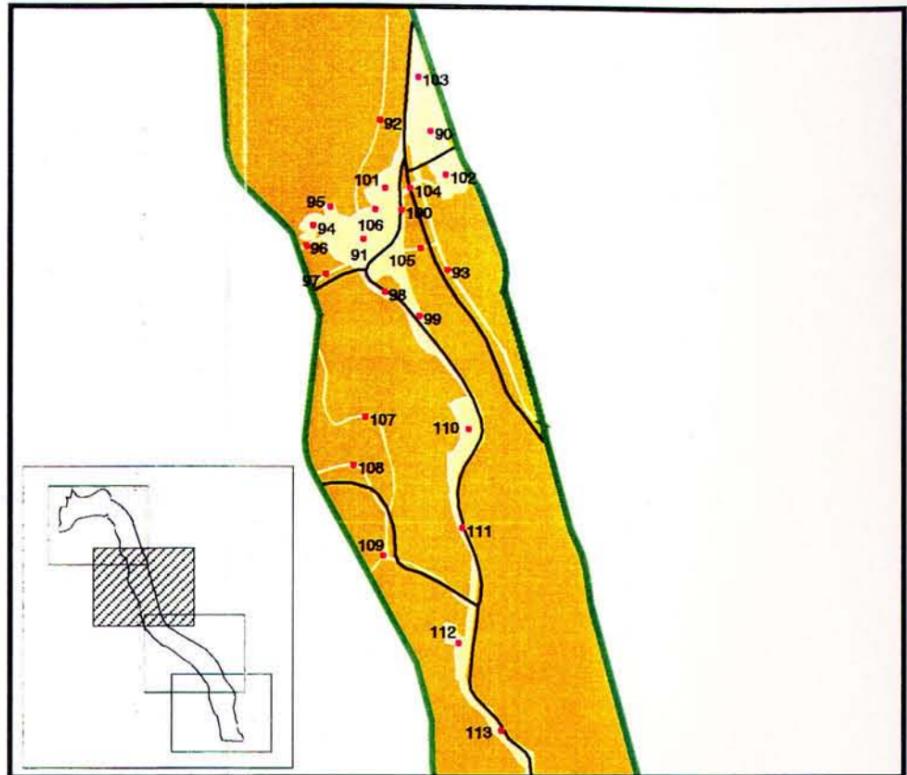
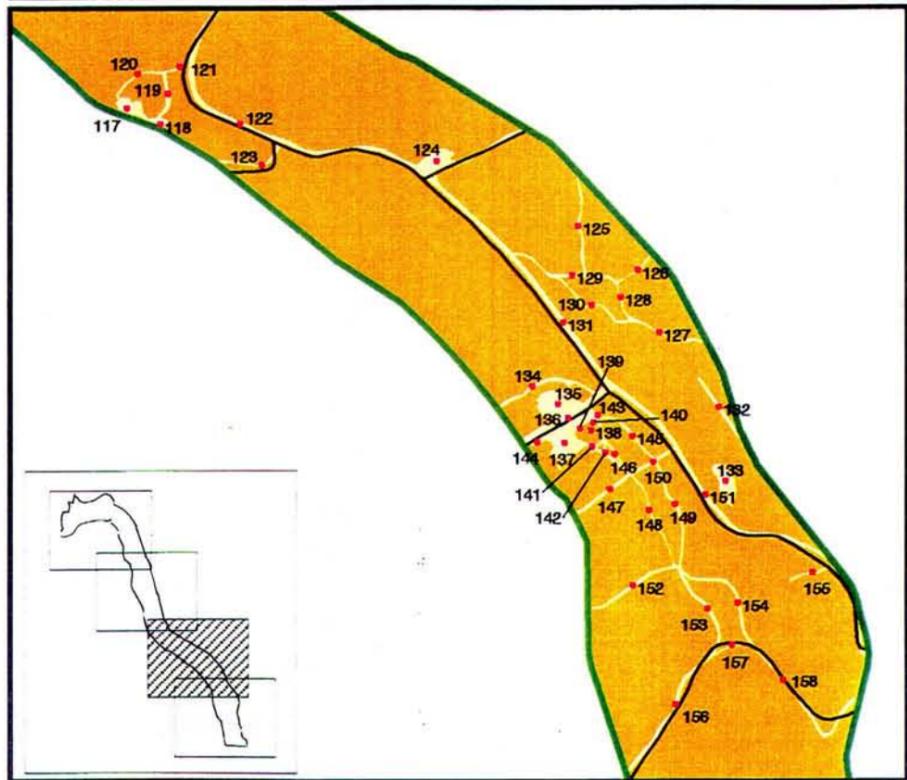
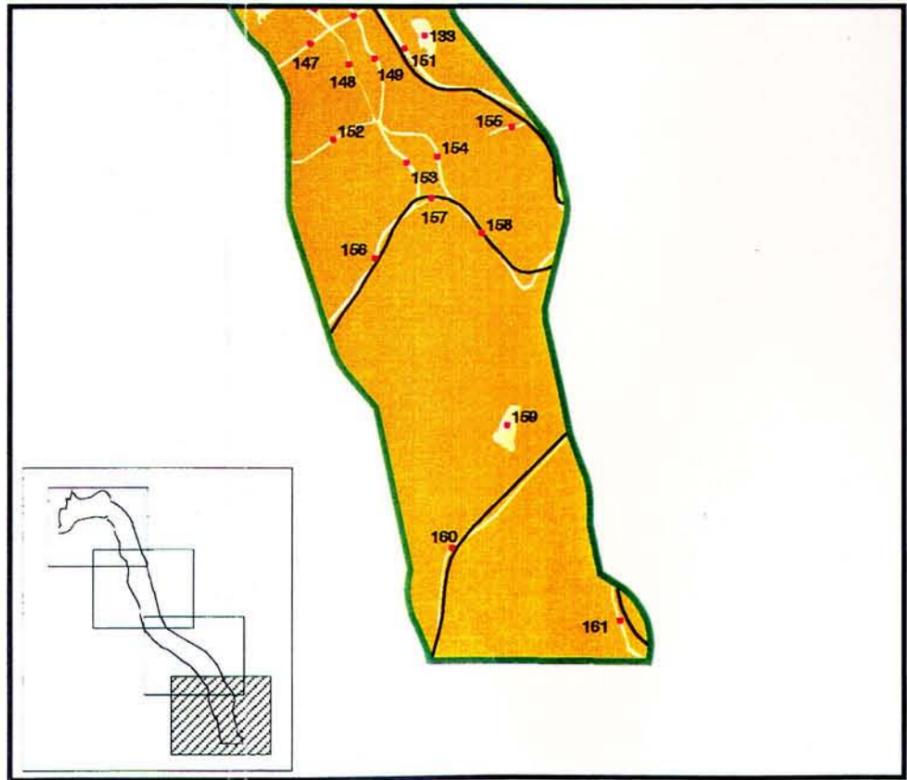
Anomalies from Interpretation of Historical Aerial Photography: 1937-1994

One hundred sixty-one anomalies were identified by the historical aerial photography investigation and are shown on the figure titled "Anomalies from Interpretation of Historical Aerial Photography: 1937-1994." Table 2 contains information for each anomaly; including the anomaly tracking number, the center point coordinate (in Alabama State Plane East, North American Datum [NAD] 83 coordinates), the reason (or cause) of the anomaly, and comments. During the final quality assurance review of the land use/cover anomalies, four anomalies were determined to be photographic interpretation errors. These anomalies are identified as "QA" in Table 2 and will not be discussed further. The remaining 157 anomalies were caused by or associated with the following:

- the creation/widening/destruction of roads and trails (97 anomalies),
- the construction or existence of buildings (6 anomalies),
- firing range/ammunition areas (3 anomalies), and
- cleared or disturbed areas of unknown cause (51 anomalies).

While all roads are considered human disturbance to landcover and are identified as anomalies, those of concern are the many roads that appear for only a brief period of time. This phenomenon occurred predominately during the 1960's. It is possible that these roads were built in association with disposal or training activities.

Other common anomalies include small areas that were cleared or partially cleared of vegetation. While the reason for some of these clearings (e.g., construction of a building complex) is evident in the photographs, the cause for many others is unknown.

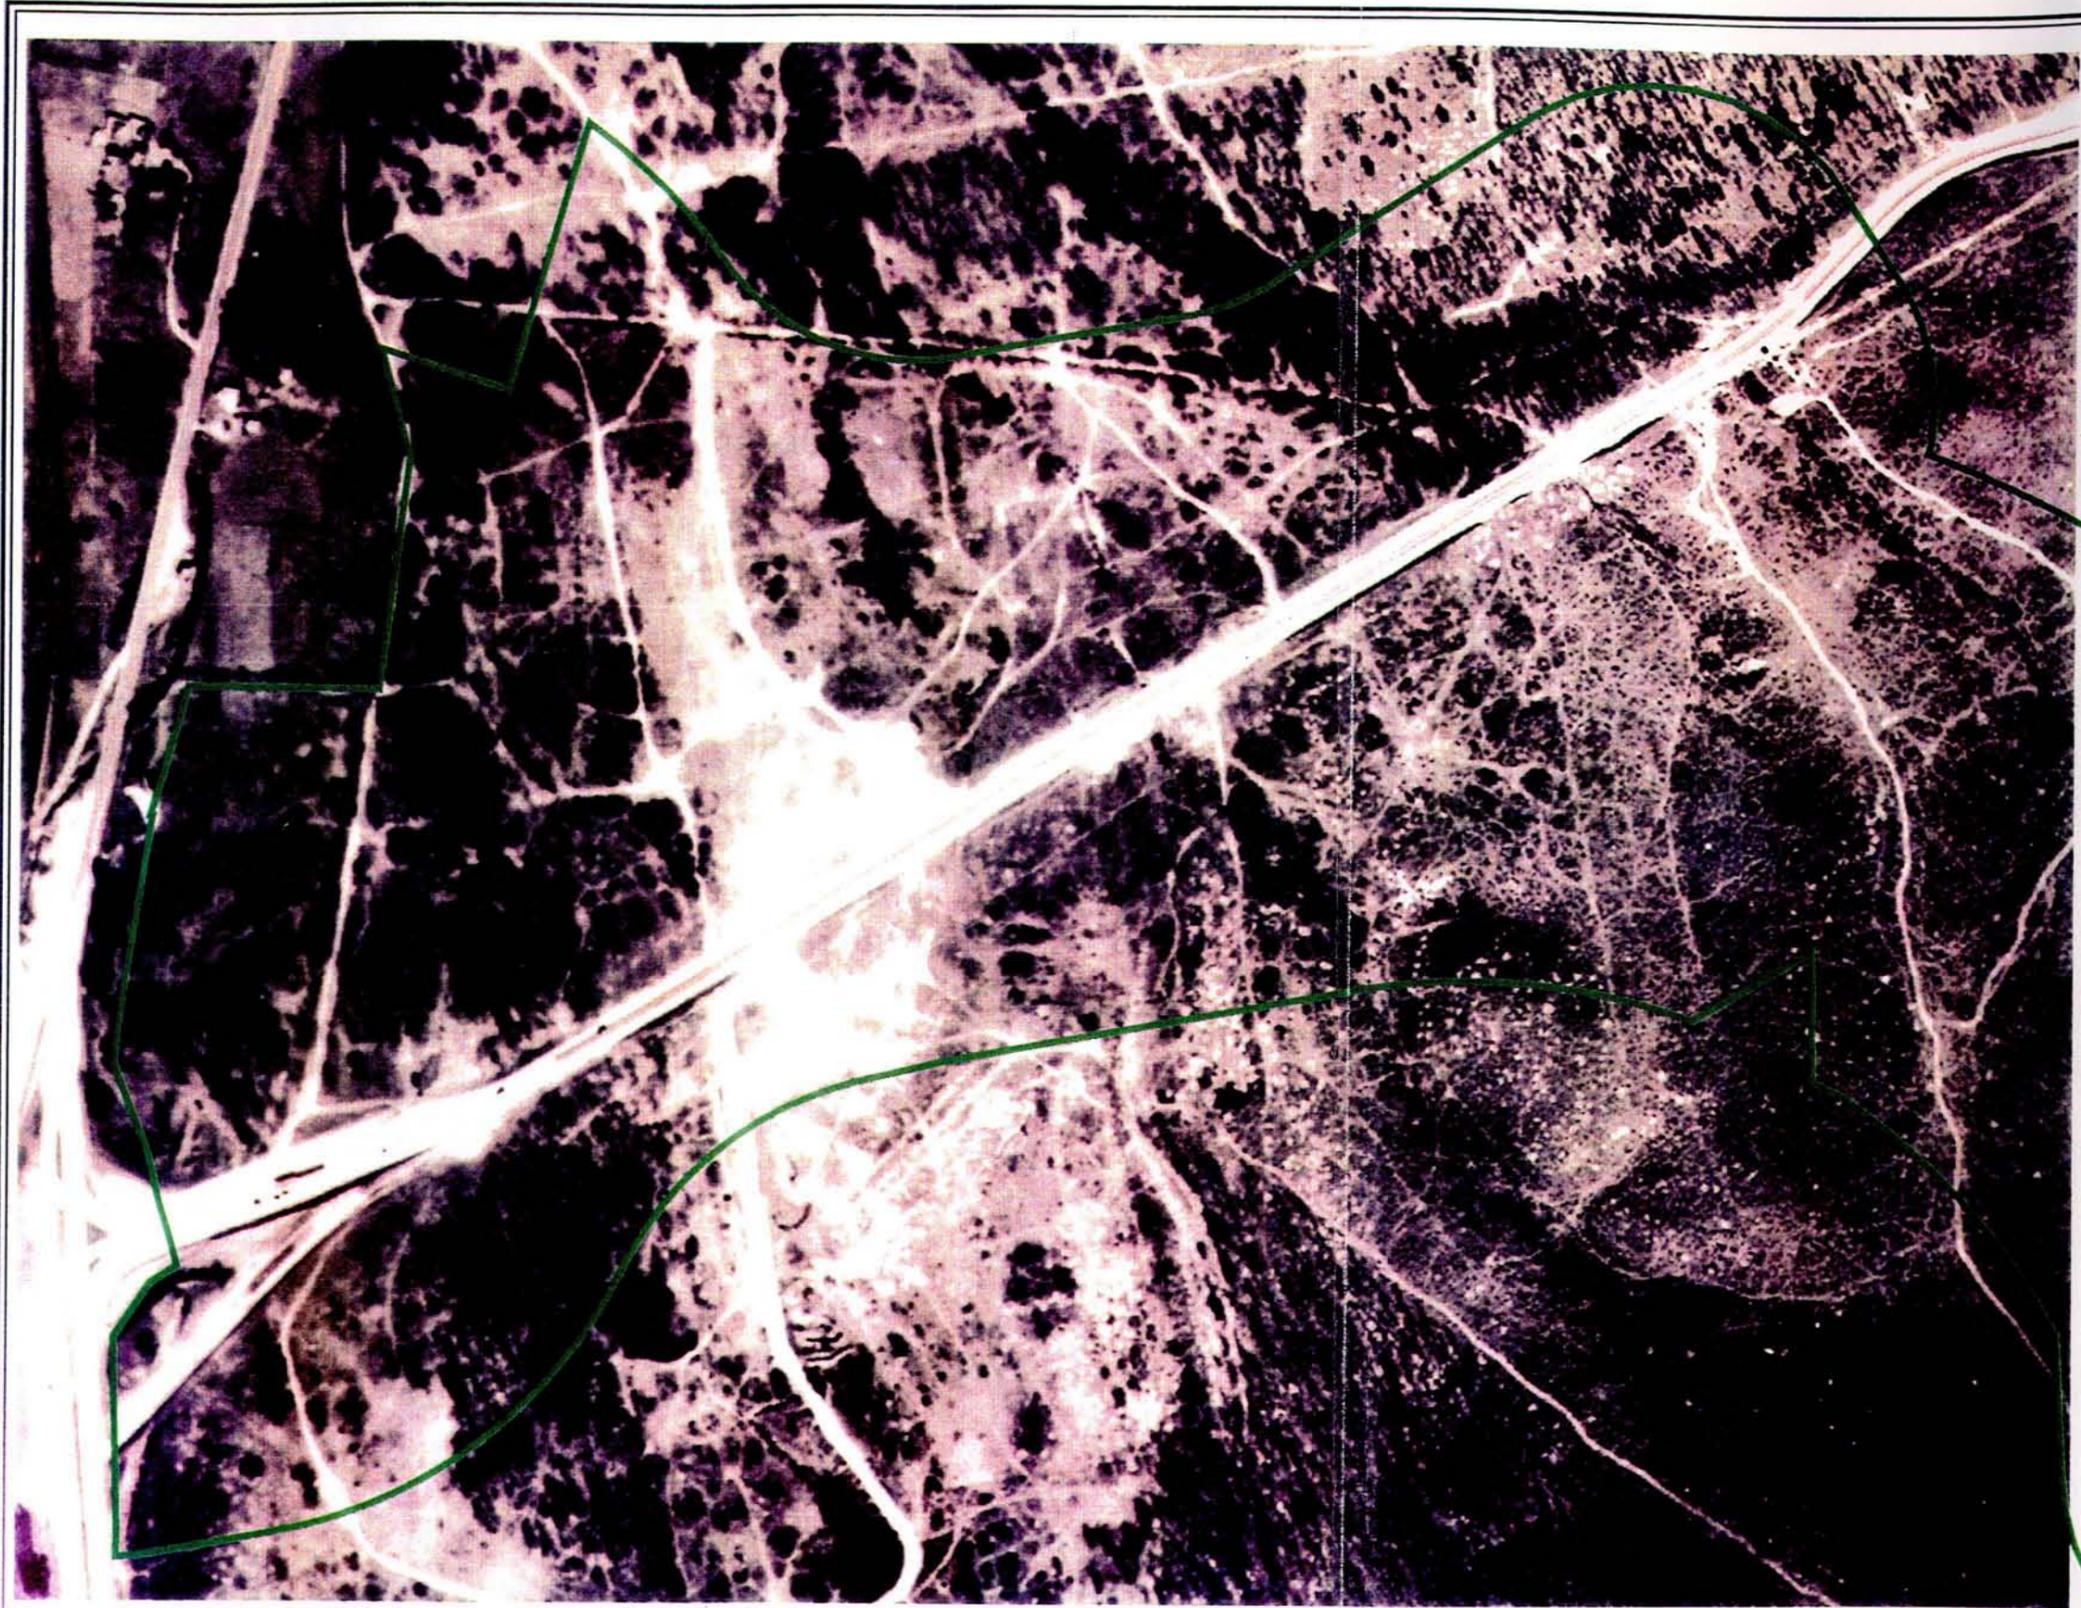
1944 Disturbed Area

In the northern part of the Fort McClellan East By-Pass Study Area, the greatest change in landcover and the cause for most anomalous areas of concern occurred during the years of World War II. Between 1937 and 1944 the terrain was deforested and criss-crossed with numerous roads, trails and vehicle paths. The figure, "1944 Disturbed Area" depicts these activities in a 1944 photograph of the northwest portion of the study area. Located approximately .25 miles south of this area, along the eastern boundary of the study area, is a firing range or ammunition area. First evident after the end of the war, gradual increase in activity can be observed in photographs acquired in 1954 through 1994. The figure "Firing/Ammunition Range" shows photographs of this area for the five time periods of concern.

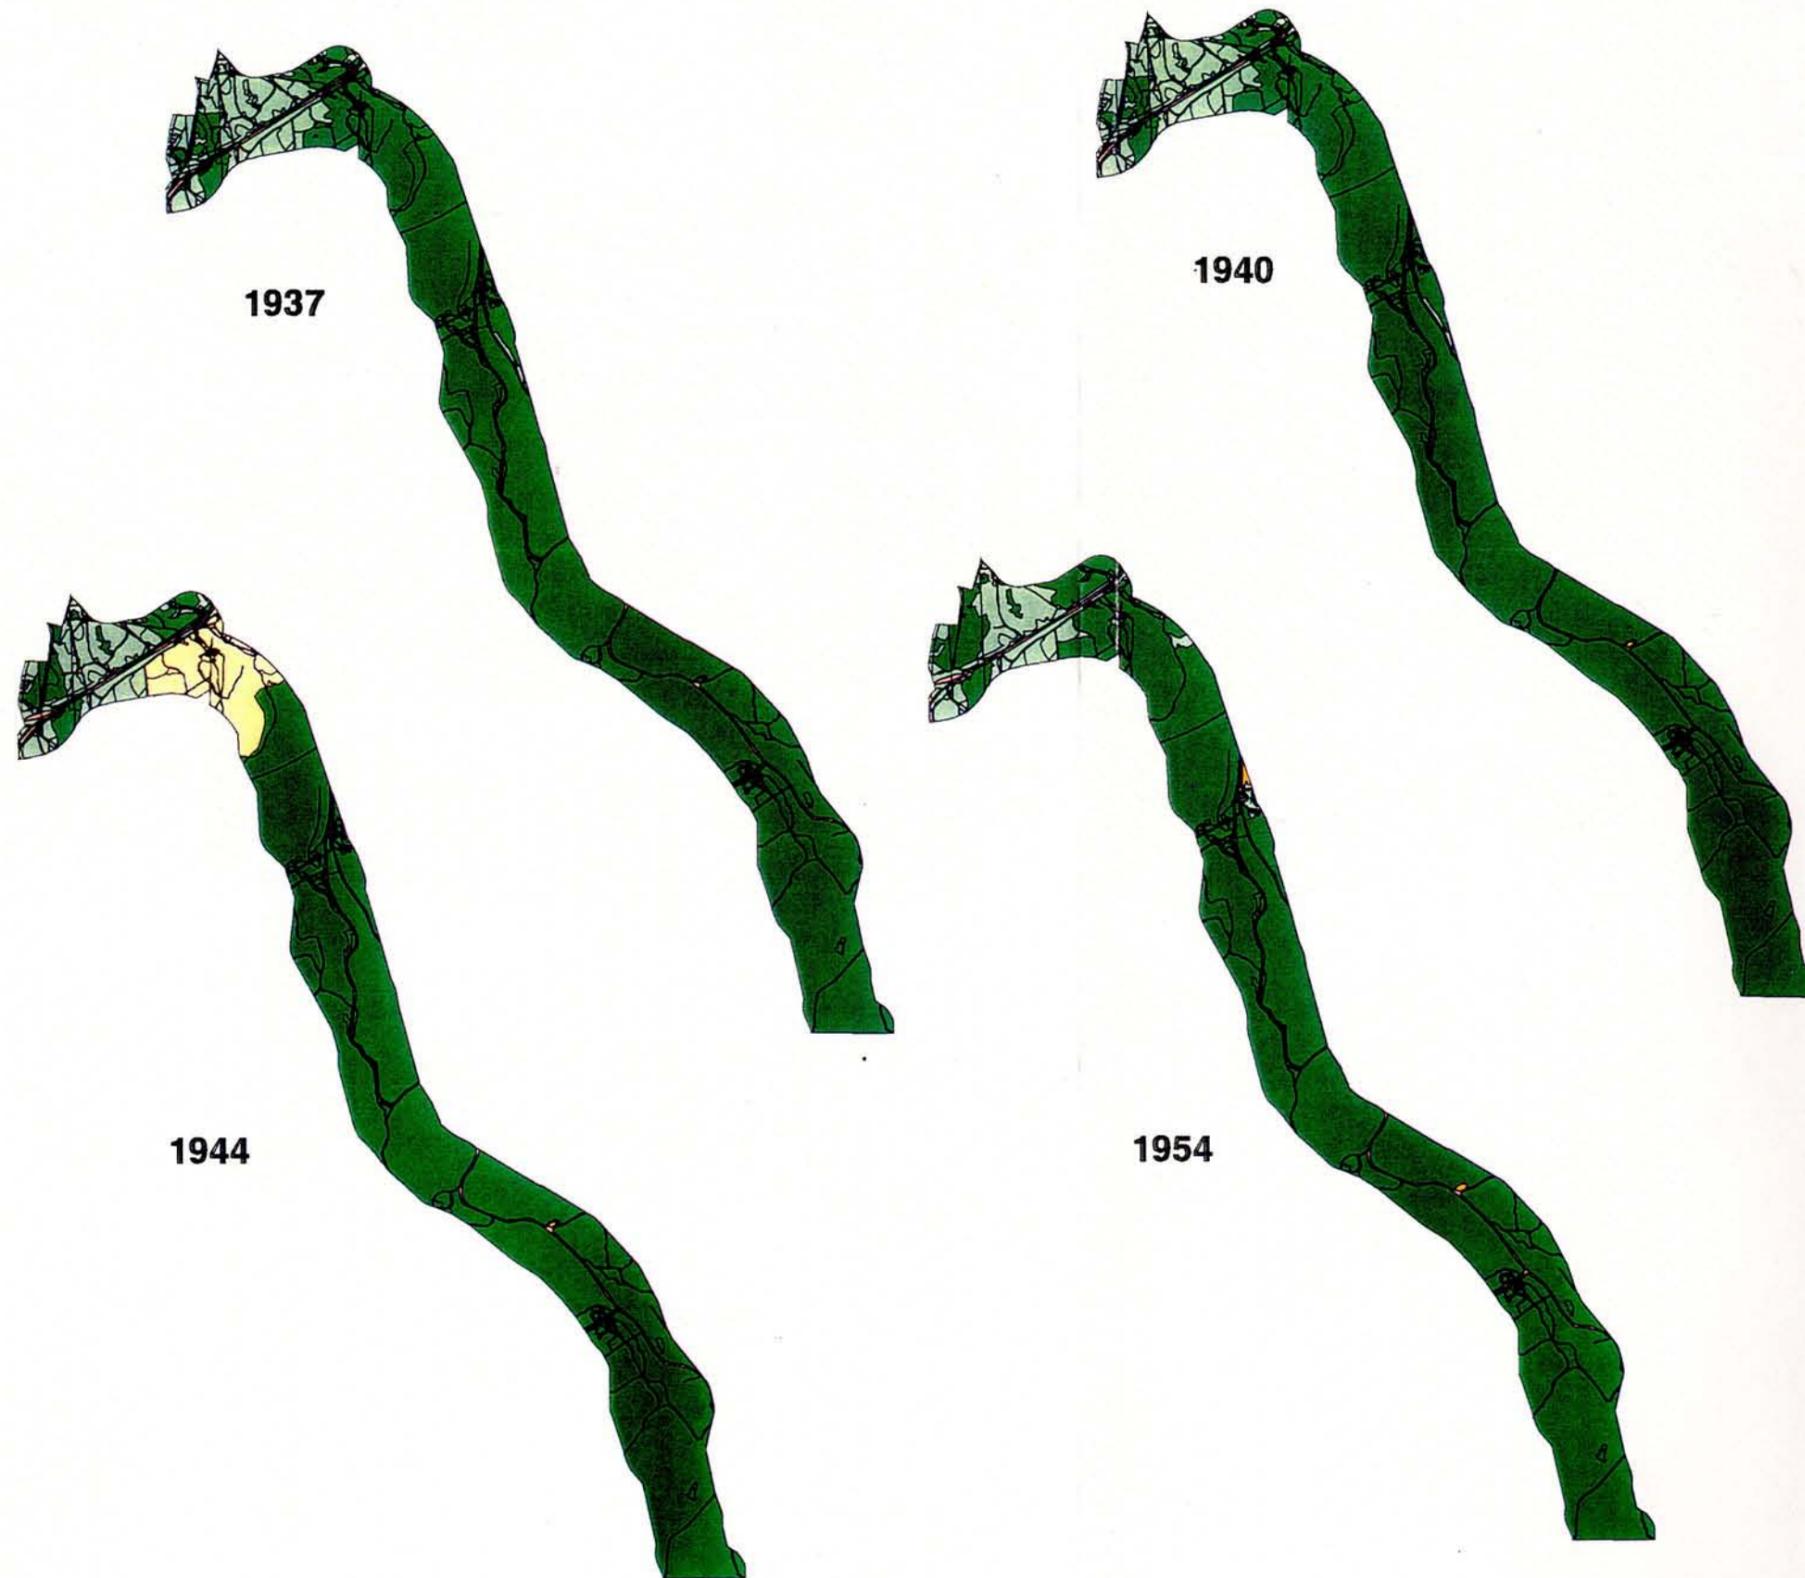
Landuse/Cover

Fort McClellan Aerial Photographic Interpretation Land Use/Cover Classification System		
Level I	Level II	Level III
Developed Land	(Dc) Commercial	
	(De) Excavation	
	(Di) Industrial	(Dia) Airport (including runways, towers, buildings, etc.)
		(Dib) Building
		(Dih) Hazardous Waste Operations
	(Dn) Institutional	(Dna) Ammunition Range
		(Dnc) Cemetery
		(Dnj) Correctional
		(Dne) Educational
	(Dng) Governmental Building	
	(Dnl) Landscaped Area	
	(Do) Open Land	
	(Dp) Pile	
	(Dr) Recreational	(Drg) Golf Course
		(Drp) Park
		(Drm) Marina or Boat Dock
		(Drs) Stadium, Fairgrounds, Race Track
	(Ds) Residential	(Dss) Single House
		(Dsm) Subdivision
	(Dt) Transportation	(Dtr) Railroad
		(Dth) Road (major roads and highways)
		(Dtp) Parking Lot
	(Du) Utility	
Agricultural	(Ab) Building	
	(Ac) Cropland/Pastureland	
	(Ao) Orchard	
Undeveloped	(Ub) Bare Land	
	(Ue) Erosion	
	(Uf) Forest	
	(Ug) Grassland	
	(Us) Scrub/Shrub	
Water	(Wl) Lake/Pond
