Site Investigation Report
Former Ordnance Motor Repair Area,
Parcels 75(7), 5(7), 6(7), 41(7), and 42(7)

Fort McClellan
Calhoun County, Alabama

September 2001

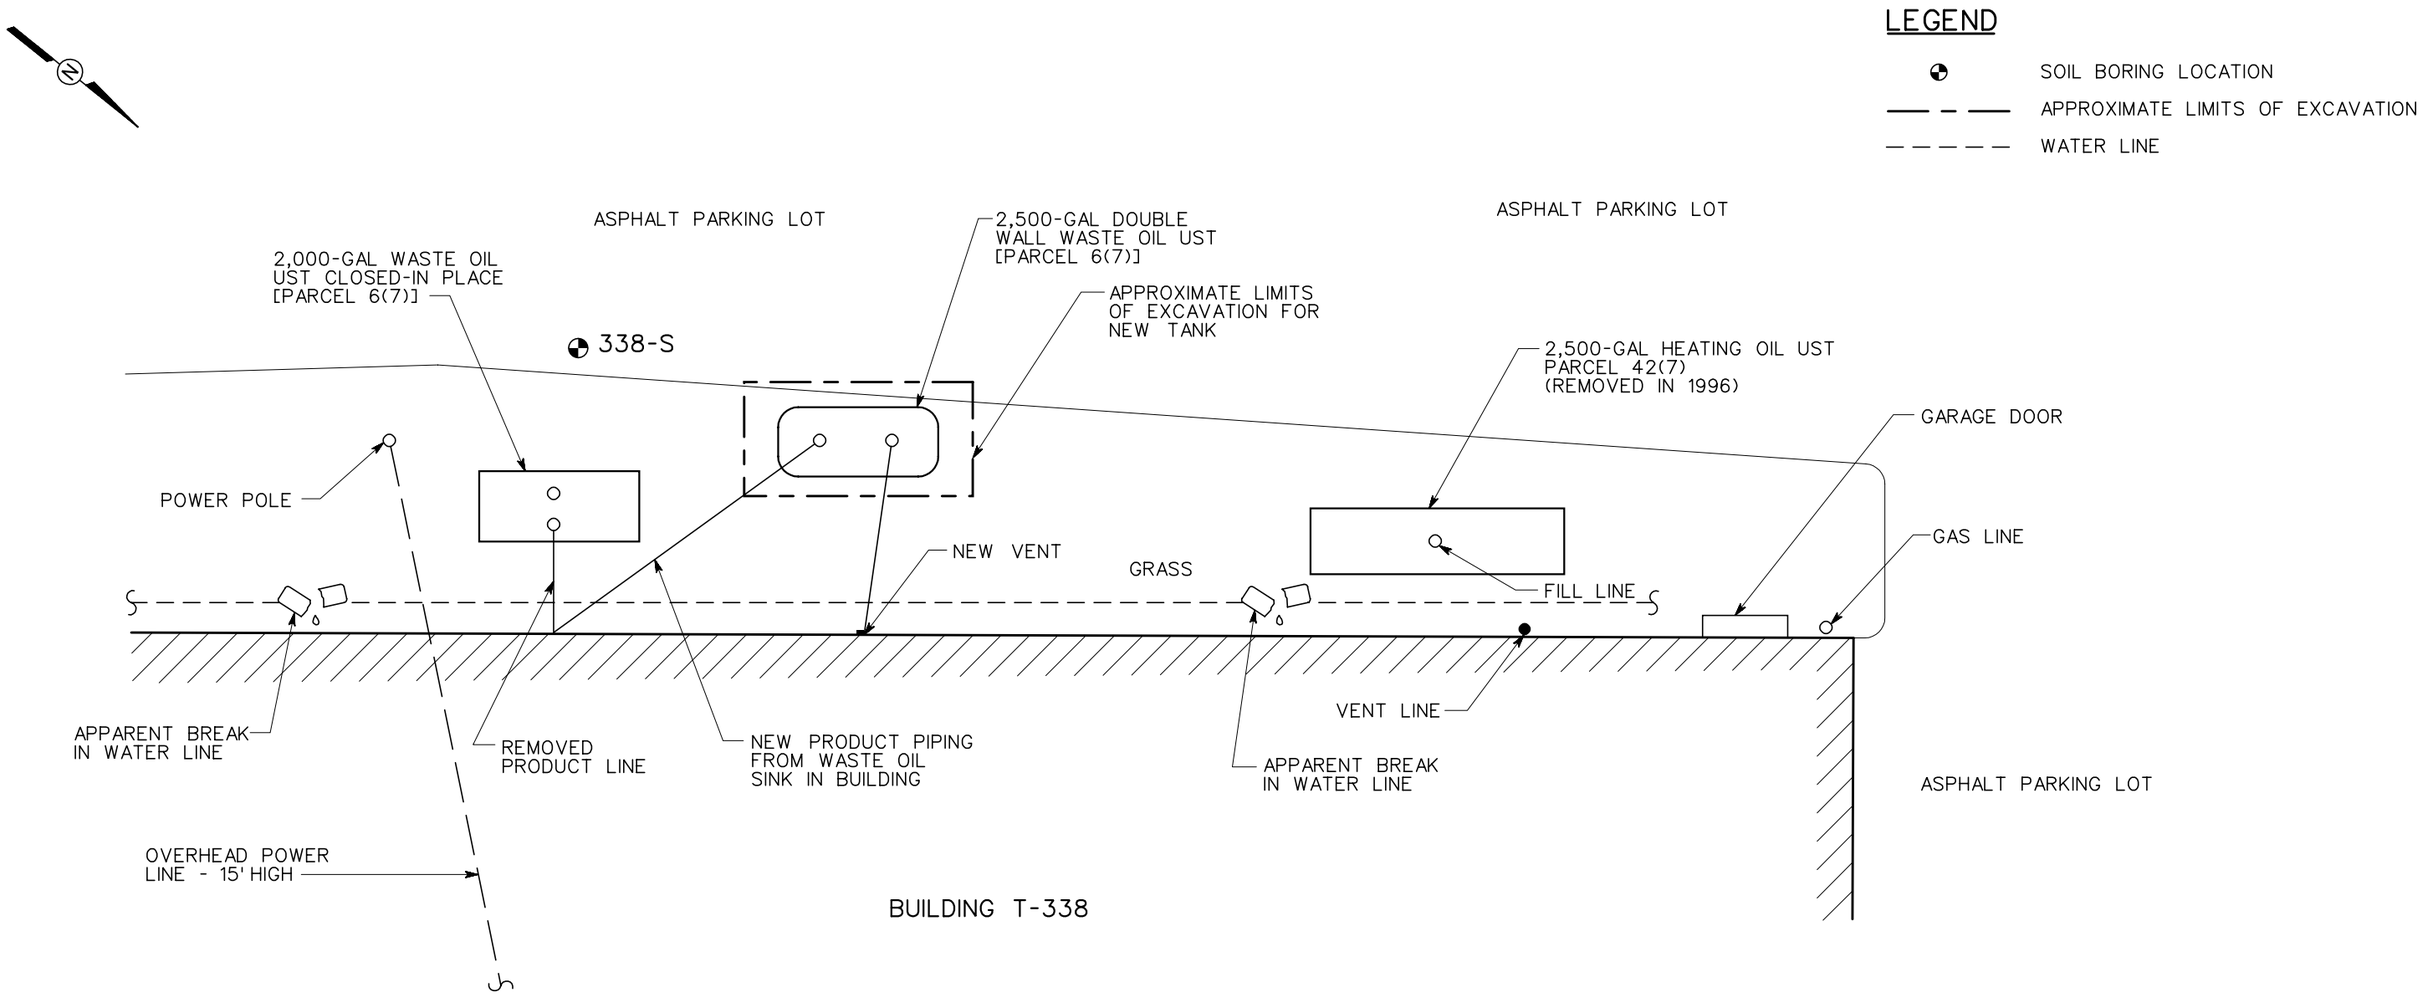
FIGURE 2-1
EXISTING AND REMOVED USTs AT BUILDING T-338, PARCELS 6(7) AND 42(7)
FORMER ORDNANCE MOTOR REPAIR AREA
PARCELS 75(7), 5(7), 6(7), 41(7), AND 42(7)
U. S. ARMY CORPS OF ENGINEERS
MOBILE DISTRICT
FORT McCLELLAN
CALHOUN COUNTY, ALABAMA
Contract No. DACA21-96-D-0018

USTs at Building T-338 (Parcel 6[7]). A 2,000-gallon waste oil UST (Parcel 6[7]) was located on the western side of Building T-338, the former Radiator Repair Shop (Figure 1-3). The original UST was located adjacent to the wall footing and, therefore, was closed in place on May 5, 1994. The ADEM closure report is included in the UST summary report (IT, 1998c). A replacement 2,500-gallon waste oil UST (Parcel 6[7]) was installed in 1994.

Waste oil was placed into a sink in Building T-338 and gravity-fed via an underground plastic pipe to the 2,000-gallon waste oil UST. The piping was removed during the closure and apparent petroleum-contaminated soil was found in the excavation trench. The soil was removed and placed in a stockpile. Petroleum-contaminated soil, which was found where the pipe connected to the UST, was removed and added to the stockpile. The excavated soil removed from the top of the tank was also added to the stockpile. The stockpiled soil (approximately 3 cubic yards) was removed and thin-spread at a Base landfill (Braun Intertec Corporation [Braun], 1995). Since no holes were observed in the UST, the tank was abandoned in-place by filling with concrete slurry.

Only one soil boring was installed near the 2,000-gallon waste oil UST because of its close proximity to Building T-338 and overhead power lines. The soil boring was placed southwest of the closed-in-place UST (Figure 2-1). Weathered bedrock was encountered at 6 feet bgs and refusal was reached at 7.5 feet bgs (Braun, 1995). It was not possible to determine whether groundwater was encountered in the excavation because two water mains, one on each side of the closed tank, ruptured and flooded the excavation (Figure 2-1). According to FTMC, these water mains had been broken for several months (Braun, 1995). Water was encountered in the soil boring at approximately 5 feet bgs.

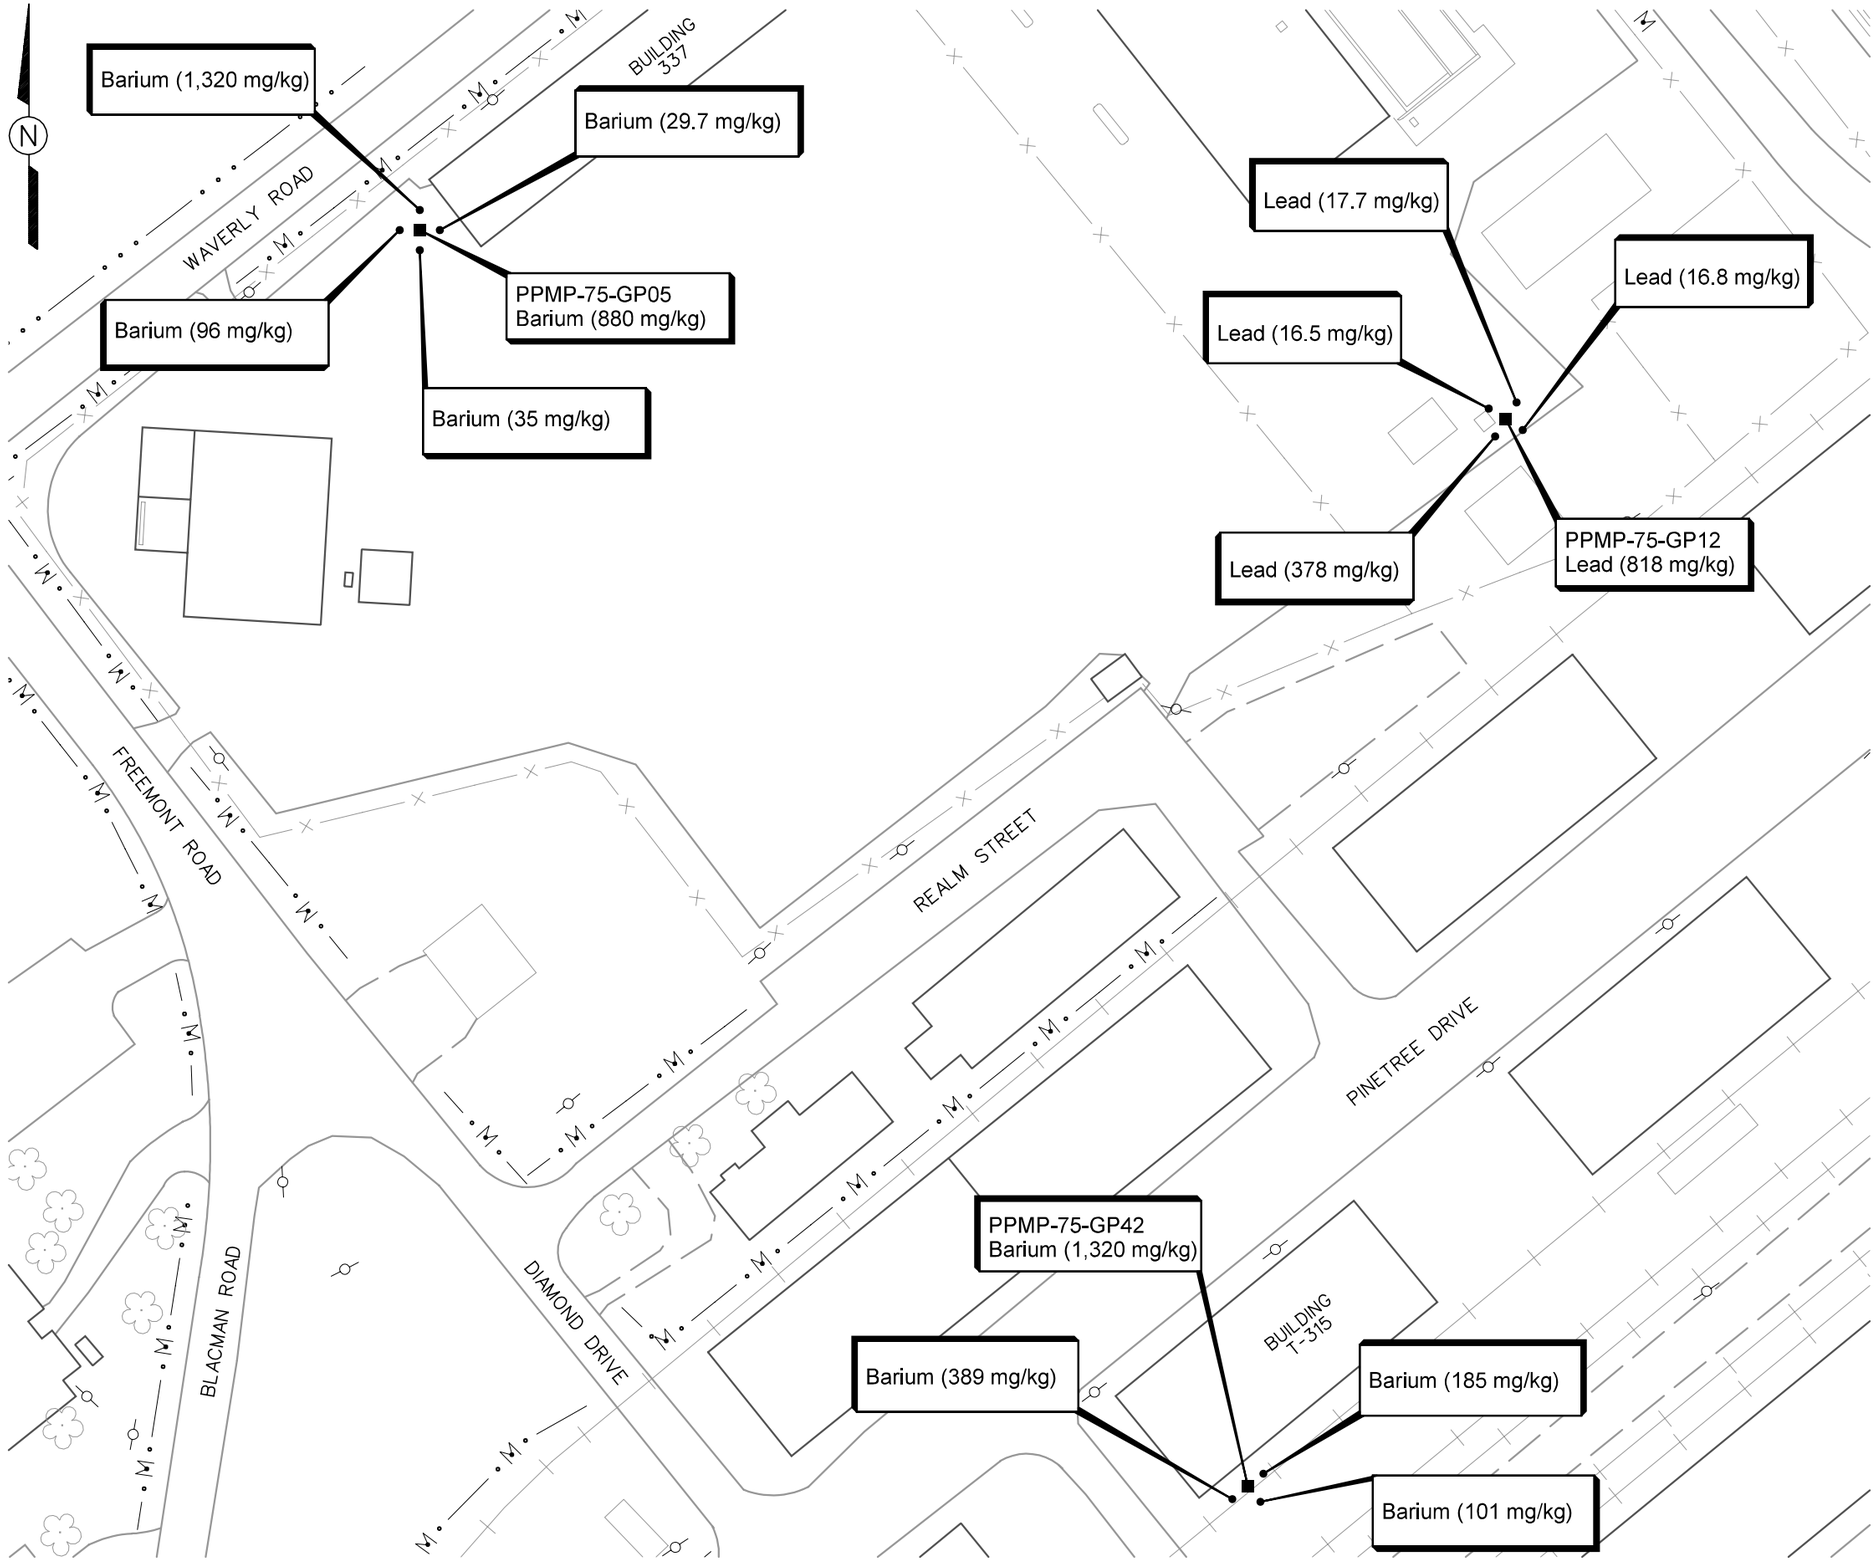
Metals. Twenty-three metals were detected in surface and depositional soil samples collected at the FOMRA. The concentrations of eight metals (aluminum, arsenic, barium, chromium, iron, lead, manganese, and thallium) exceeded SSSLs. Of these metals, aluminum (three locations), arsenic (thirteen locations), barium (PPMP-75-GP05 and PPMP-75-GP42), chromium (four locations), iron (four locations), lead (PPMP-75-GP12 and PPMP-75-GP31), and manganese (PPMP-75-GP08 and PPMP-75-GP57) concentrations also exceeded their respective background concentrations. Of these exceedances, the results were within the range of background values determined by SAIC (1998) (Appendix H) with the exception of barium at two locations (PPMP-75-GP05 and PPMP-75-GP42), chromium at one location (PPMP-75-GP40), iron at one location (PPMP-75-GP08), and lead at two locations (PPMP-75-GP12 and PPMP-75-GP31).

Two surface soil sample locations with elevated barium results (880 mg/kg at PPMP-75-GP05 and 1,320 mg/kg at PPMP-75-GP42) and one location with an elevated lead result (818 mg/kg at PPMP-75-GP12) were considered to be possibly anomalous results. To verify whether these results were representative of the surface soil at these locations, initial confirmation samples were collected in 10-foot intervals to the north, south, east, and west of each location, where feasible, on February 9, 2001 (Figure 5-1). At locations PPMP-75-GP12 (lead) and PPMP-75-GP42 (barium), initial confirmation sample analytical results were below SSSLs (Table 5-2). However, the barium concentration in the confirmation sample collected north of PPMP-75-GP05 was 1,320 mg/kg. Therefore, two final confirmation samples were collected at approximately 10-foot intervals from that sampling location on May 11, 2001 (Figure 5-2). Barium concentrations in the final confirmation samples were 20.7 mg/kg and 34.1 mg/kg, well below the 547 mg/kg SSSL (Table 5-3).
