FORT McCLELLAN, ALABAMA

LEAD-BASED PAINT WIPE SAMPLE RISK ASSESSMENT ANALYTICAL RESULTS

BUILDING #9

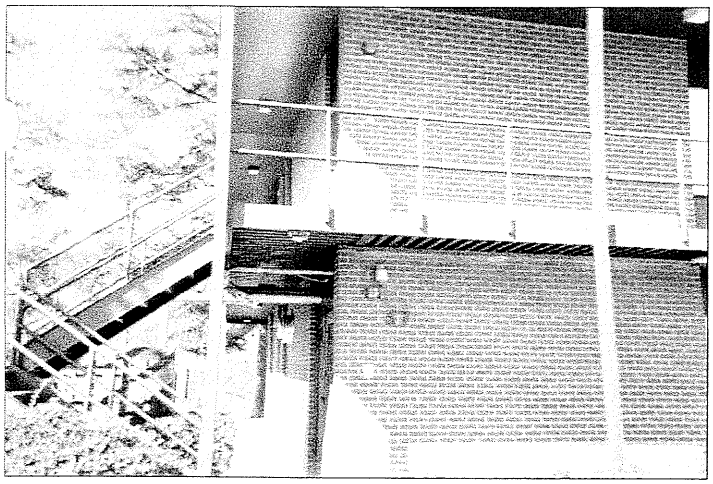
View of Building No. 57

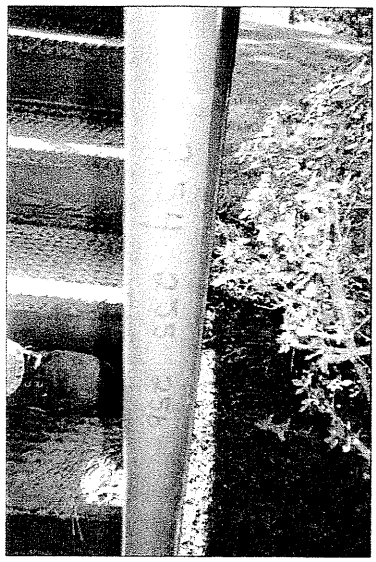
Metal post (XRF #254-256)

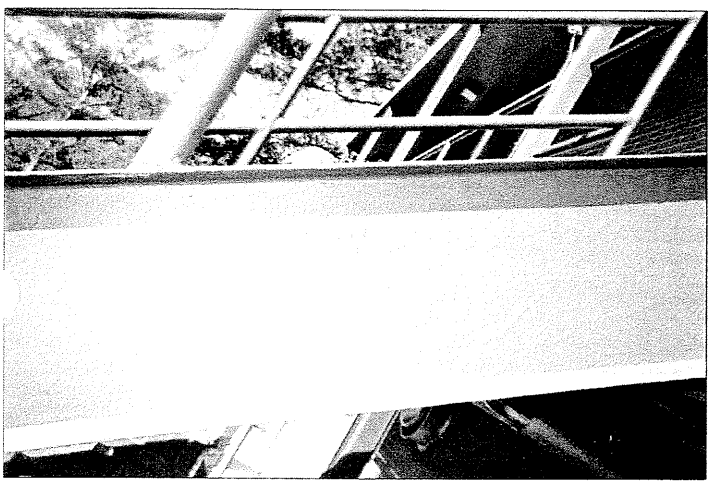
Stair beam (XRF #248-250)

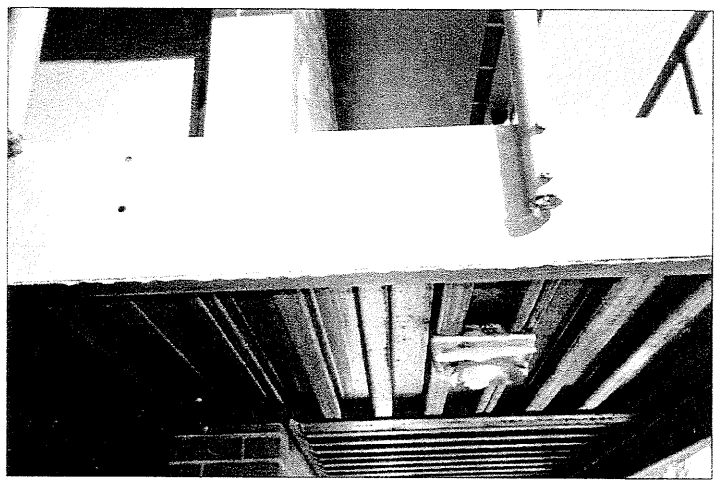
Upper level walkway horizontal beam (XRF #263-265)

Corrugated metal decking (XRF #260-262)

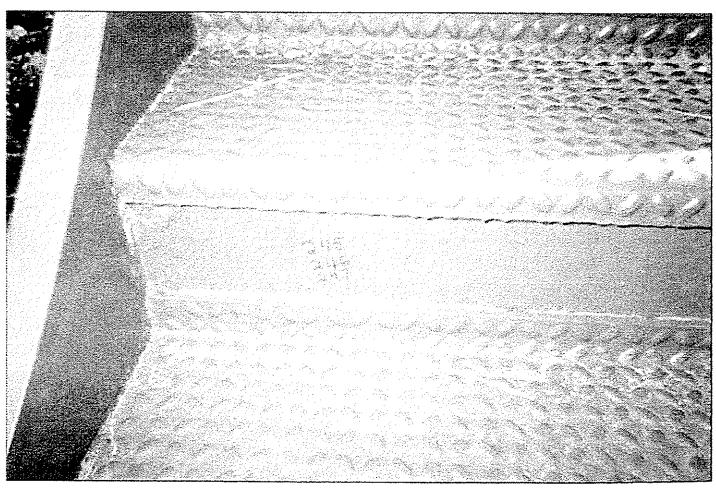
Stairs (XRF #245-247)

Handrail (XRF #257-259)

Stair baseboard (XRF #251-253)

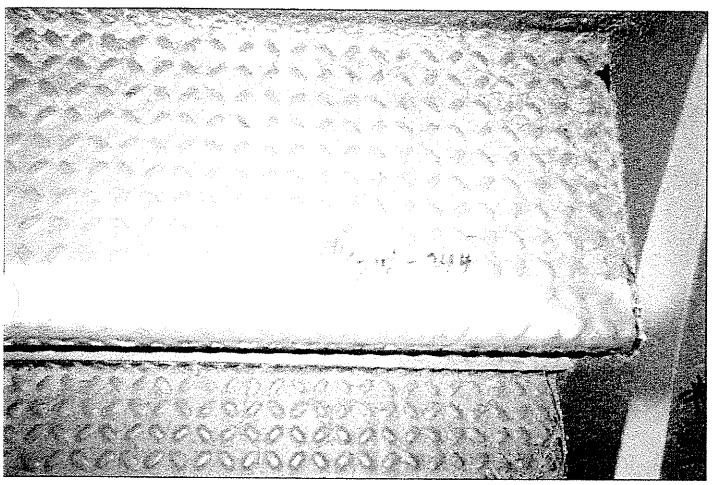
Stair tread (XRF #242-244)

Ceramic tile (XRF #116)
