FORT McCLELLAN
CALHOUN COUNTY, ALABAMA
BUILDING #3134

LEAD-BASED PAINT XRF SAMPLING RESULTS

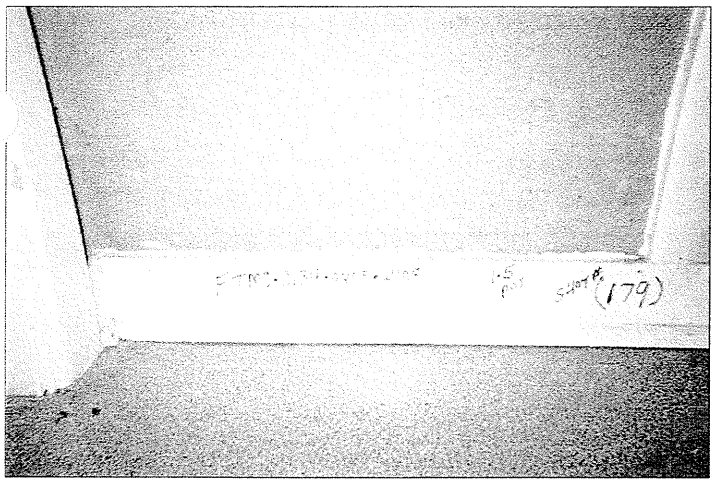
Baseboard (#179) & wipe sample W108

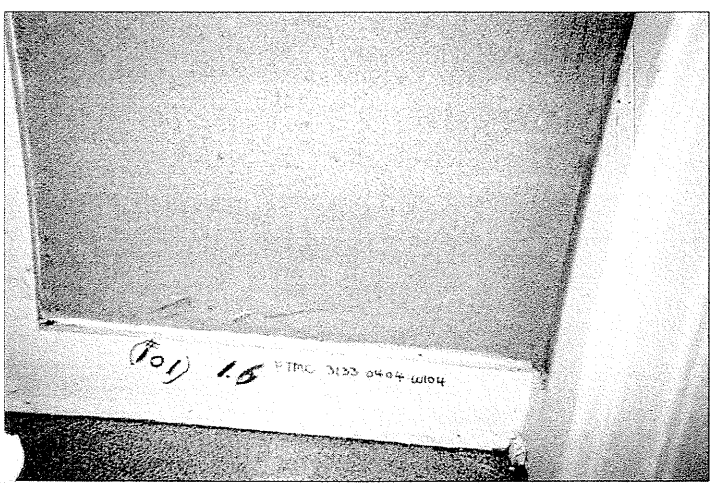
Baseboard (#101) & wipe sample W104

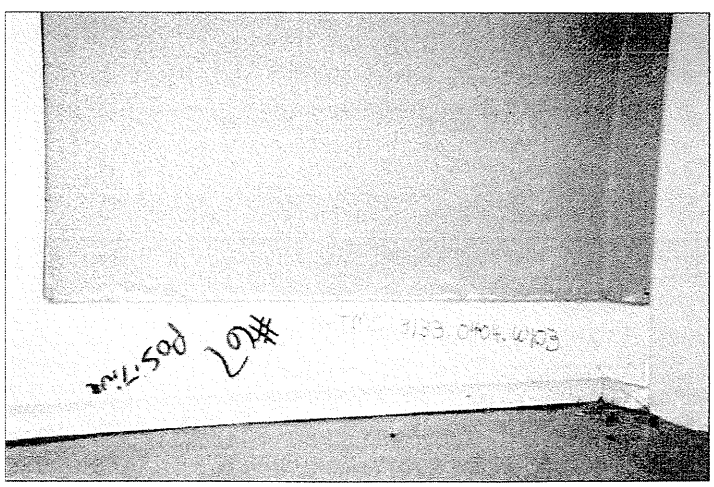
Baseboard (#67) & wipe sample W103
