**ASBESTOS CONTAINING BUILDING MATERIALS  
SURVEY REPORT**

**ASBESTOS CONTAINING BUILDING MATERIALS SURVEY  
MISCELLANEOUS BUILDINGS  
PACM**

**FORT McCLELLAN, ALABAMA**

U.S. ARMY CONTRACT NO. DABT02-96-D-0005  
DELIVERY ORDER 0033

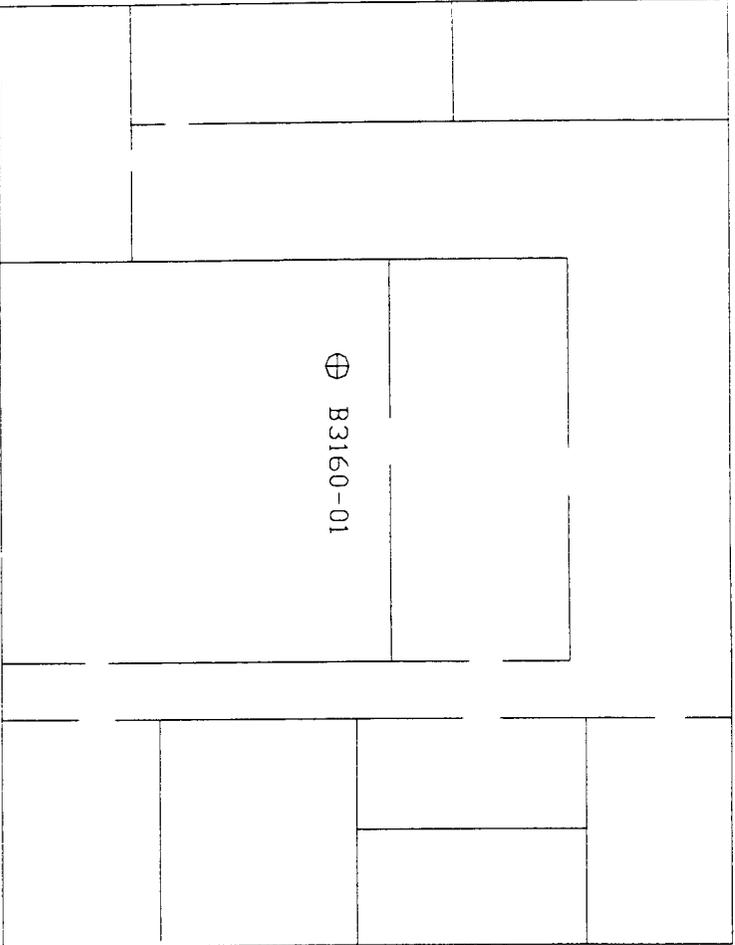
BUILDING: 2109	FIG. 1 LAYOUT	ASBESTOS SURVEY DAB102-96-D-0005 FM705	<b>REISZ ENGINEERING</b>
----------------	---------------	--	--------------------------

⊕ Positive Sample Locations

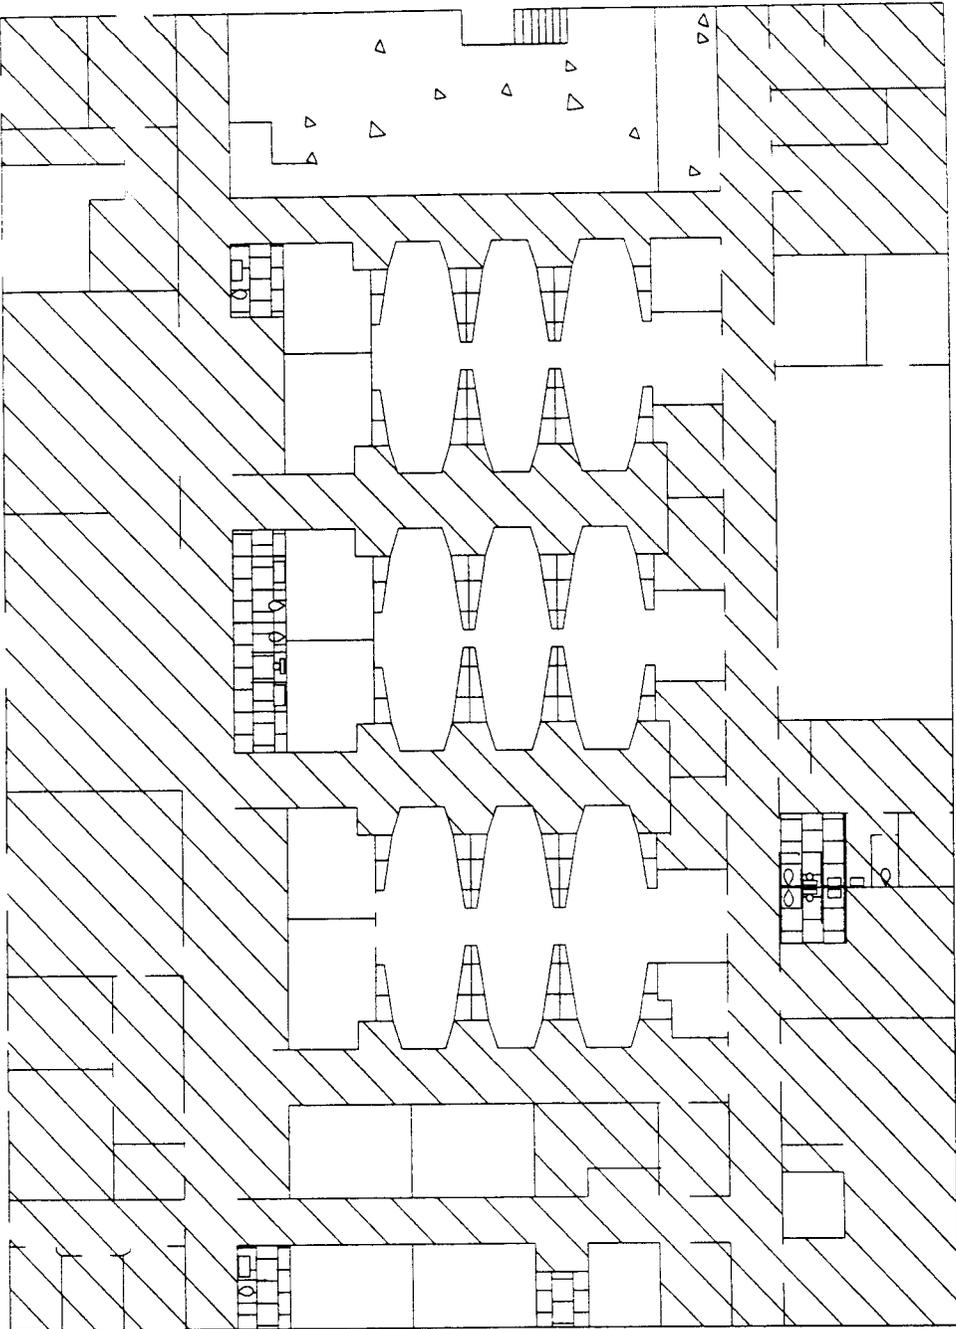
BUILDING: 337	FIG. 1 LAYOUT	ASBESTOS SURVEY DAB102-96-D-0005 FM705	<b>REISZ ENGINEERING</b>
---------------	---------------	--	--------------------------

12 x 12 Floor Tile

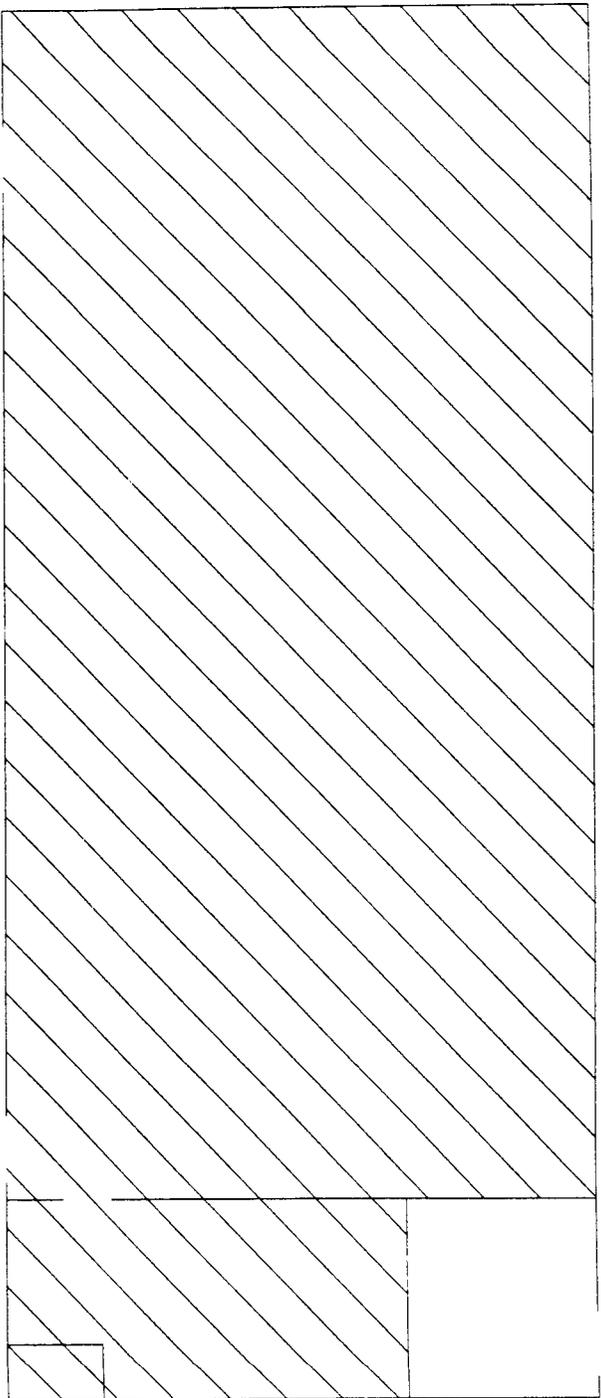
BUILDING: 2091	FIG. 1 LAYOUT	ASBESTOS SURVEY DAB102-96-D-0005 FM705	<b>REISZ ENGINEERING</b>
----------------	---------------	--	--------------------------

9 x 9 Floor Tile
