**LBP SURVEY REPORTS**

**LEAD BASED PAINT  
SURVEY REPORT**

**BUILDING(S): 9 and 13**

**LEAD-BASED PAINT SURVEY  
REPORTS FOR BUCHNER FAMILY HOUSING UNITS  
FORT McCLELLAN, ALABAMA**

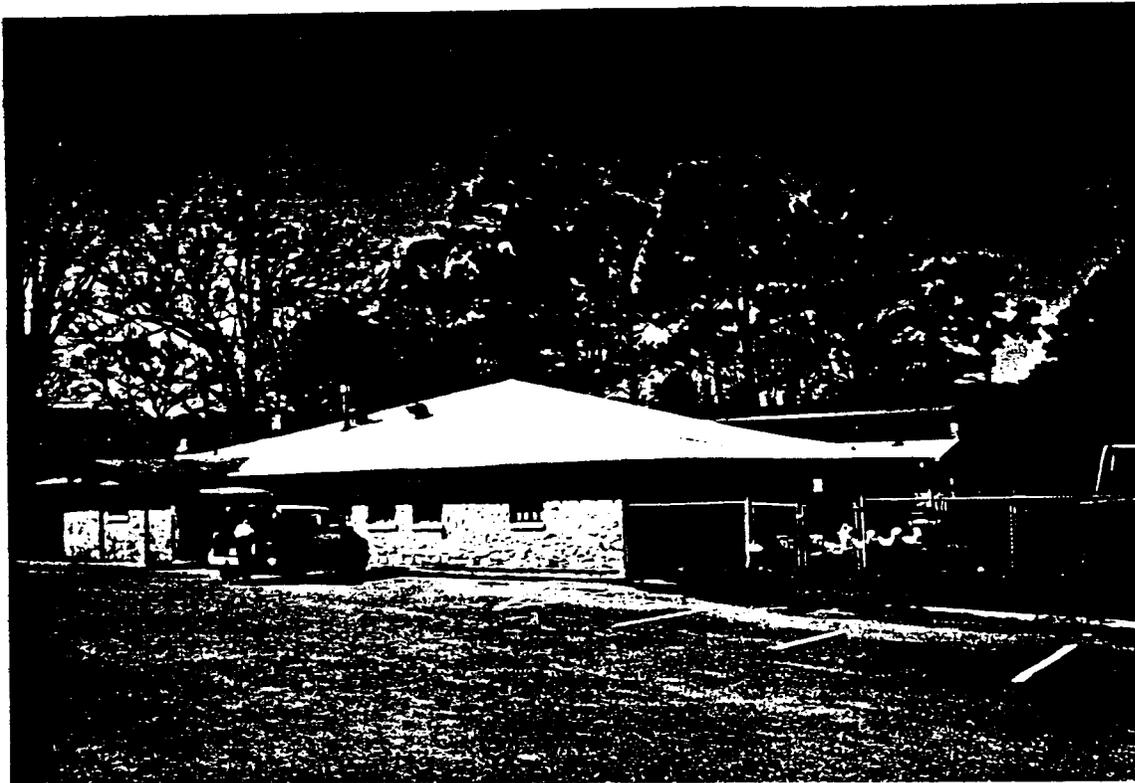
Figure 1. Front view of Building 66.

12. The paint on the interior of this building is in good condition. The paint on the exterior is in fair condition.
